An investigation of the moisture content in the walls of a straw-bale building

Steve Goodhew*¹ ^a, Richard Griffiths^b and Tom Woolley^c

Abstract

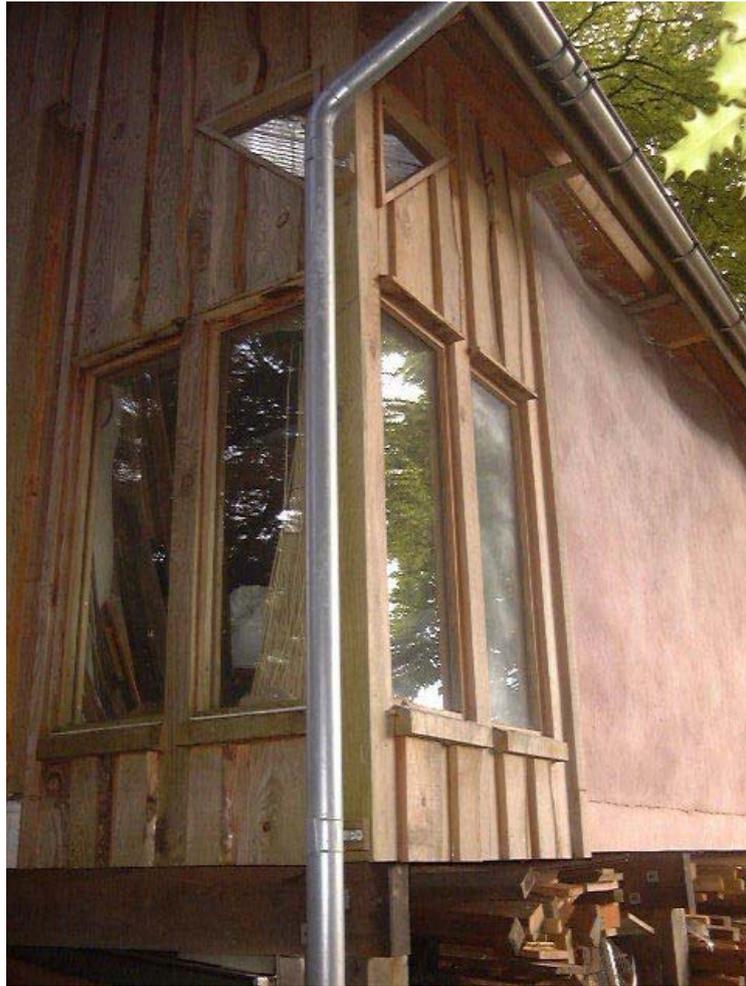
Figure 2, The south-east corner of the case study building.

Due to the many surrounding mature trees, mostly concentrated around the northern and eastern elevations, the environmental conditions around the building encourage an unusually high relative humidity. The moisture content within the walls of the building and in the relative humidity surrounding it, have been recorded since November 2000. Wood-disc probes were inserted into the walls after construction. Figure 3 shows a floor plan of the building with the location of the probes marked by letters A to I, (probe 'C' stopped functioning soon after fitment and so readings are not included). Two hygrometers were also installed in the building, one on the inside and outside of the external walls on the building.

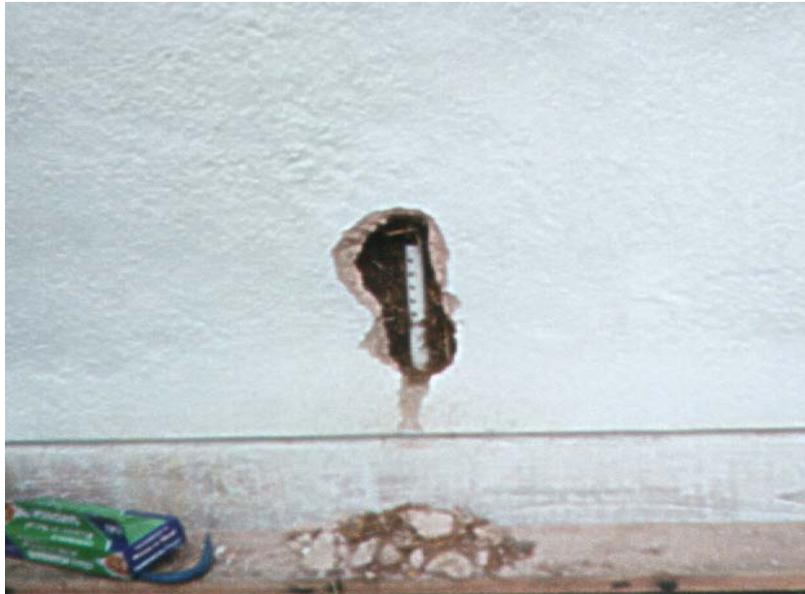
It was therefore concluded that the cause of the high moisture reading was moisture penetrating the render on the outside face of the south side of the building. As there were no more probes located lower down the wall it was not possible to locate how far down the wall the moisture reading became higher. However, as the inner probe, placed only 100mm from the outer probe had as low a moisture content reading as the probe placed in the top of the wall, it can be assumed that even in quite moist areas of straw, moisture migration is relatively slow.

Figure 10, Chipped off render, exposing the probe.

Five samples were oven dried and the average moisture content of the removed damp straw from the south wall was 27%. This value compares well with the 25% moisture content reading from the wood-disc sensor. The previous laboratory calibration gave a potential accuracy of +/- 1% between oven drying and wood-disc sensors and this field comparison, with 2% difference supports this degree of accuracy.

It was decided to remove the lower part of the lime render and expose the straw. This has presented a unique opportunity for samples to be taken from around the wood-disc probe that has been in situ for over a year. The lower part of the straw felt damp, this was removed and replaced with fresh straw. The removed samples were oven dried to find the exact moisture content and these values compared with the readings the sensor has been giving for the straw in this location.
