# Causes of Defects Associated with Tolerances in Construction: A Case Study

Saeed Talebi<sup>1</sup>; Lauri Koskela<sup>2</sup>; Patricia Tzortzopoulos<sup>3</sup>; Michail Kagioglou<sup>4</sup>; Chris Rausch, S.M.ASCE<sup>5</sup>; Faris Elghaish<sup>6</sup>; and Mani Poshdar<sup>7</sup>

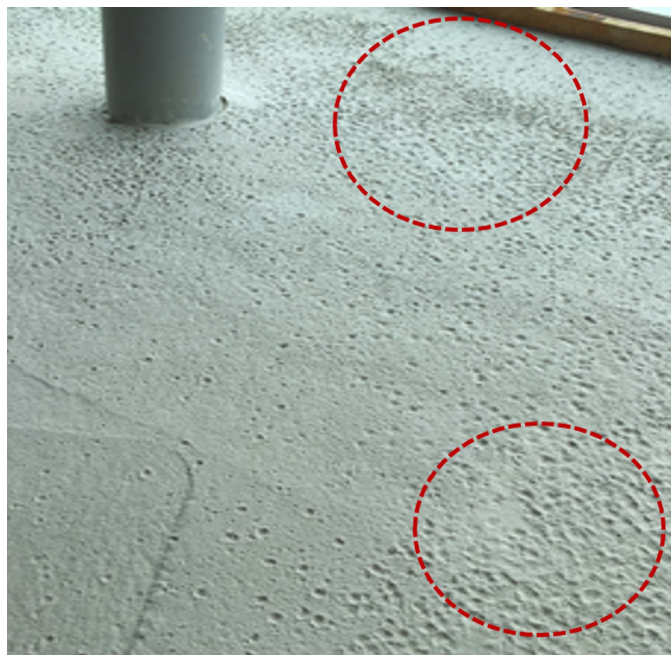
The concrete subcontractor had to stop working in the evenings when pouring upper floors due to complaints from residents living around the site to the Environment Agency of the Local Authority and could not use the power float when it started to rain (Interviewees 1, 7). Rain as an *environmental condition* (Interviews 6, 8) and people’s complaints as an *unforeseen special cause* (Interviewees 2, 8) “made it difficult for the concrete subcontractor to achieve the required [flatness tolerances in] surfaces” (Interviewee 8) (Fig. 2).

**Fig. 2.** Flatness of concrete slabs affected by special issues.

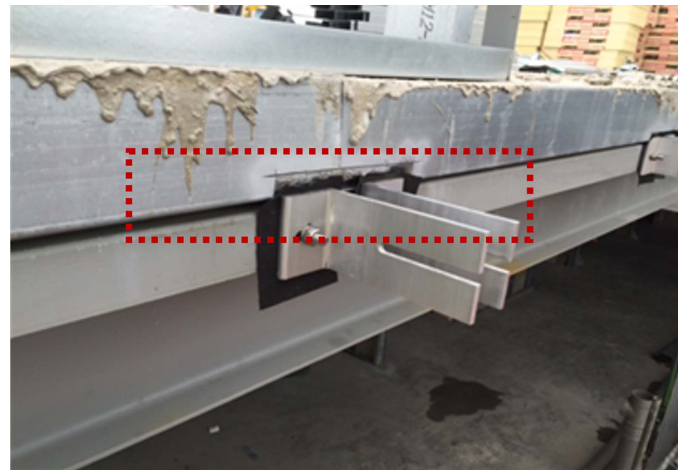
documents) (Interviewee 7). CONSTRUCT Concrete Structure Group (2010) states that the permitted deviation for the position of the slab edge relative to the actual position of the slab edge is  $\pm 10$  mm. However, “as soon as the concrete slabs at the roof level start to deviate toward outside the building, they will conflict with the cladding brackets” (Interviewee 7), which shows the overreliance on reference documents to specify tolerances resulting in this tolerance issue. Given that the concrete edge protruded more than permitted from the surface of the steel beam, the bracket could not be installed without cutting the edge of the slab (Interviewees 1, 8, 9) (Fig. 3).

**Fig. 3.** Modified edge of the concrete slab.

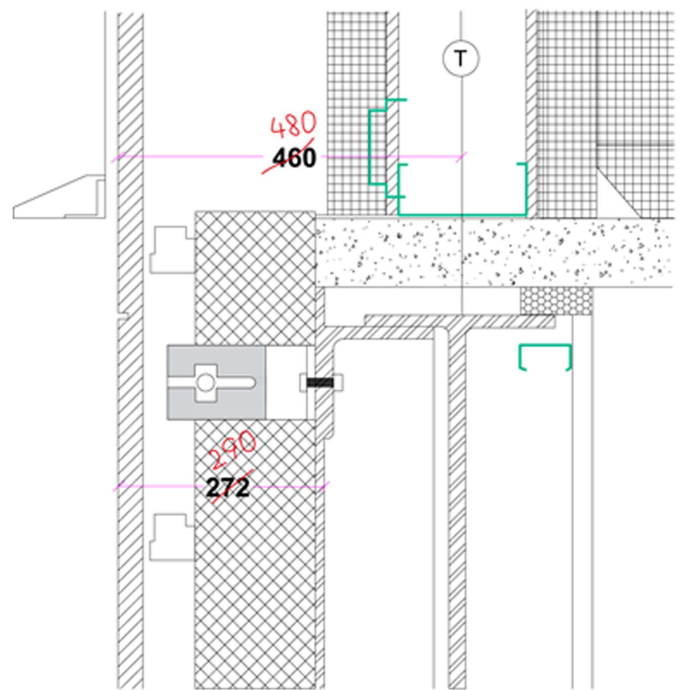
The steel framing systems (SFS) studs were out of plumb (Fig. 4). “None of the Quality Check Sheets included information about the

**Fig. 4.** Excessive perpendicularity variations of columns and stone panels.

permissible deviations of the plumbness of the SFS studs” (Interviewee 1), or “how and when they should be measured” (Interviewee 1). As a result, the tolerance problem with the SFS studs was recognized after they were handed over by the cladding subcontractor (Interviewee 7), when “they started to build their system on the SFS studs” (Interviewee 7). Thus, this problem was due to ineffective quality control documents. Also, Interviewee 4 says that given “the operatives had to complete their work as quickly as possible, they were not that much concerned about the quality of their work.” Hence, poor workmanship was another cause behind this tolerance issue.

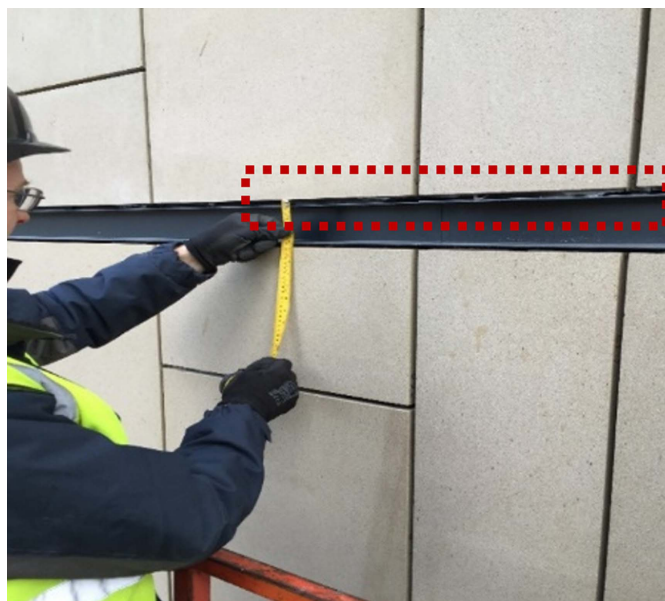
Fig. 5. Inconsistent gaps in some areas between the channel and the stone panel.

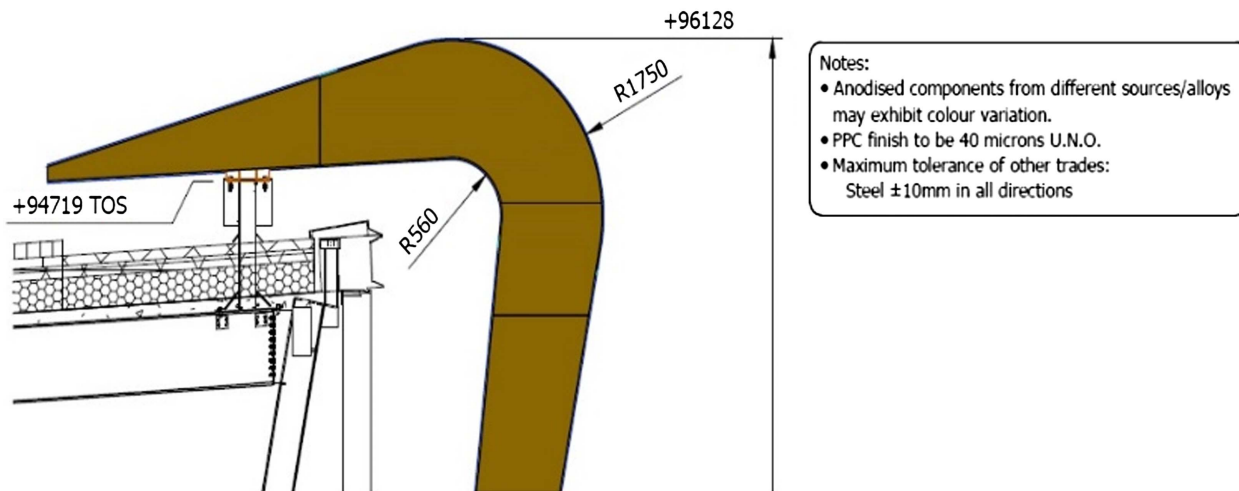
and steel structure, but rather, tolerance information for each component could be found in dispersed specifications (i.e., fragmented tolerance information in specifications). In the specification called projecting feature fin system, it is stated that any points on the steel columns are allowed to have a tolerance of  $\pm 10$  mm. It turned out this tolerance was not achievable by the steel subcontractor (Interviewees 2 and 8). This indicates not only inaccurate tolerance information in specifications (Interviewees 1, 2, 8, 9) but also incompatibility between the specified tolerances and process capability (Interviewees 1, 8) (Fig. 6). Hence, the design of connections between the steelwork and fins had to change to accommodate more deviations (Interviewees 1, 6, 7, 9) as columns on level 3 were more than 30 mm out of plumbness (i.e., inferior design of connections) (Interviewees 7, 9).

**Fig. 6.** Connection between the structural frame and a fin and the specified tolerances for the steel columns.

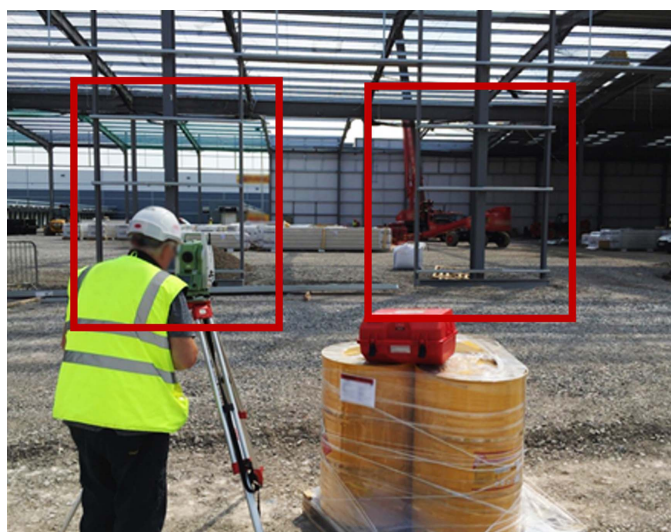
No information could be found in the specifications indicating that the parallelism of stanchions is essential to ensure that the electrically operated shutter doors will fit in the doorways (i.e., insufficient tolerance information in specifications) (Interviewees 10, 14). “There was no communication of tolerance information before construction whatsoever” (Interviewee 11). The only information communicated between the site manager and the steel subcontractor was whether deviations in the plumbness of installed columns and in the position of the installed base plates complied with the tolerances stated in BCSA (British Constructional Steelwork Association) (2010) (Interviewees 11, 12). As a result, despite the fact that the steel and cladding subcontractors were functioning in the project as one entity, the required tolerance for the steelwork to fit the shutter doors was not communicated between them (Interviewees 10, 12, 14). Moreover, the structural designer had tried to use steel and ancillaries as little as possible (Interviewee 13). The two sides of the doorways were “neither connected to each other nor [were] they . . . fixed to the ground” (Interviewee 11), that is, they are free-standing. The inconsistency between a tolerance requirement (i.e., fitting the shutter door without any rework) and its budget led to a situation that by aligning one side of a cladding rail,

**Fig. 7.** Misalignment of stanchions.

the other side was becoming out of alignment (Interviewees 10–12) (Fig. 7). This inconsistency was to cut down the project costs but resulted in a tolerance issue (Interviewee 14). “Setting a datum to either side of the doorway could have helped the people on-site to install the columns right in the first try” (Interviewee 11). This could also have assisted the site engineer to align the columns easier (Interviewees 11) (i.e., poor datum selection). Interviewee 15 believed that this tolerance issue shows that practitioners do not often have adequate knowledge about tolerances (i.e., lack of training on tolerance management).

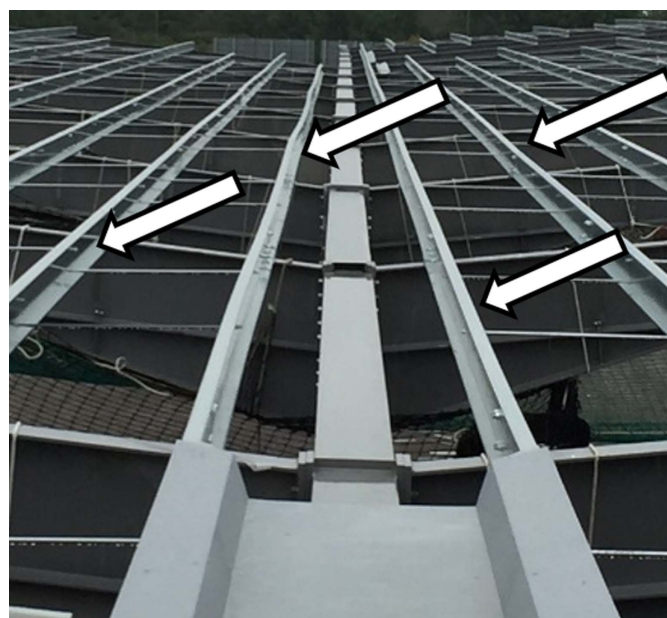
**Fig. 8.** Wavy purlins on the roof.

is not any indication in this document about how to install the purlins and avoid the risk of having them be wavy (i.e., insufficient information in specifications) (Interviewee 13). Moreover, poor workmanship is another cause of the issue with the purlins (Interviewees 10–12, 14, 15). If the steel subcontractor had been competent, they would have assessed whether the cladding subcontractor could be able to install the roof panels between the purlins (Interviewee 13).

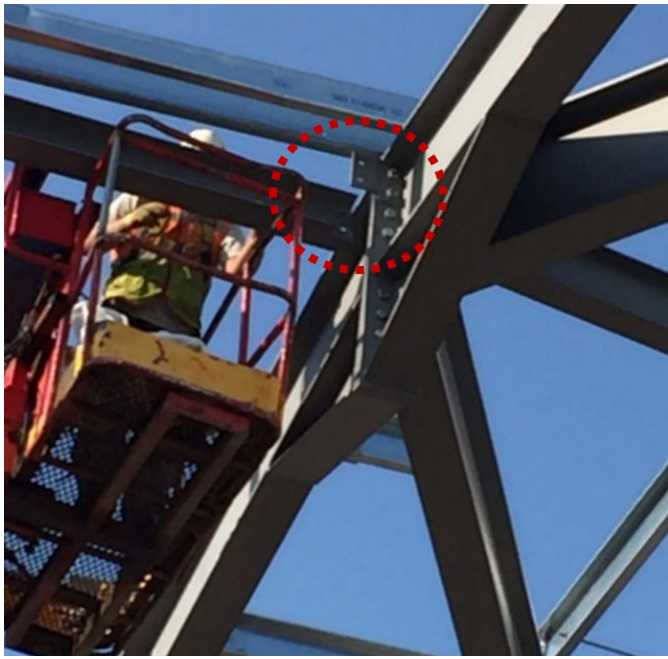
The building was erected from two sides: the first erected side initiated from Gridline 1 and continued to Gridline 30, and the second erected side started from Gridline 31 and was connected to Gridline 30. Hence, there was an interface between these two sides of the structure in Gridline 30. The columns in Gridlines 31 were out of plumb, and they were leaning toward the inside of the building. Also, the entire columns on the first erected side of the structure

**Fig. 9.** Lack of fit of the beam between two grid lines.

were oriented toward the first erected side. As a result, the beam coming across the top between Gridlines 28E and 30E from the initial side overlapped Gridline 30E where it connects two sides of the building (Fig. 9).
