# 3D Laser Scanning documentation for informing the post-earthquake recovery of heritage settlements a practical guide

This document is a product of the research project: *A sustainable re-construction method for seismic-prone heritage areas of India based on advanced recording technologies*, funded by the UKRI Arts and Humanities Research Council (AHRC) and the Department for Digital, Culture, Media and Sport (DCMS).

**Project Lead:** The Centre for Architecture, Urbanism and Global Heritage, Nottingham Trent University.

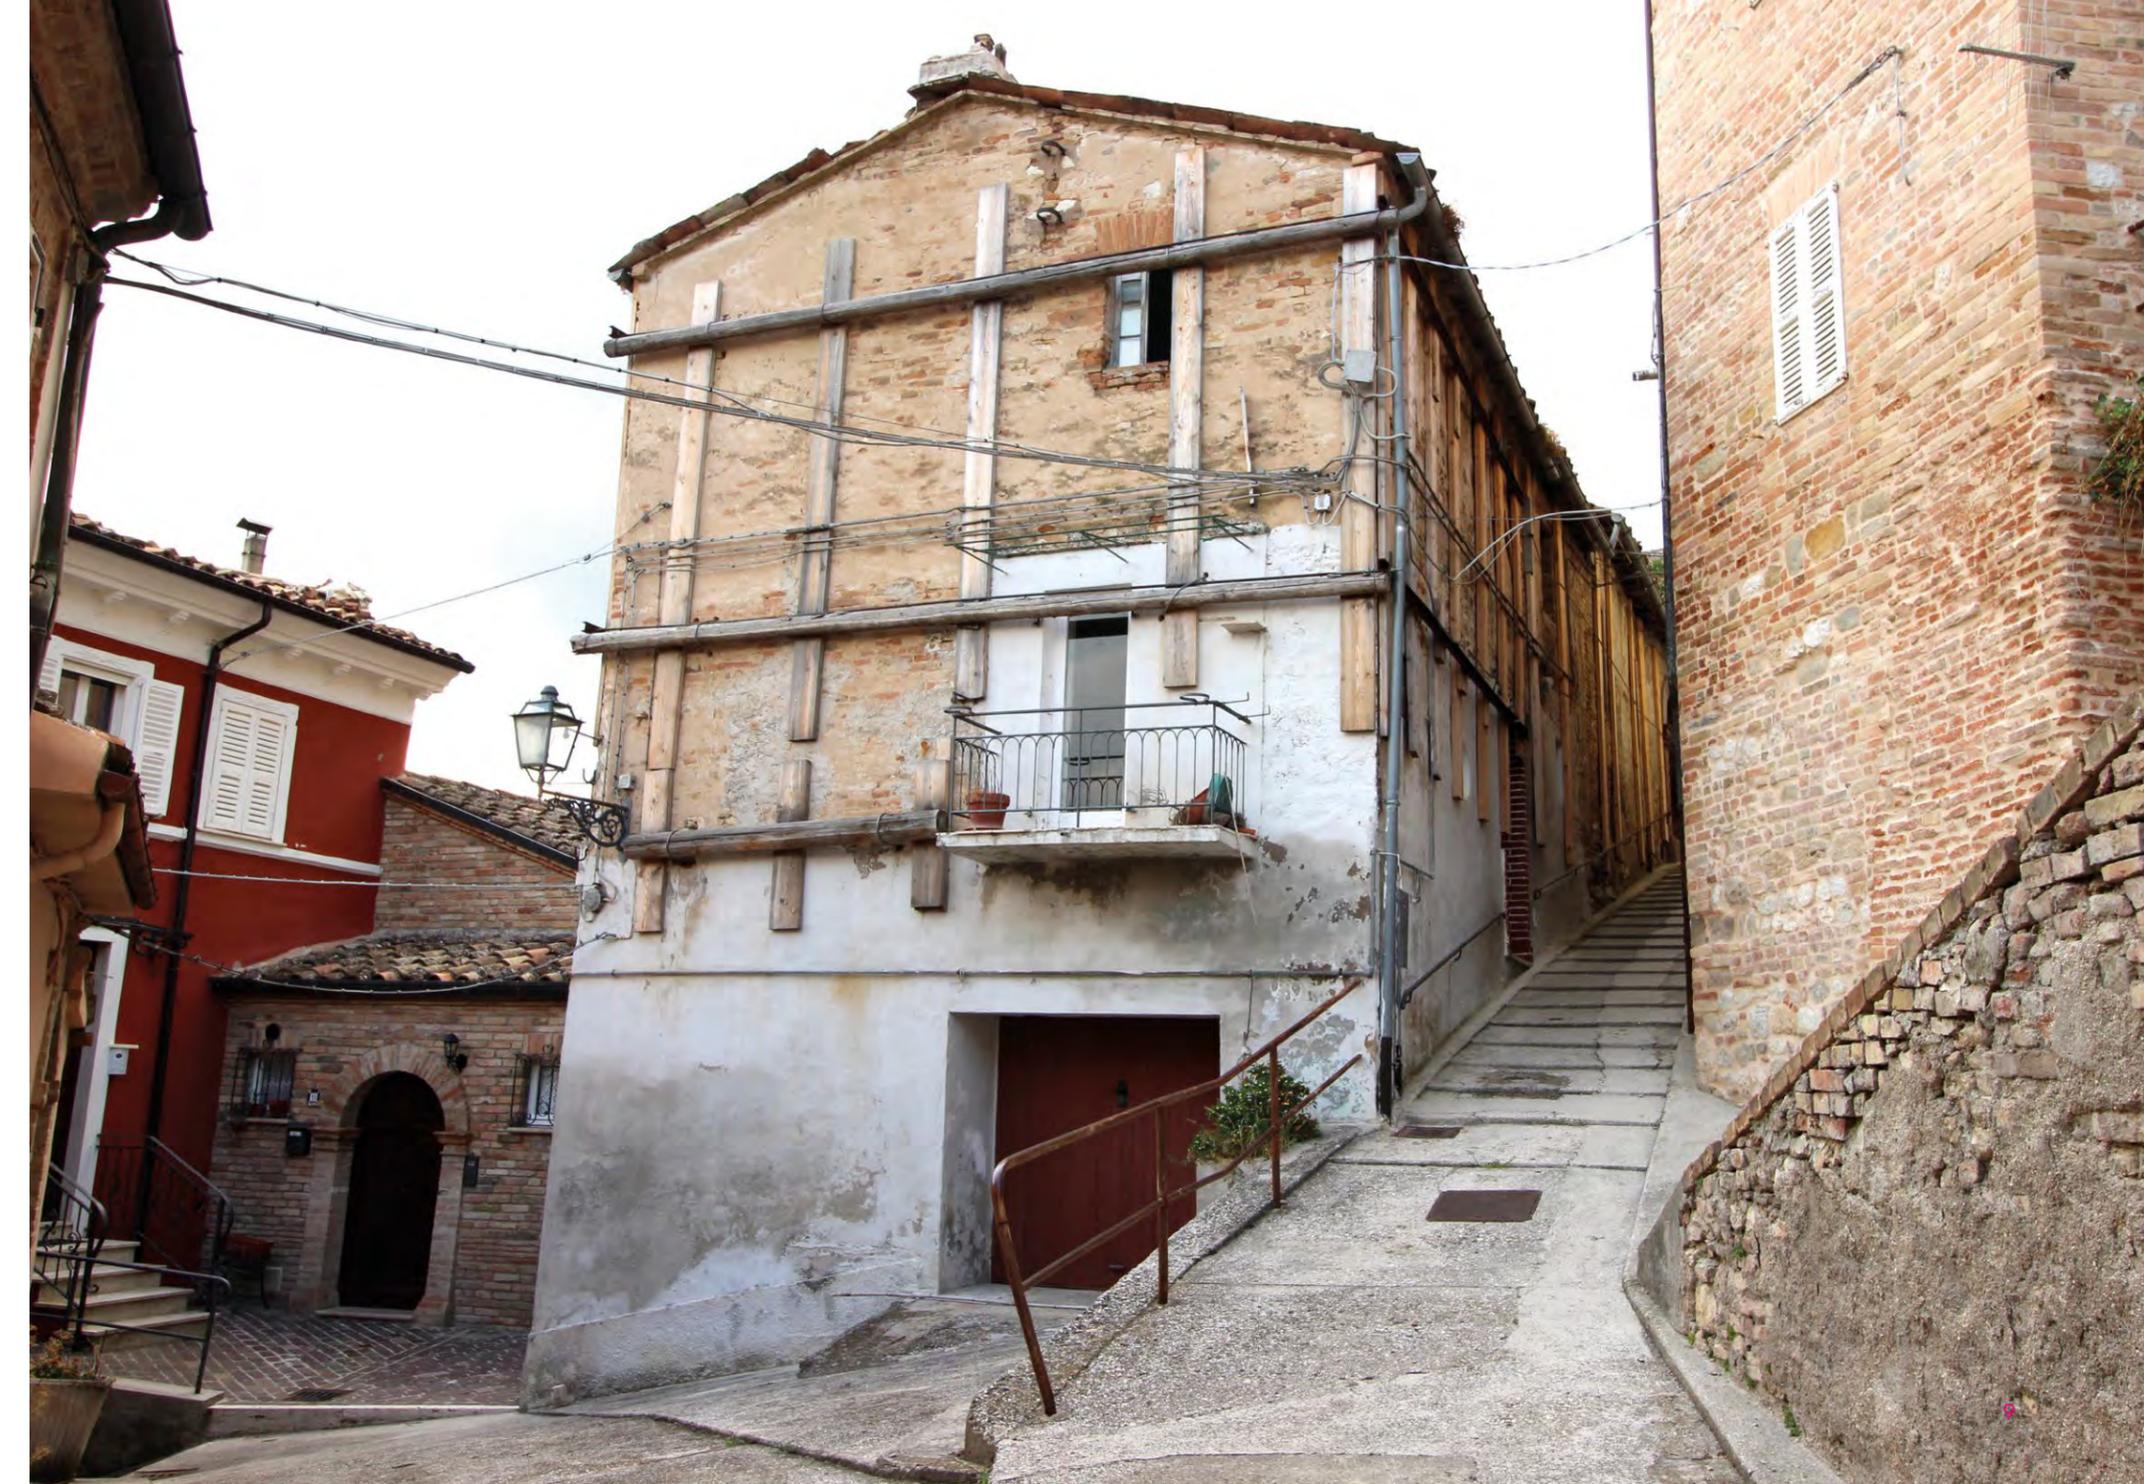
1. A photograph of a house affected by the 2016 earthquake in Amandola, Italy. Wooden reinforcements are holding the structure together.

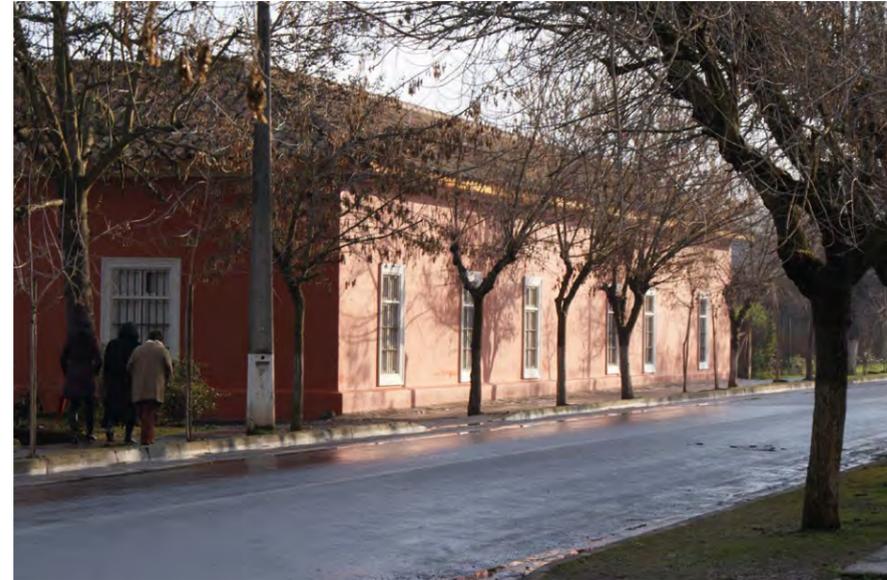
2. An adobe house with no damage after the 2010 earthquake in the historical village of Zúñiga, Chile, mainly due to regular maintenance and reinforcement.

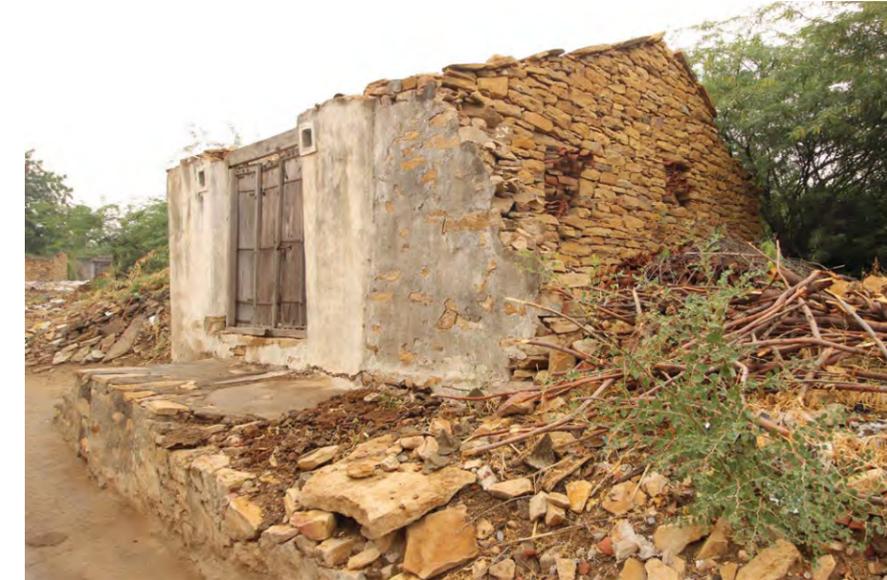
3. Photograph of a house in Bela, Gujarat, India.

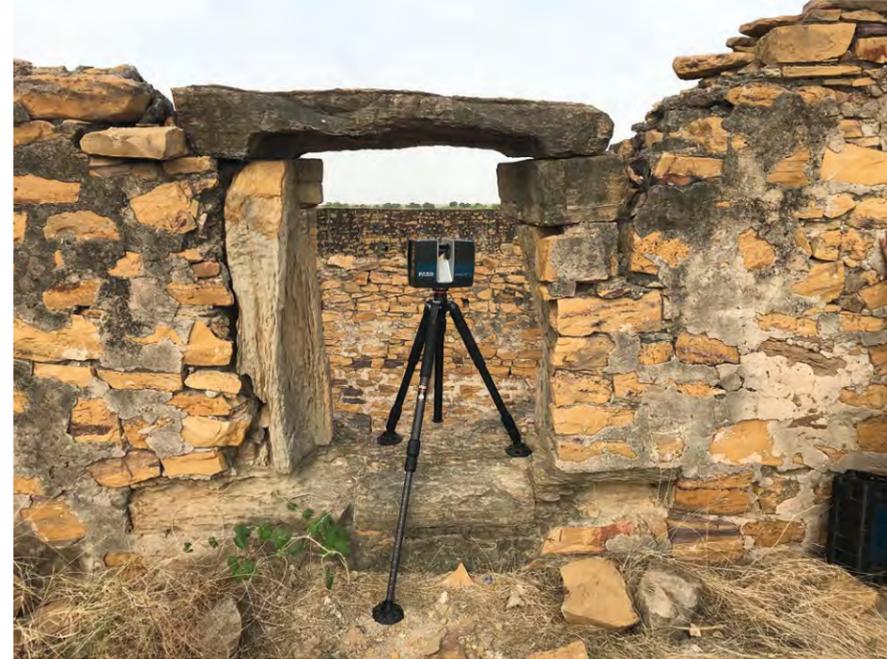
4. Faro Focus M70 3D scanner, used to scan data in Bela, Gujarat. 3D laser scanners are non-contact devices that capture data as point clouds, or millions of data points with colour information.

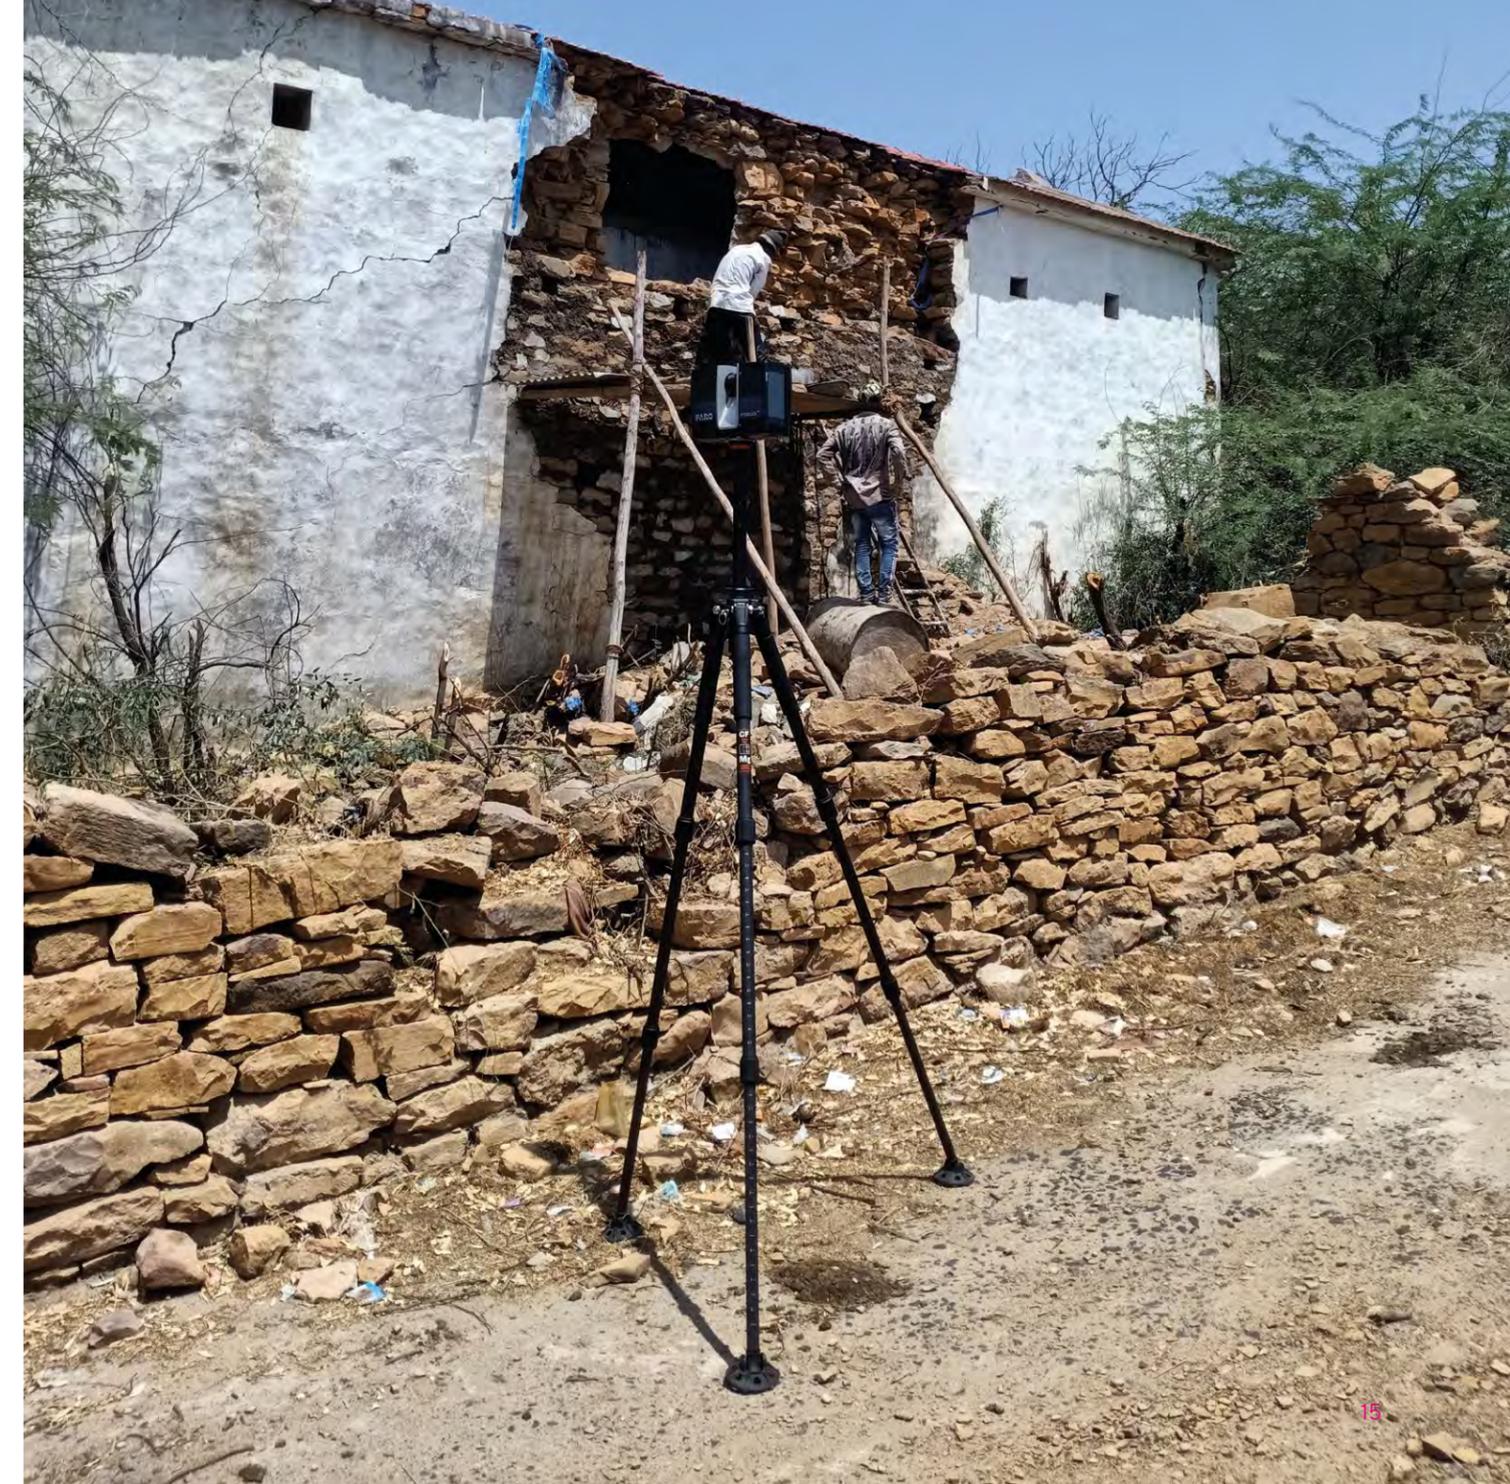
6. 3D view of a Darbar family temple in Bela, India, captured in only a couple of hours on-site (building number 5 as referenced in image 23, page 47). 3DLS is a powerful tool for understanding the vulnerabilities of structures at risk or that have already been damaged by earthquakes. In addition to providing a complete record for assessing the built aspects of a building or site, 3DLS is a high-speed, user-friendly tool that can generate a precise, visual model of three-dimensional spaces and show the relationship between internal and external areas, further helping users understand the social setting of the site being documented, e.g. sociocultural practices or its function.

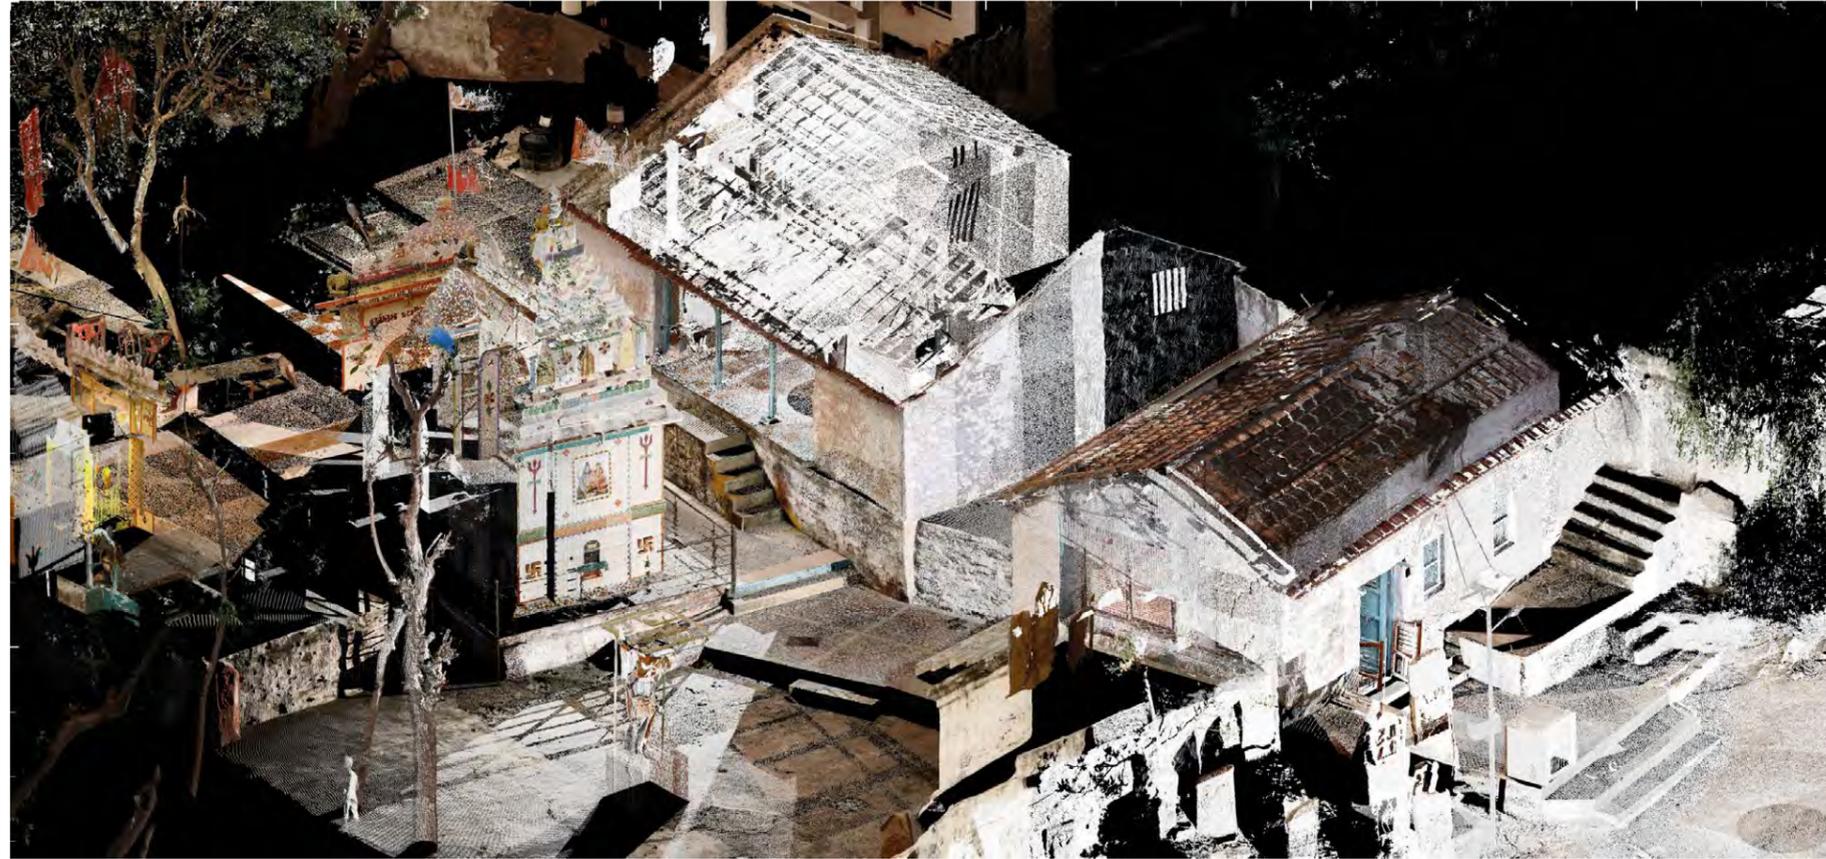
**7. 3D image of temple 18 in Bela indicating data gaps.** The limitations mentioned can be tackled by following the recommendations given, the expertise of surveyors, the specific aims and the latest advances in the technology's software and hardware. However, understanding the advantages and limitations of 3DLS, it is recommended to complement it with other forms of documentation of the built environment, such as photography, photogrammetry, and short videos – a fast and easy way of documenting spaces, materials, and activities.

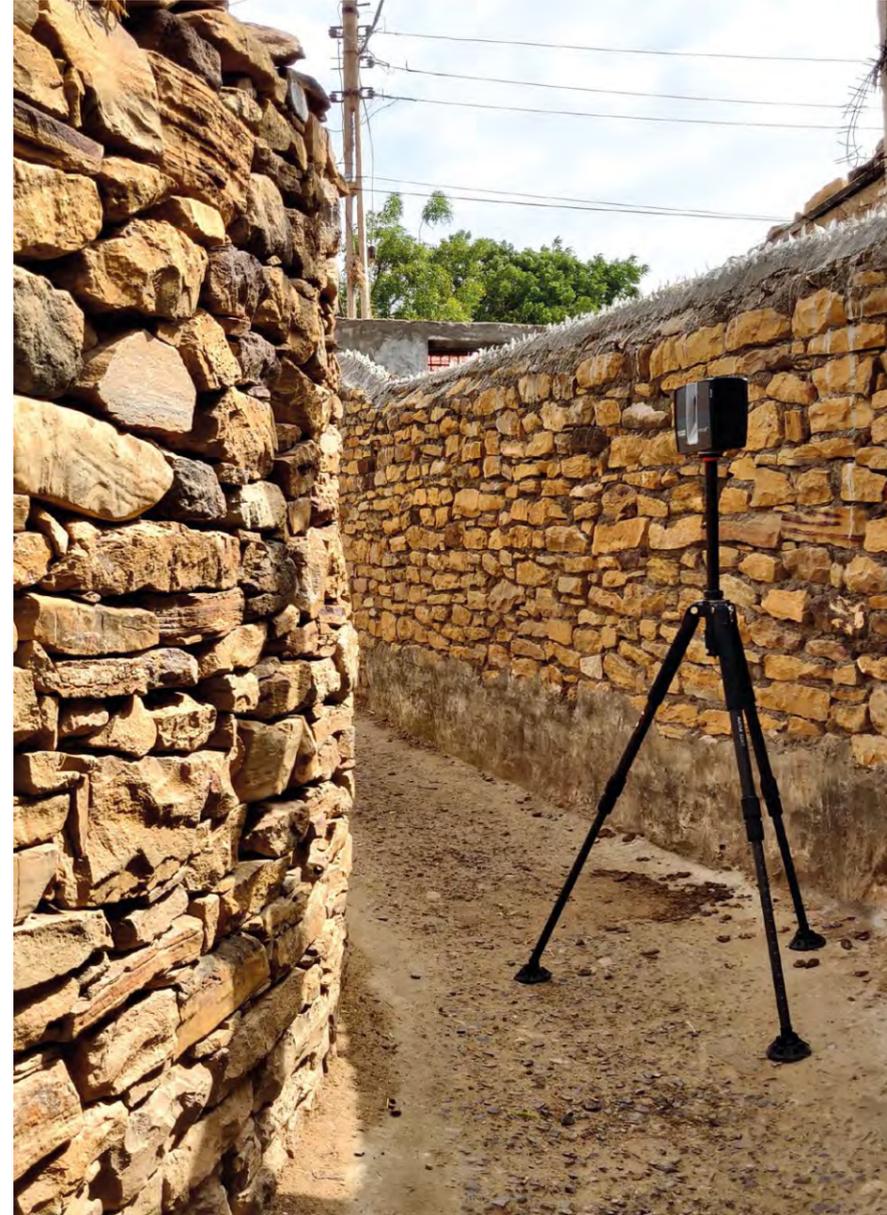
8. 3D laser scanner used in the data capture of Bela. Model: Faro Focus M70.

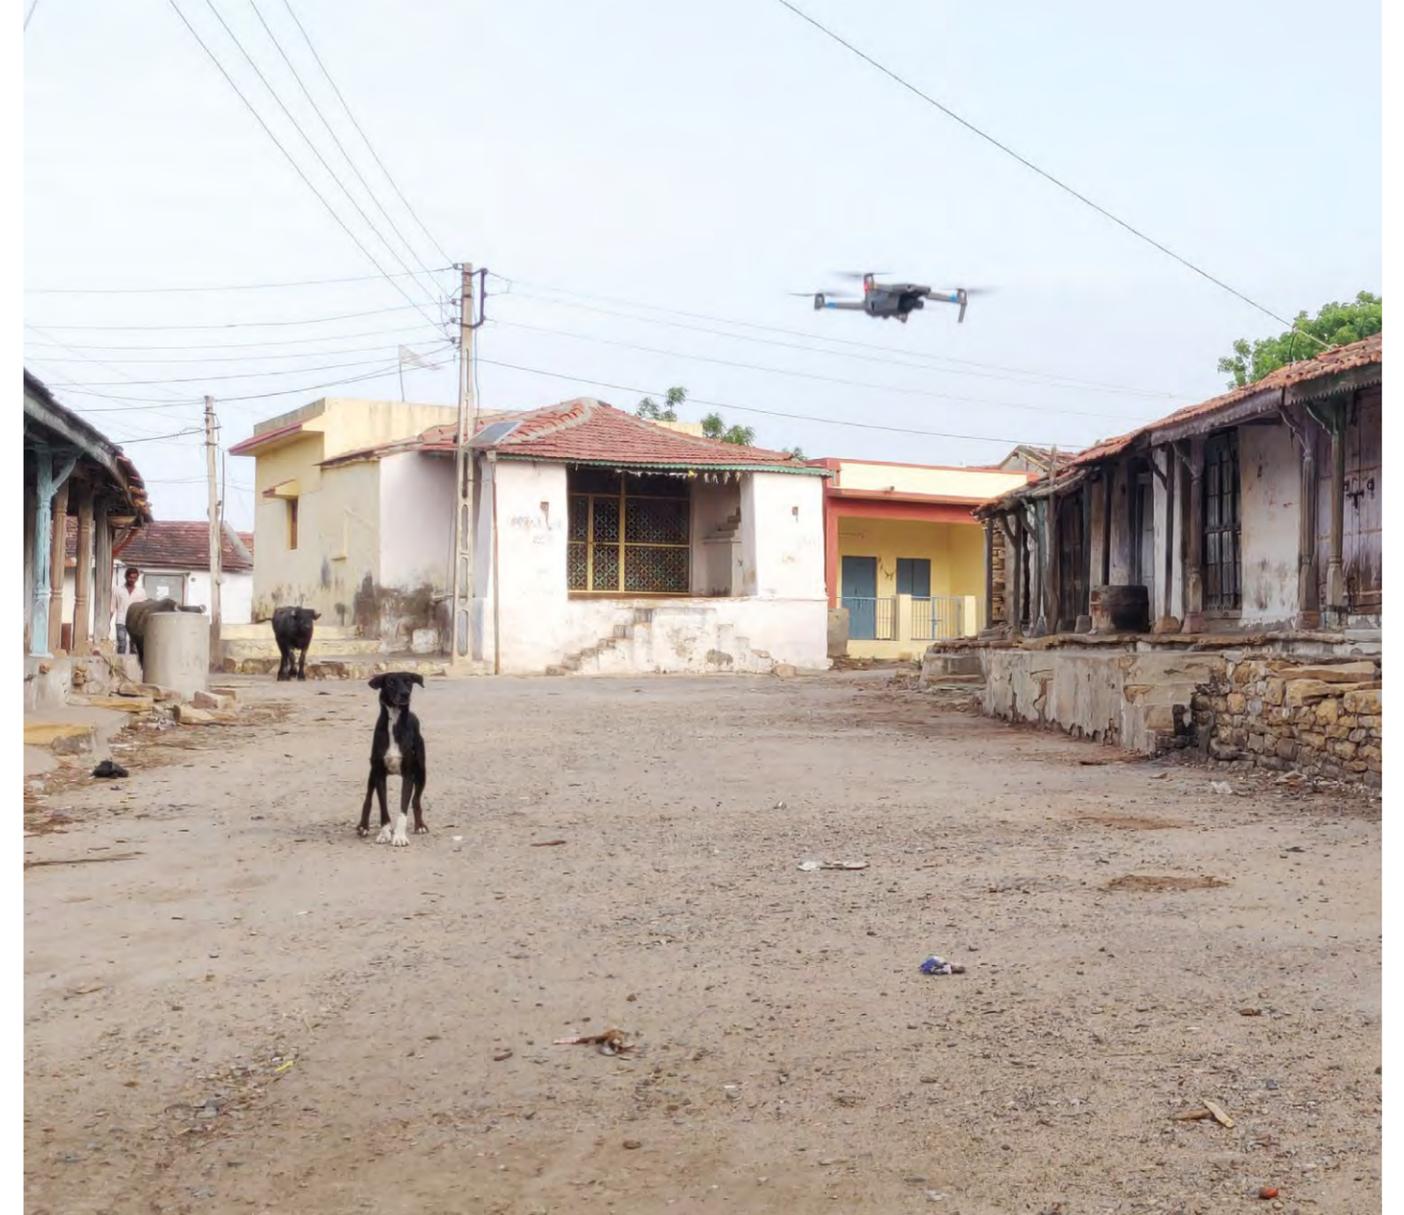
9. Drone used in the data capture of Bela. Model: DJI Mavic Air 2.

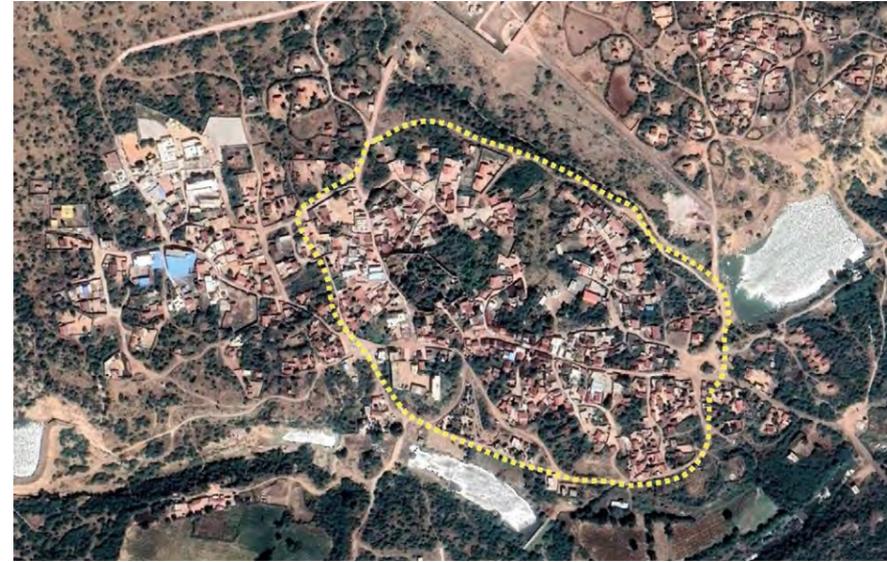
10. Understanding the site from existing google maps to get an idea of the village profile and a potential area to focus on. Here the example of Bela in Gujarat, India, located in the district of Kutch, northwest of the State of Gujarat, India. One of India's most seismic areas, it was affected by the Bhuj earthquake (7.6 Mw) in January 2001. Bela was once a trade hub due to its strategic placement on the pre-independence trade routes. It is characterised by a coherent built fabric of continuous facades and porticoes. The traditional houses are constructed mainly with stone, mud mortar, tile roofs a wooden support system. Although most buildings were damaged during the 2001 earthquake, very few collapsed.

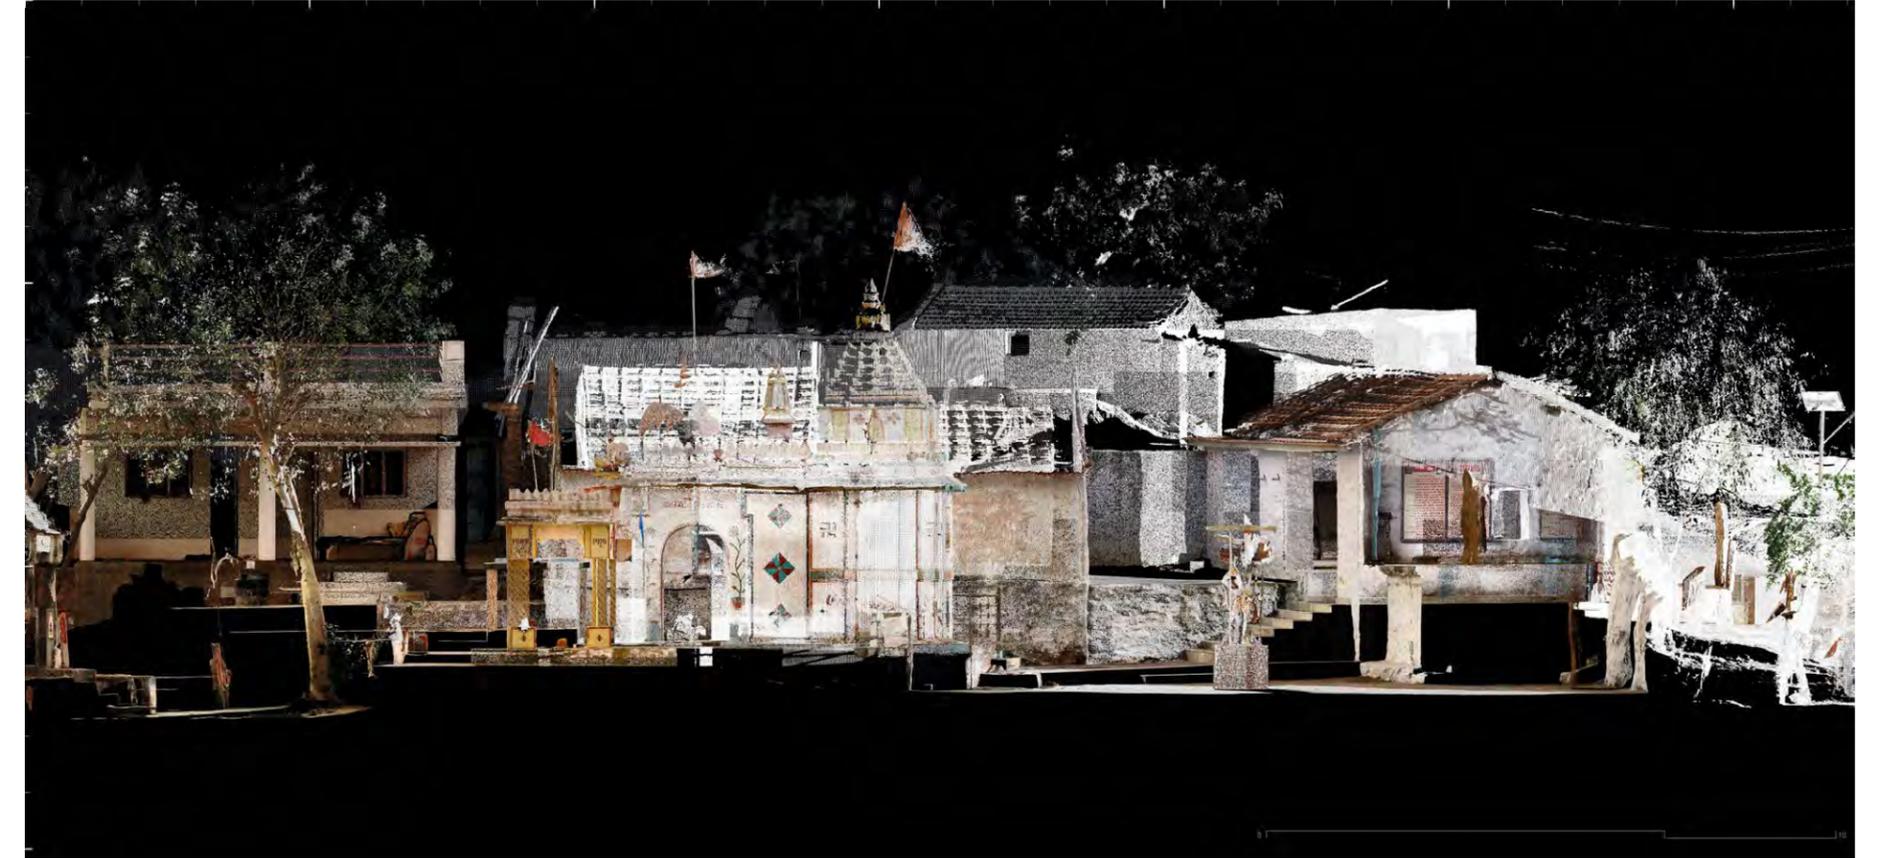
18. Section of the same temple, rendered from the 3D data of Bela. The 3D point cloud, images, and technical projections obtained can be used to interpret and analyse the information using appropriate software in 3D and 2D formats.

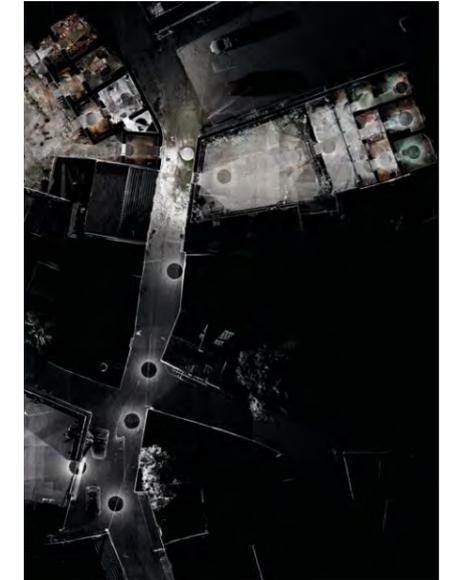
21. Zoom in on that plan, focusing on houses 1 and 2 in the Darbar area at Bela.

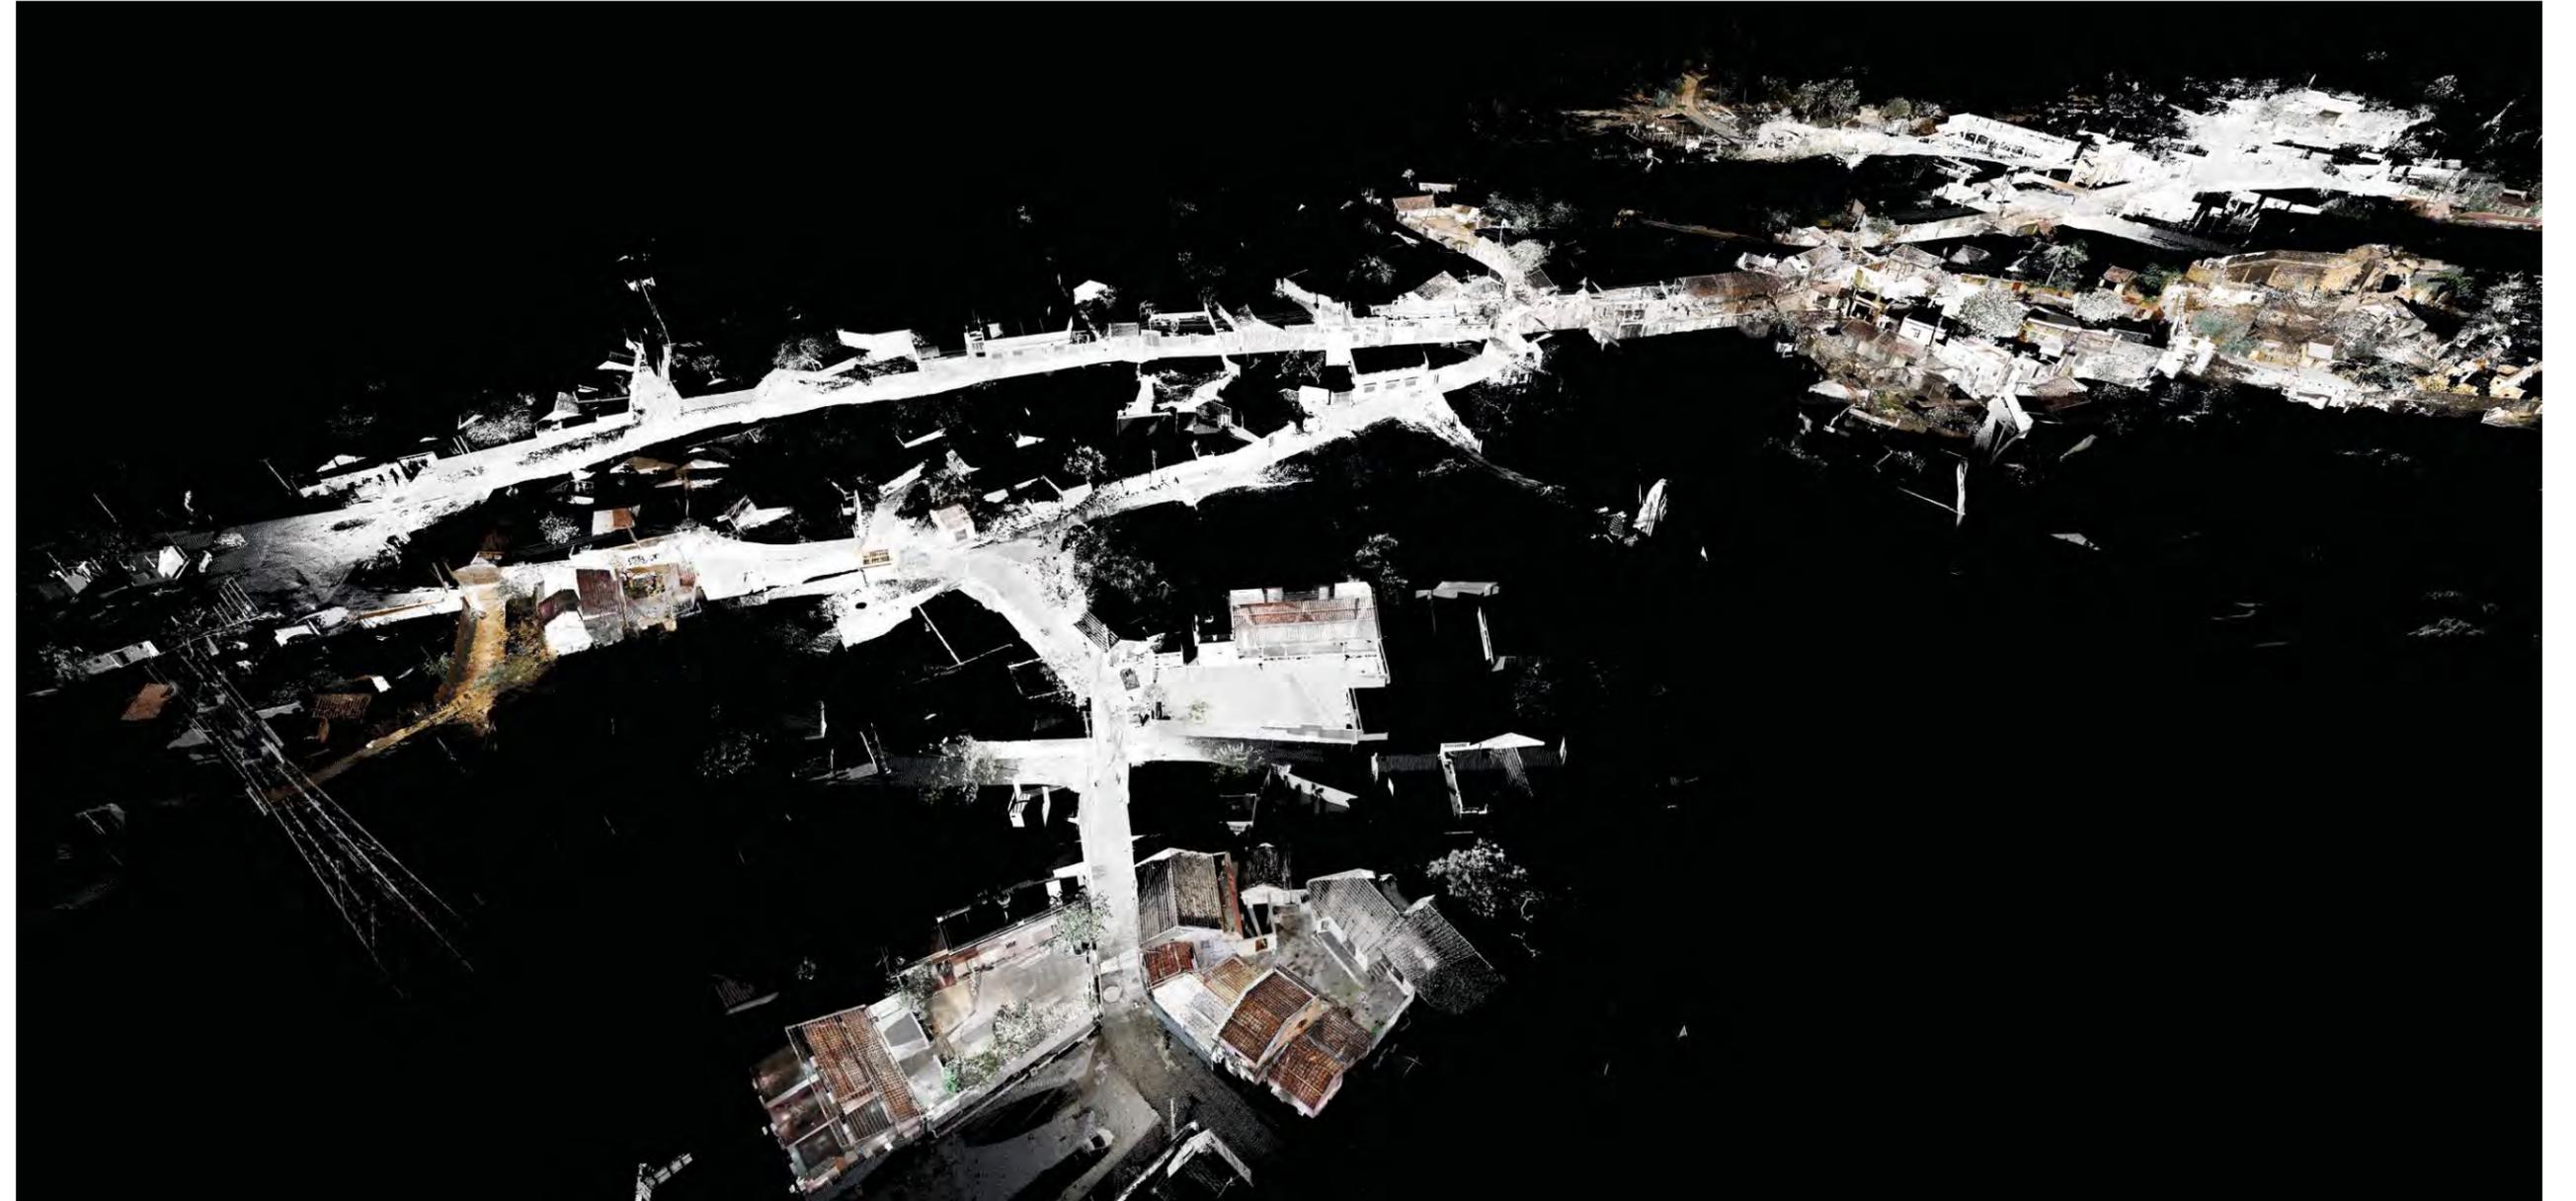
The following images have been rendered from the 3DLS data. The black circles correspond to all the positions where the 3D laser scanner was placed, and the black areas correspond to those where no scan data is available.

**23. Plan of Bela rendered from the 3DLS data indicating the 18 buildings interiorly scanned.** The 3D scan data was used as an accurate medium to further validate the CAD drawing made during the preparatory work in Bela, based on the Google Earth aerial view. Building numbers identified on this image are used to reference all the cases shown throughout this guide.

This has been used to generate a working plan that can serve to guide the post-earthquake actions according to the level of damage of each structure. The working plan combining different sources of information (Fig. 23) helped in understanding not only the physical characteristics of built and open spaces but also their connectivity with the rest of the settlement (Fig. 24). This can further inform the planning of recovery strategies such as defining appropriate intervention actions of the buildings, e.g. repair, retrofit or rebuild; or to create a mitigation and risk assessment plan at the level of the settlement, including spatial relevant information such as community refuge points or escape routes.

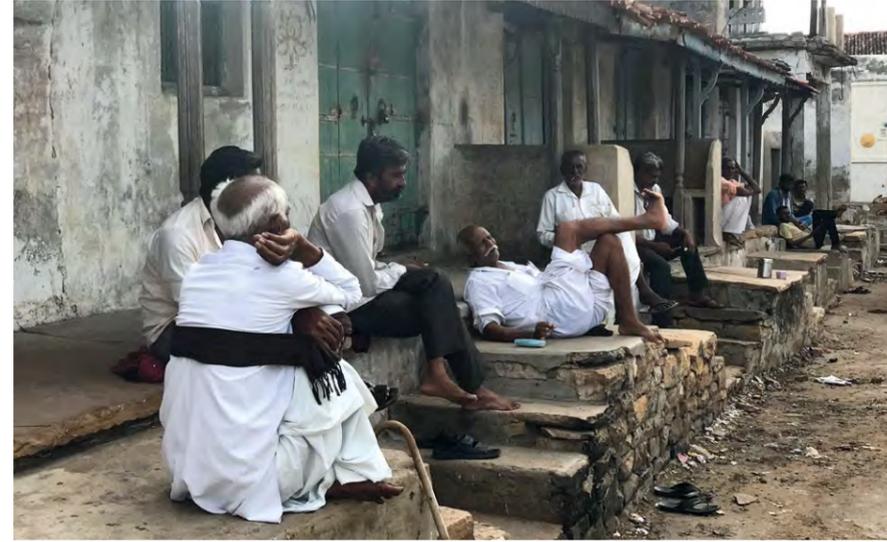
26. Public seating area at the Central Market Square where men congregate in Bela, Gujarat.

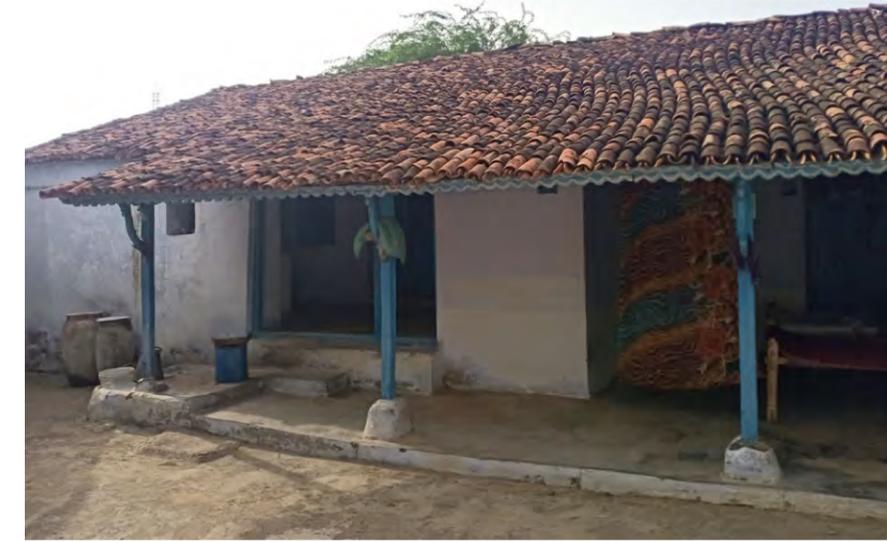
28. Single-storey house in Bela with plastered wall.

General observations, together with 3DLS data, showed that most constructions were single-storied (Fig. 28), sandstone buildings, with mud or cement mortar (Fig. 29), and sloping, clay-tiled roofs supported by wooden beams. When the walls were exposed (Fig. 30), the scans captured the detail of the stone masonry building technique.

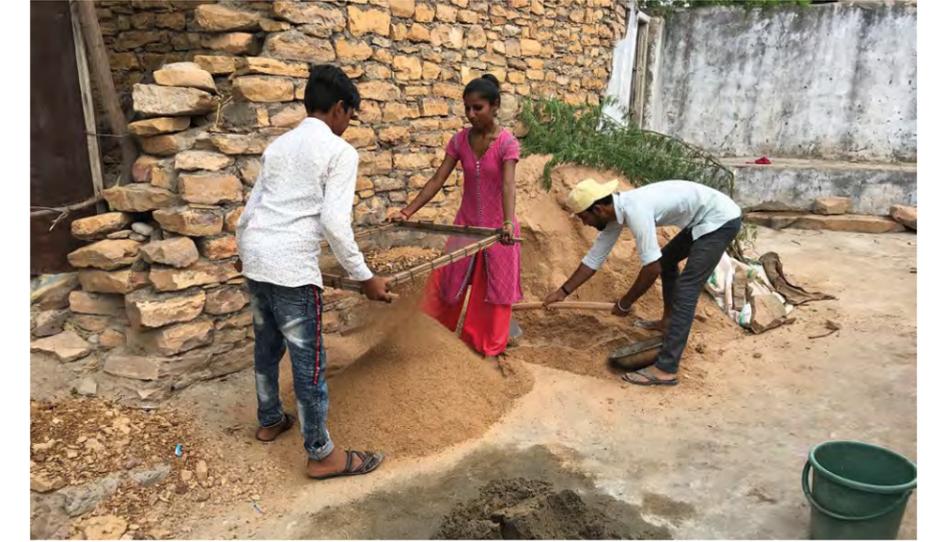
29. Community members building stone walls with cement mortar.

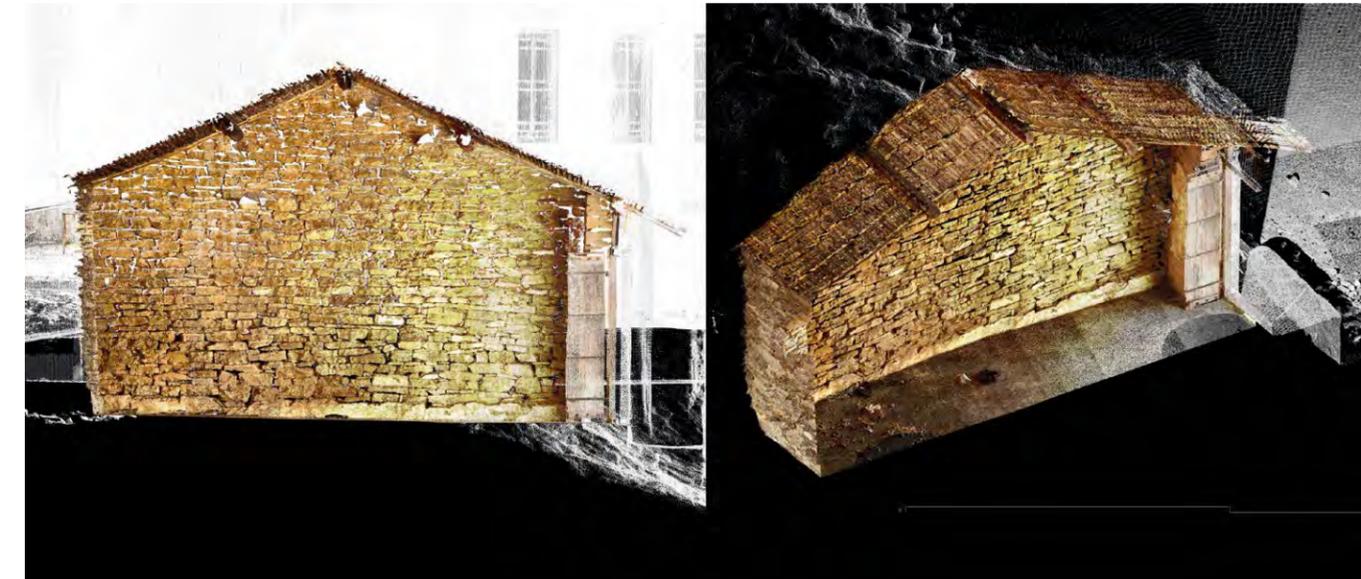
30. Section and axonometric of building 3 in Bela, rendered from the 3DLS data, revealing the detail of the stone masonry used in constructions. Refer to plan in Figure 23 for the building's location.

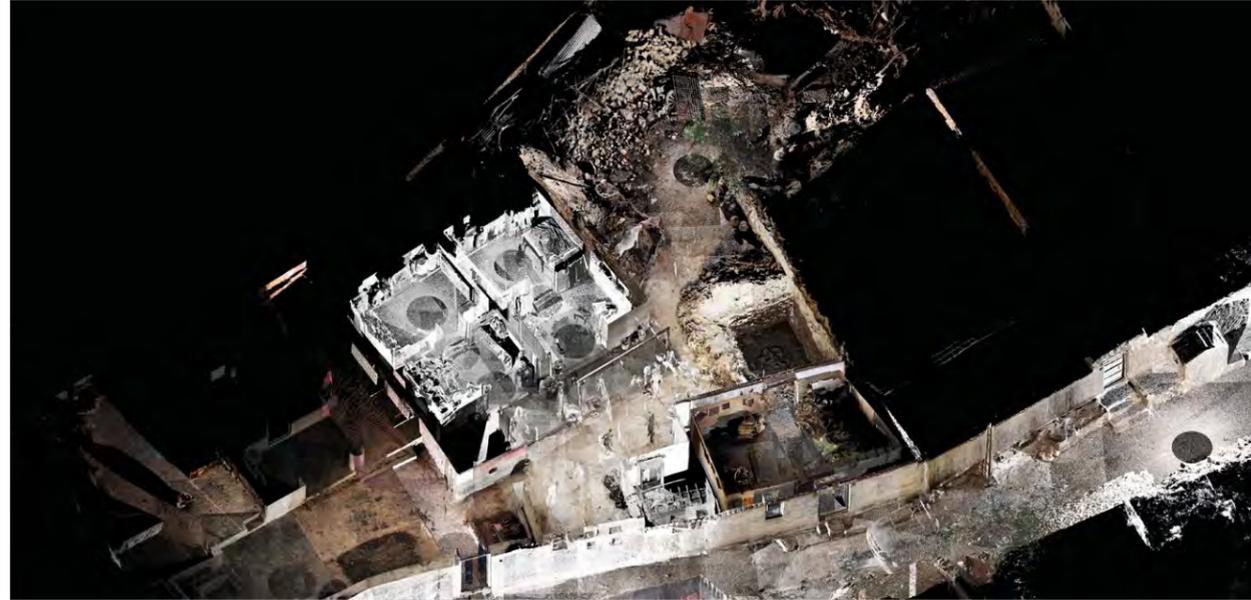
Figure 31. Axonometric view of house number 9 in Bela, rendered from the 3DLS data captured in June 2021.

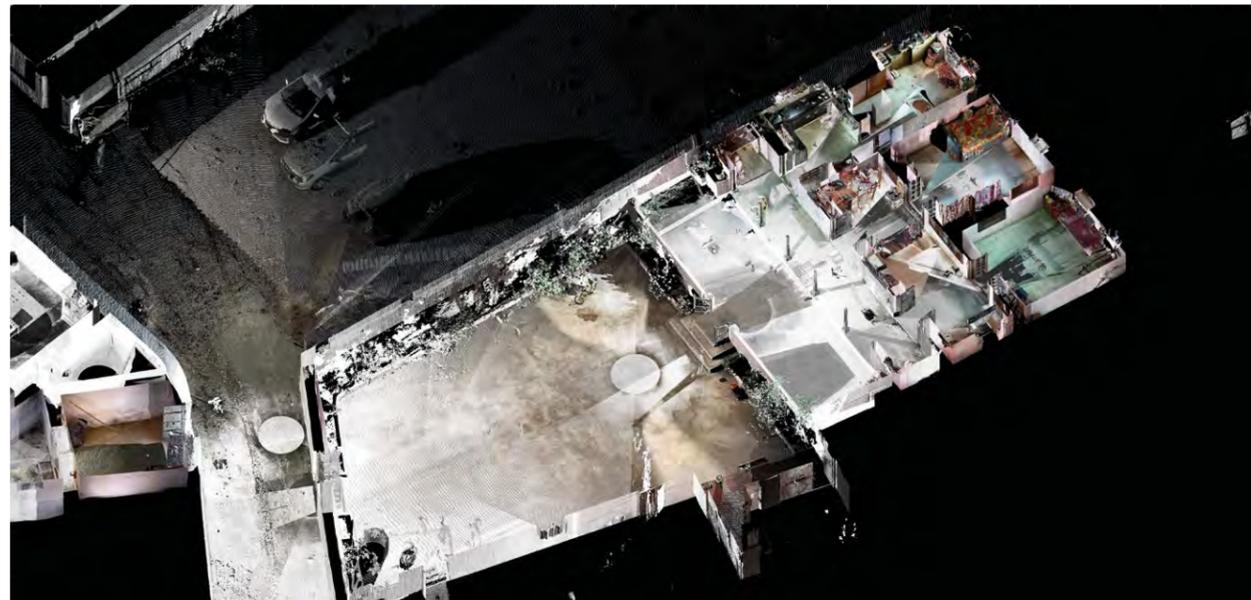
Figure 32. Axonometric view of house number 2 in Bela, rendered from the 3DLS data captured in June 2021.

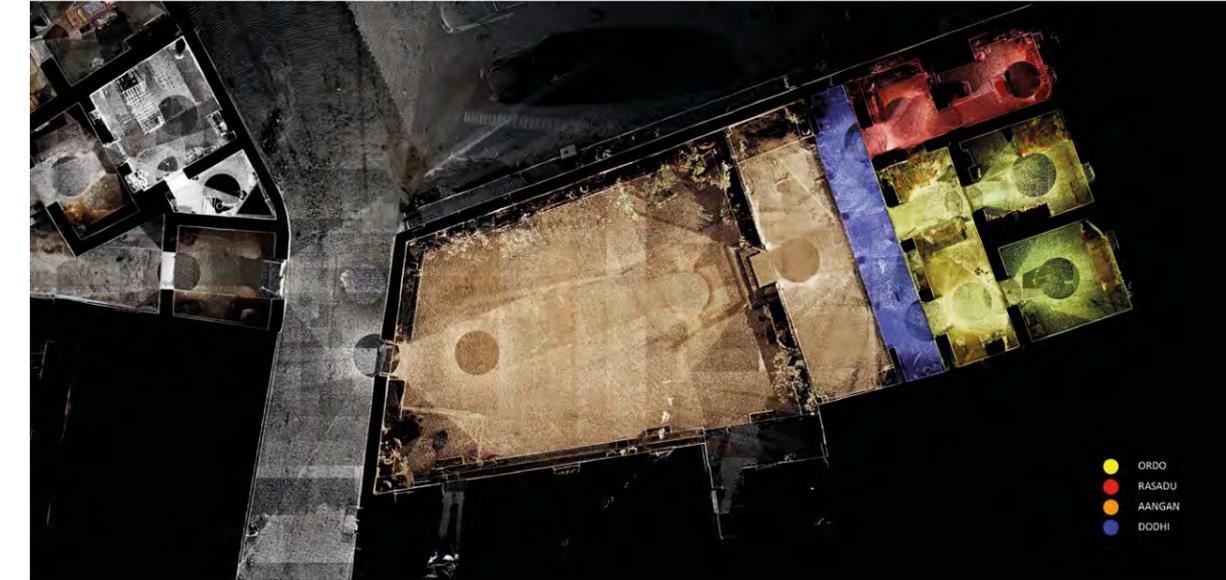
35. Plan of house number 2 in Bela rendered from the 3DLS data captured, illustrating the internal spatial arrangements.
