# 3D Laser Scanning documentation for informing the post-earthquake recovery of heritage settlements a practical guide

This document is a product of the research project: *A sustainable re-construction method for seismic-prone heritage areas of India based on advanced recording technologies*, funded by the UKRI Arts and Humanities Research Council (AHRC) and the Department for Digital, Culture, Media and Sport (DCMS).

**Project Lead:** The Centre for Architecture, Urbanism and Global Heritage, Nottingham Trent University.

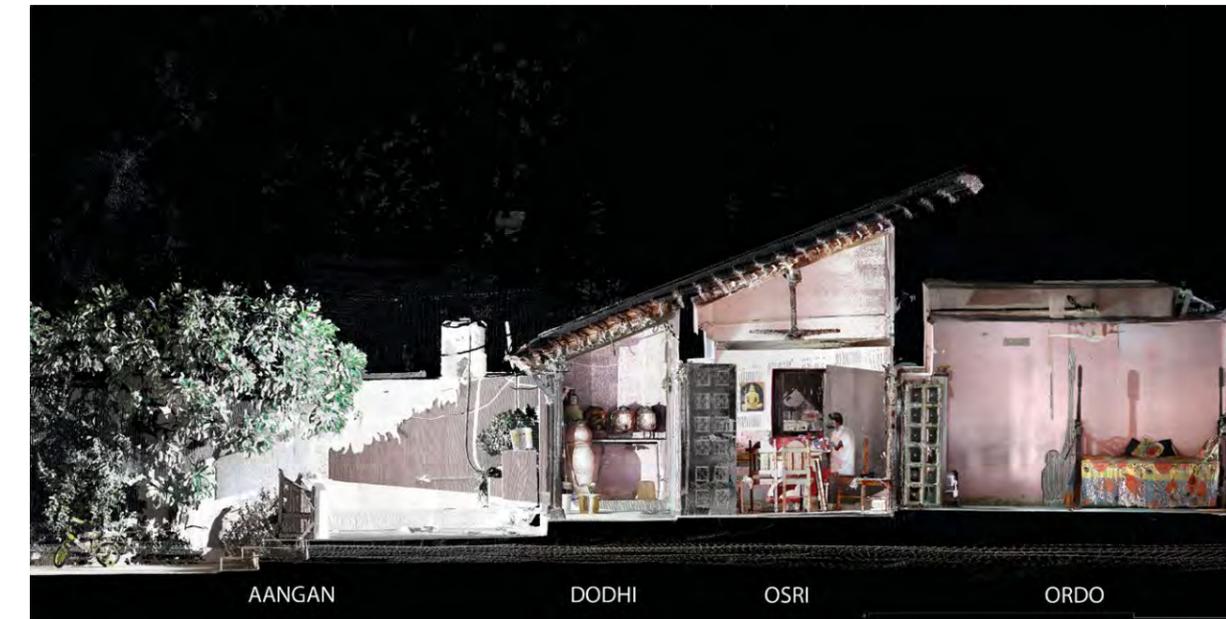
36. Section of house number 2 in Bela rendered from the 3DLS data, illustrating the internal spatial arrangements.

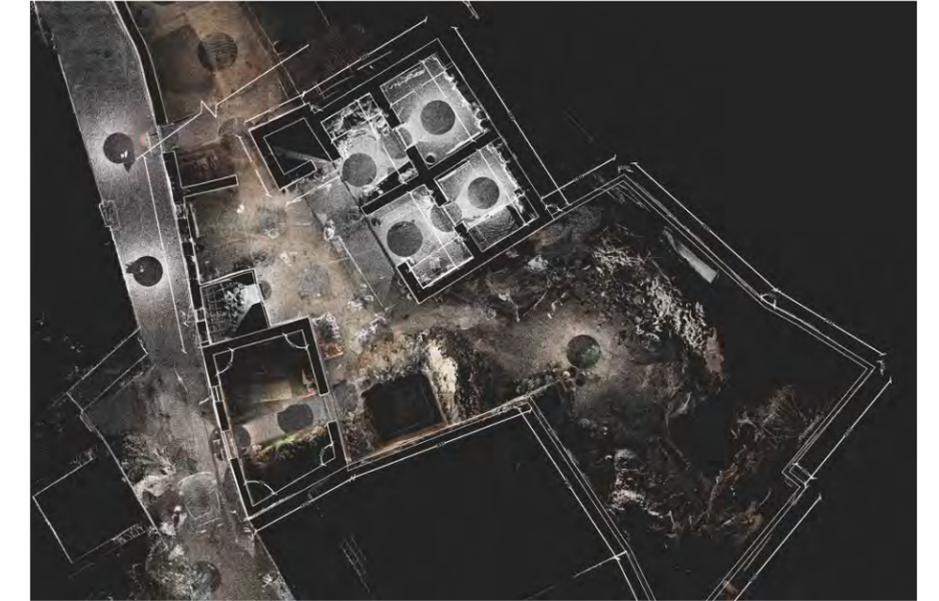
44. Line drawings extracted from scanned data from building number 9, illustrating spatial dimensions.

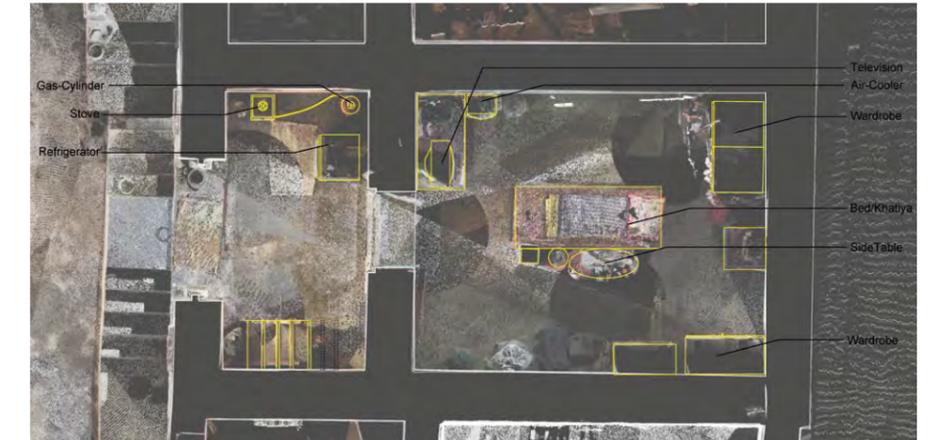
45. Furniture layout drawn in AutoCAD over the 3DLS plan of house 9.

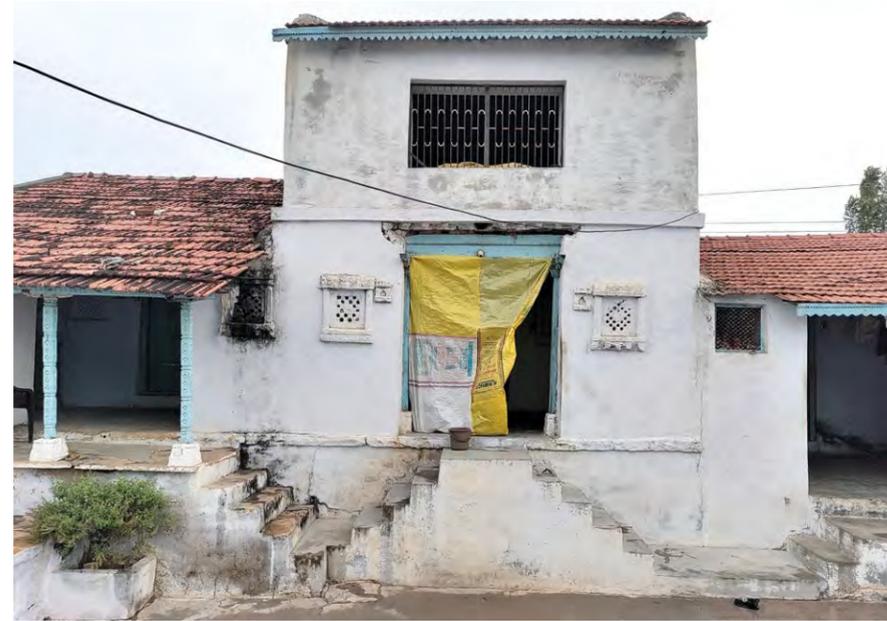
46. House 1 showing upper floor added to an existing single-storey building.

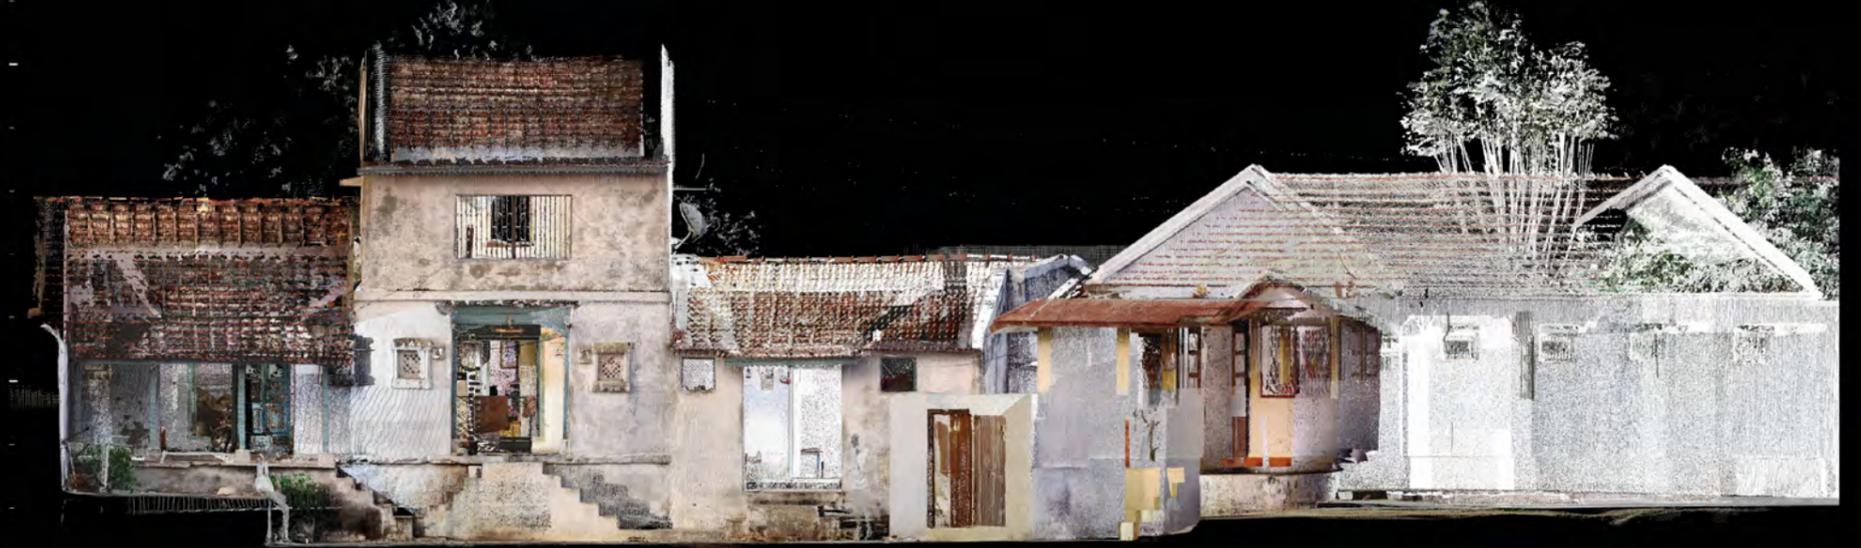
47. Elevation of house 1 from the interior courtyard, showing the upper floor and its positioning, rendered from the 3D scanned data.

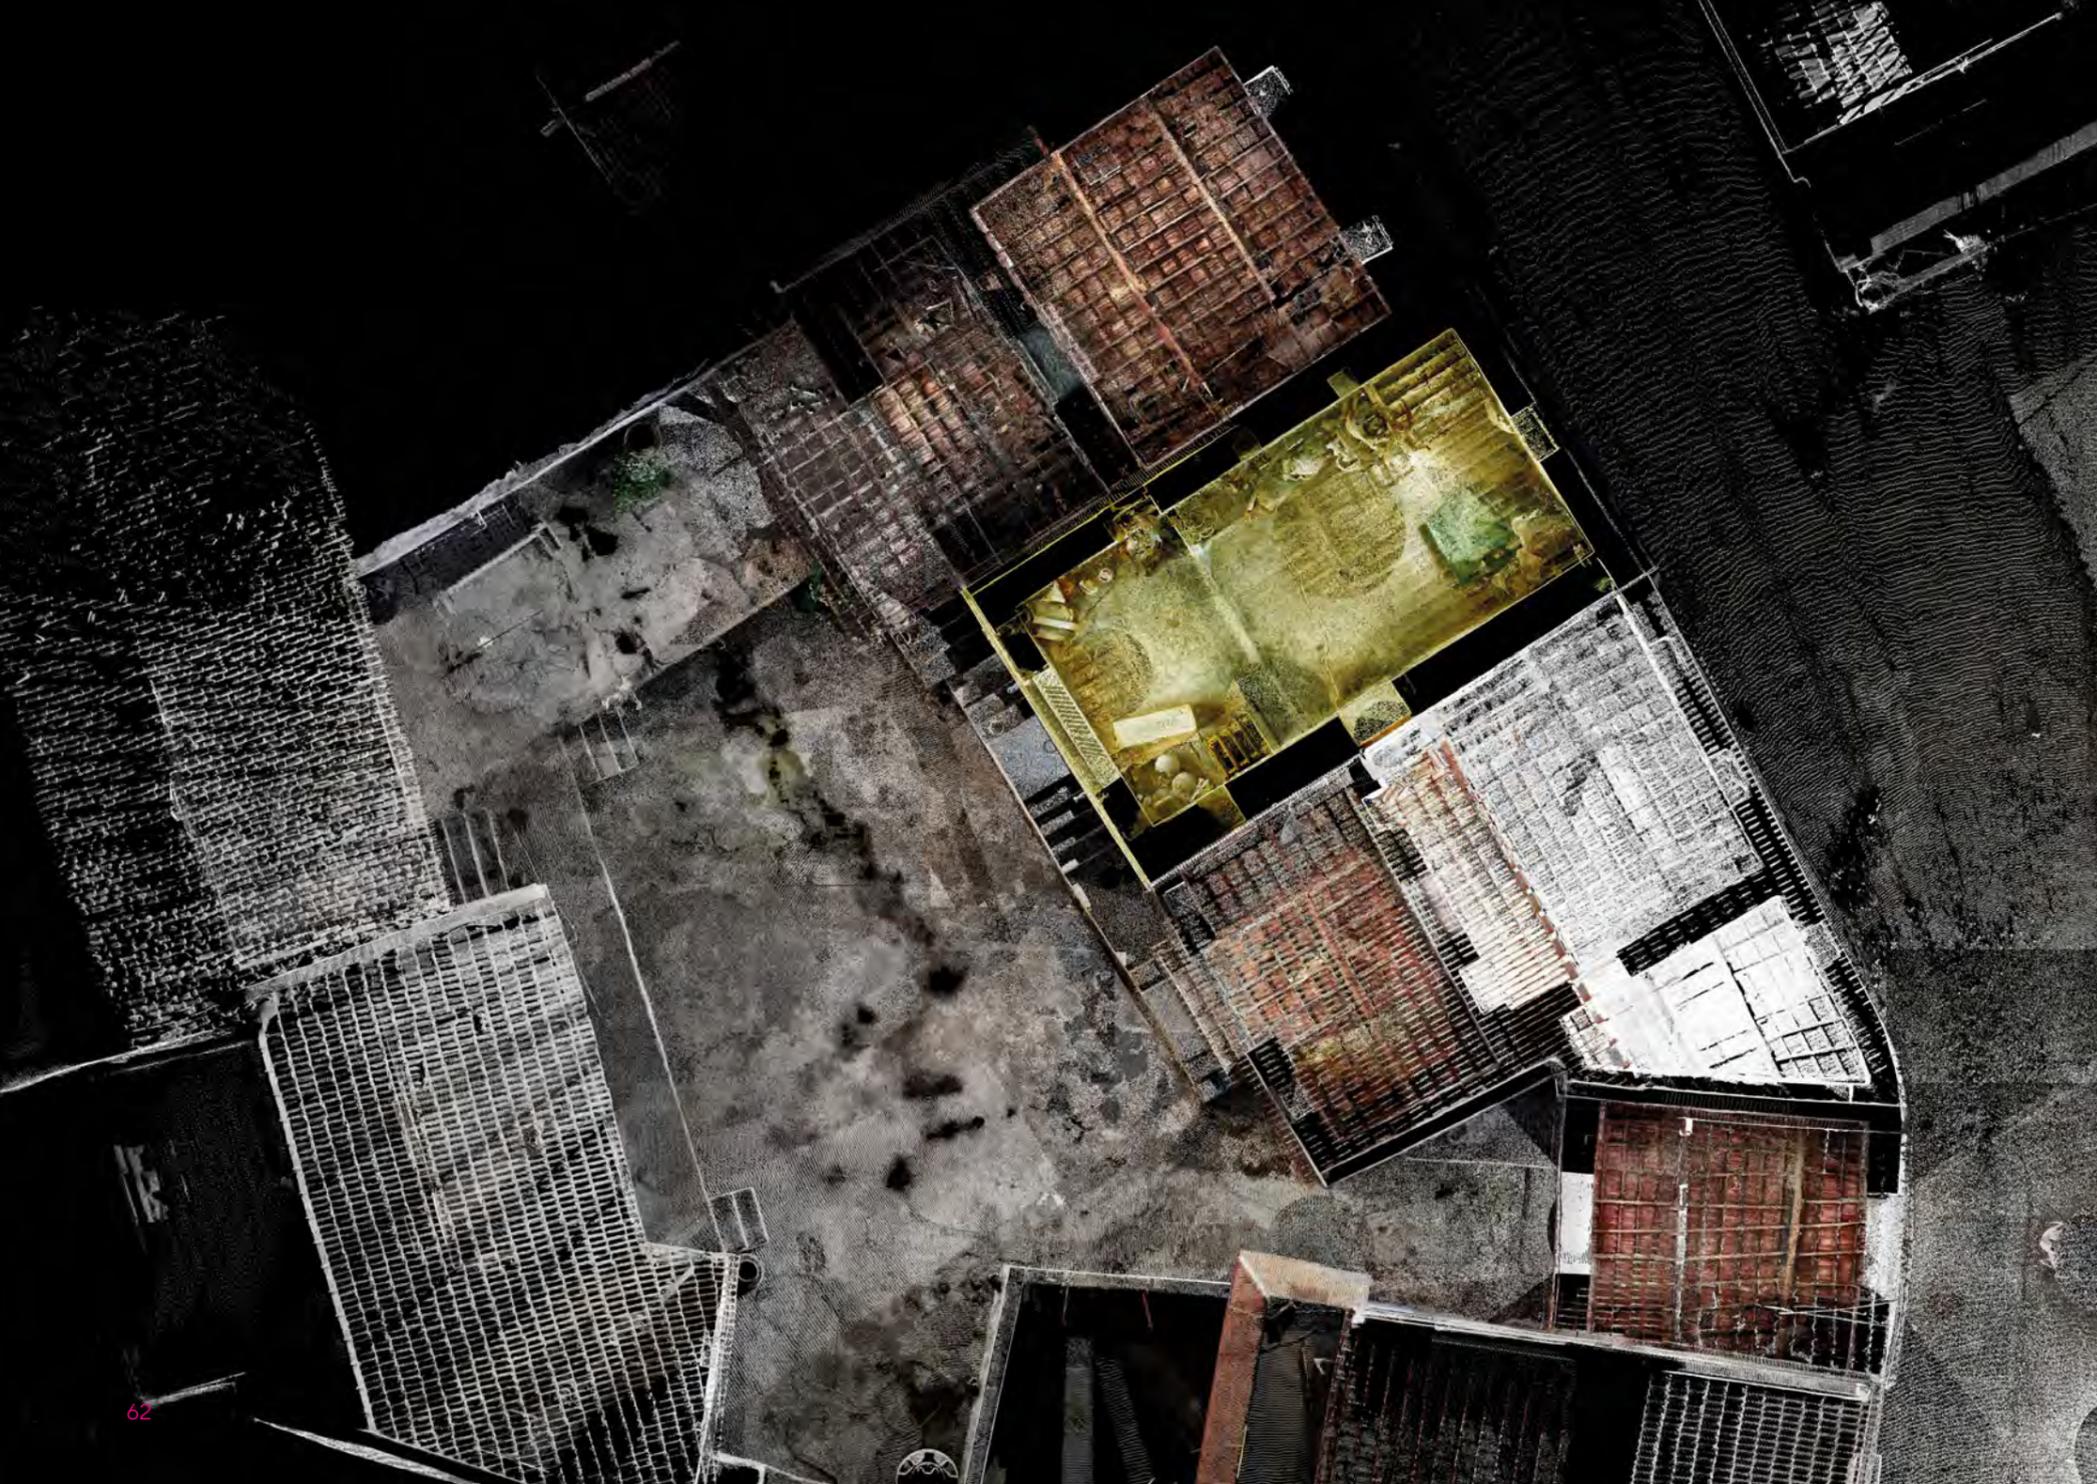
49. Schematic interpreted section of house 1 before adding the upper floor, drawn on AutoCAD from data acquired through 3DLS.

**Drawings over 3DLS images:** Sukrit Sen, using the 3D data by Bernadette Devilat and Felipe Lanuza, obtained on-site by Mrudula Mane and Zeus Pithawalla (Fig. 27, 38 to 45, 49, 50 and 53).

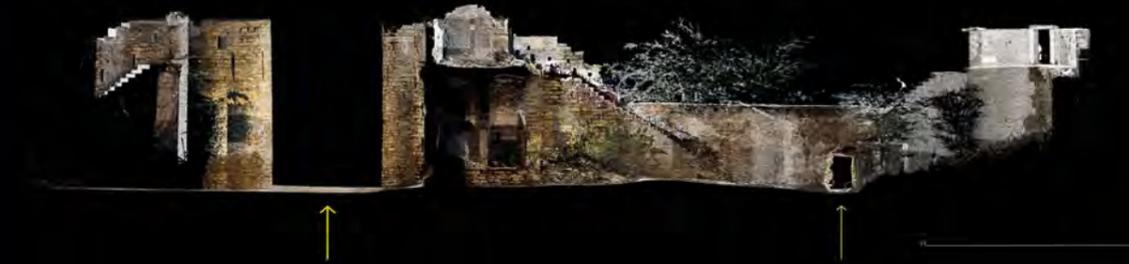
53. Section BB' showing the vegetation in Darbargadh derived from the 3D scanned data.

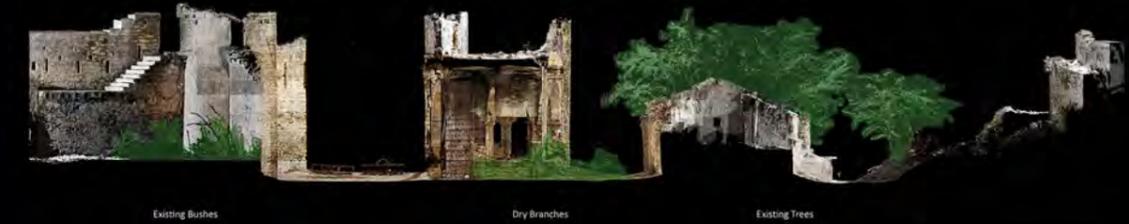
54. Section CC showing house 13 surrounded by rubble and vulnerable objects.

**Drawings over 3DLS images:** Felipe Lanuza, using the 3D data by Bernadette Devilat, Mrudula Mane and Zeus Pithawalla (Figs. 23, 24, 44, and 60, 63 and 64). Also, Figs. 33, 35, 36, 48, 51, 52, 54, and 58 based on the image concept by Sukrit Sen.

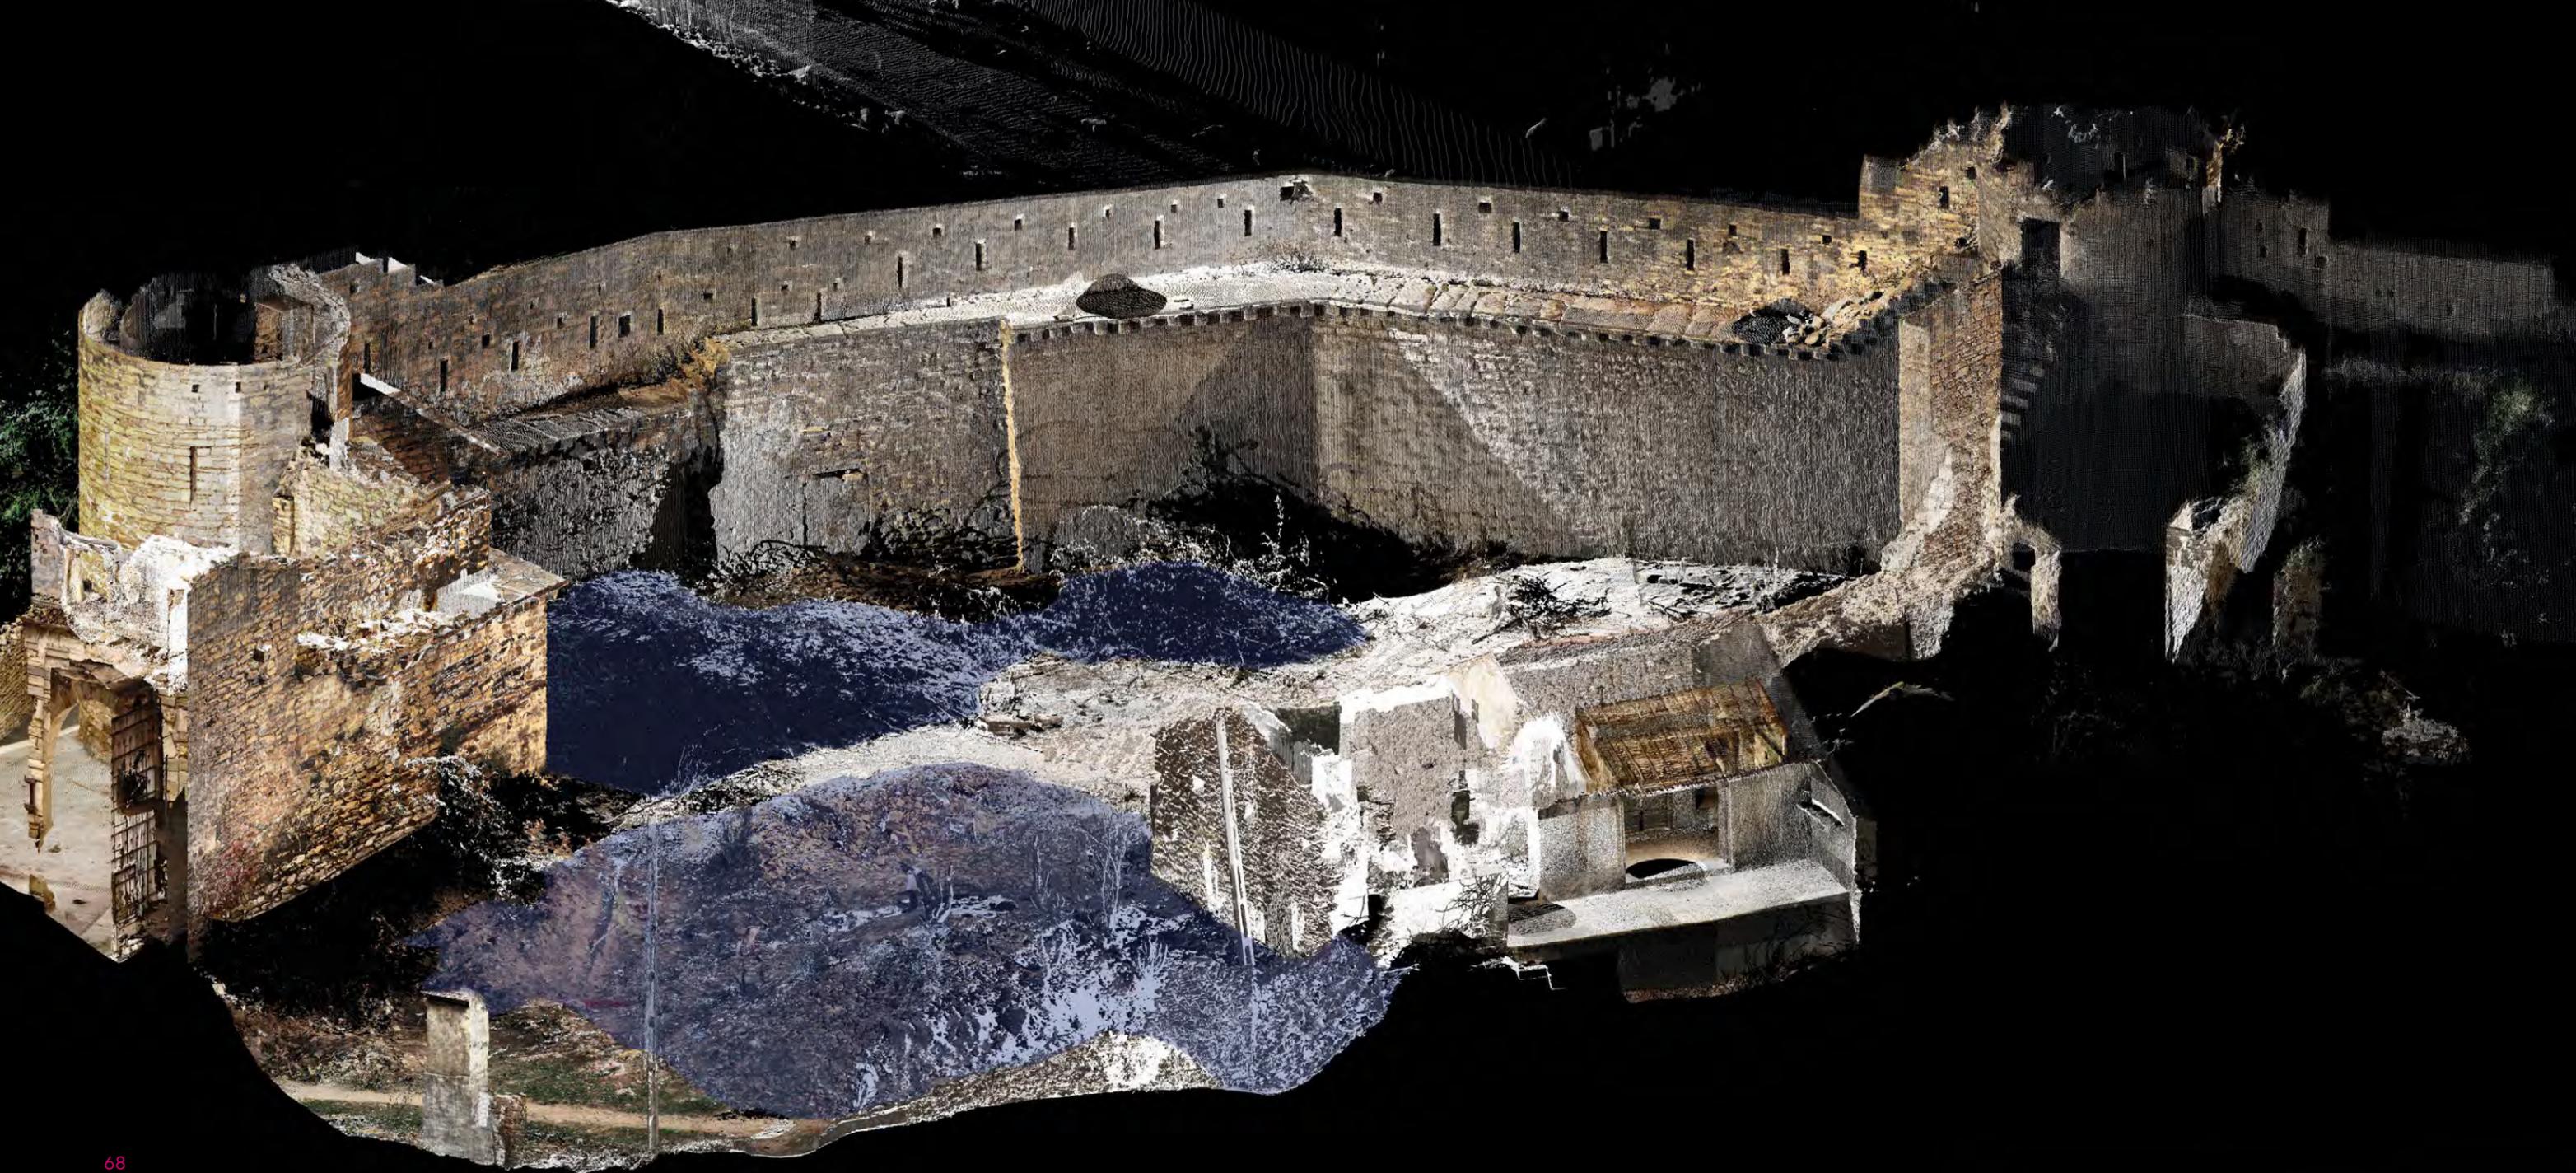
55. 3D view of building 13, with a partially collapsed roof and walls inside the Fortress in Bela. The surrounding rubble is marked in blue. The image was rendered from the 3D scanned data, using the same line profile as in section CC'.

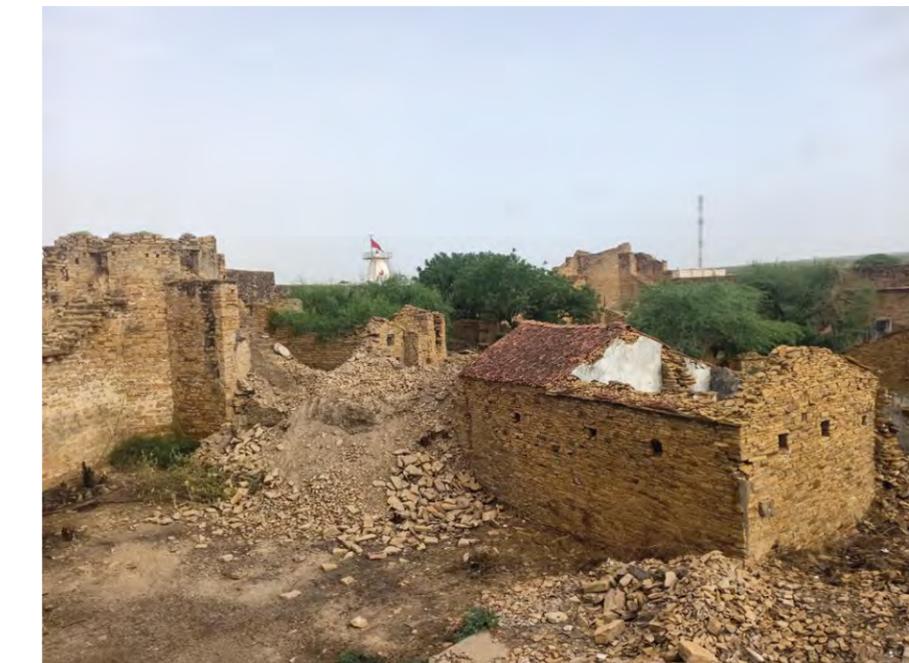
56. Photographic record of building 13 in Bela, with surrounding debris as marked in the previous figures. Photograph taken in the opposite direction of image 55, showing the back of the building.

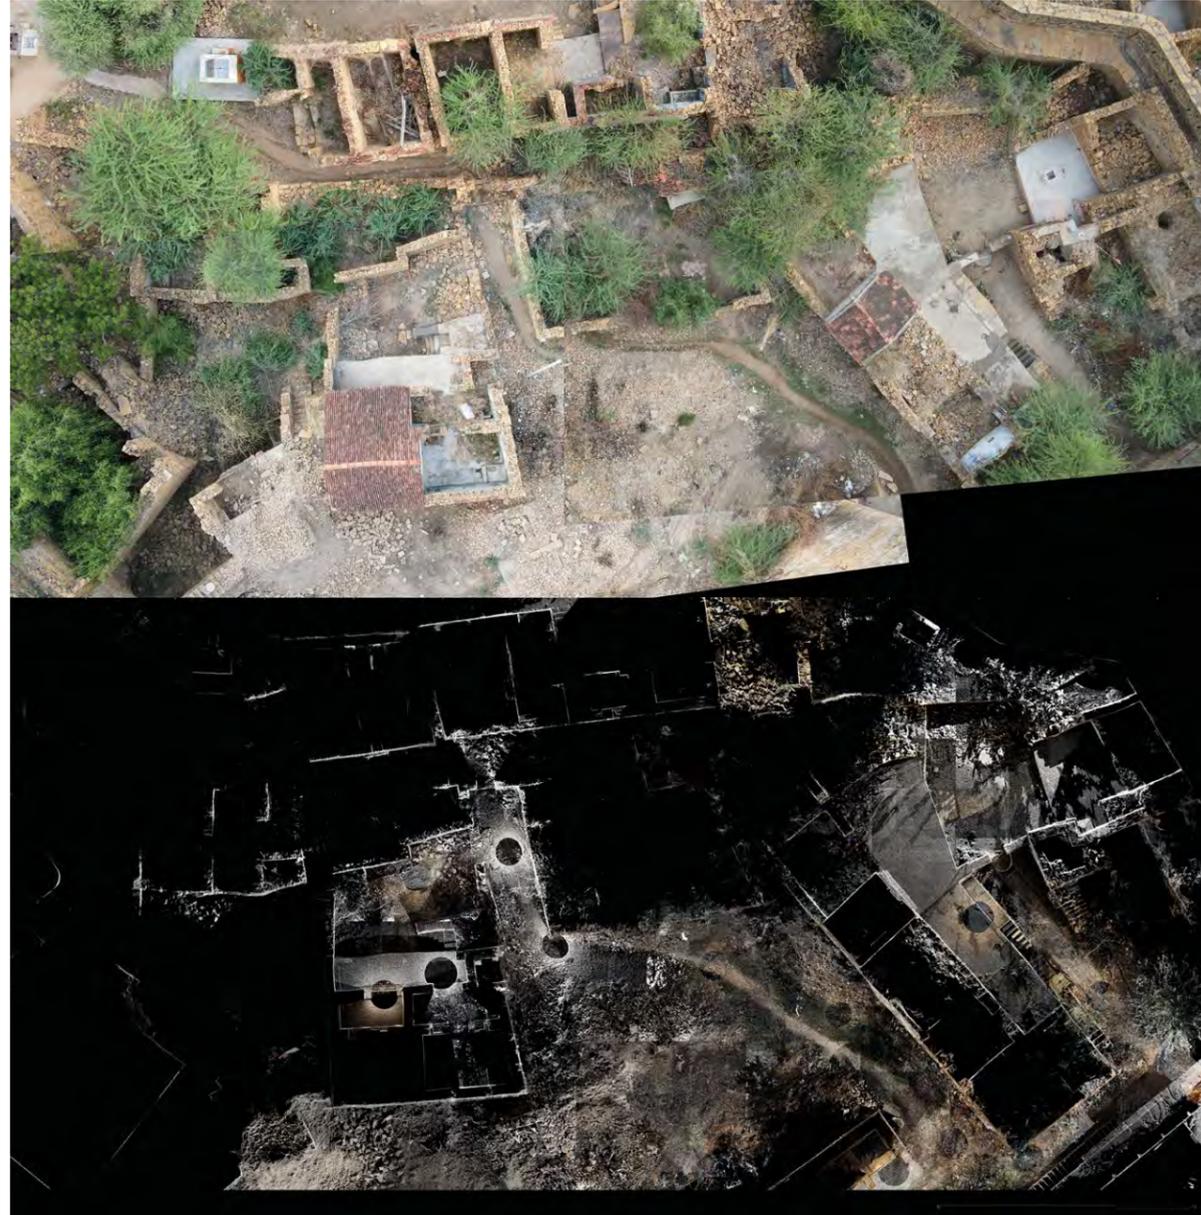
57. Top views of building 13 inside the Darbargadh in Bela, India. In a post-earthquake scenario, aerial drone photography and video capture are the most relevant records to complement the terrestrial 3D laser scan data. They can help damage assessment even when buildings are physically inaccessible. It is an excellent complement to the 3D laser scanner that only captures data from the ground level, especially when there is no access to higher points to cover rooftops, treetops or inaccessible open spaces.

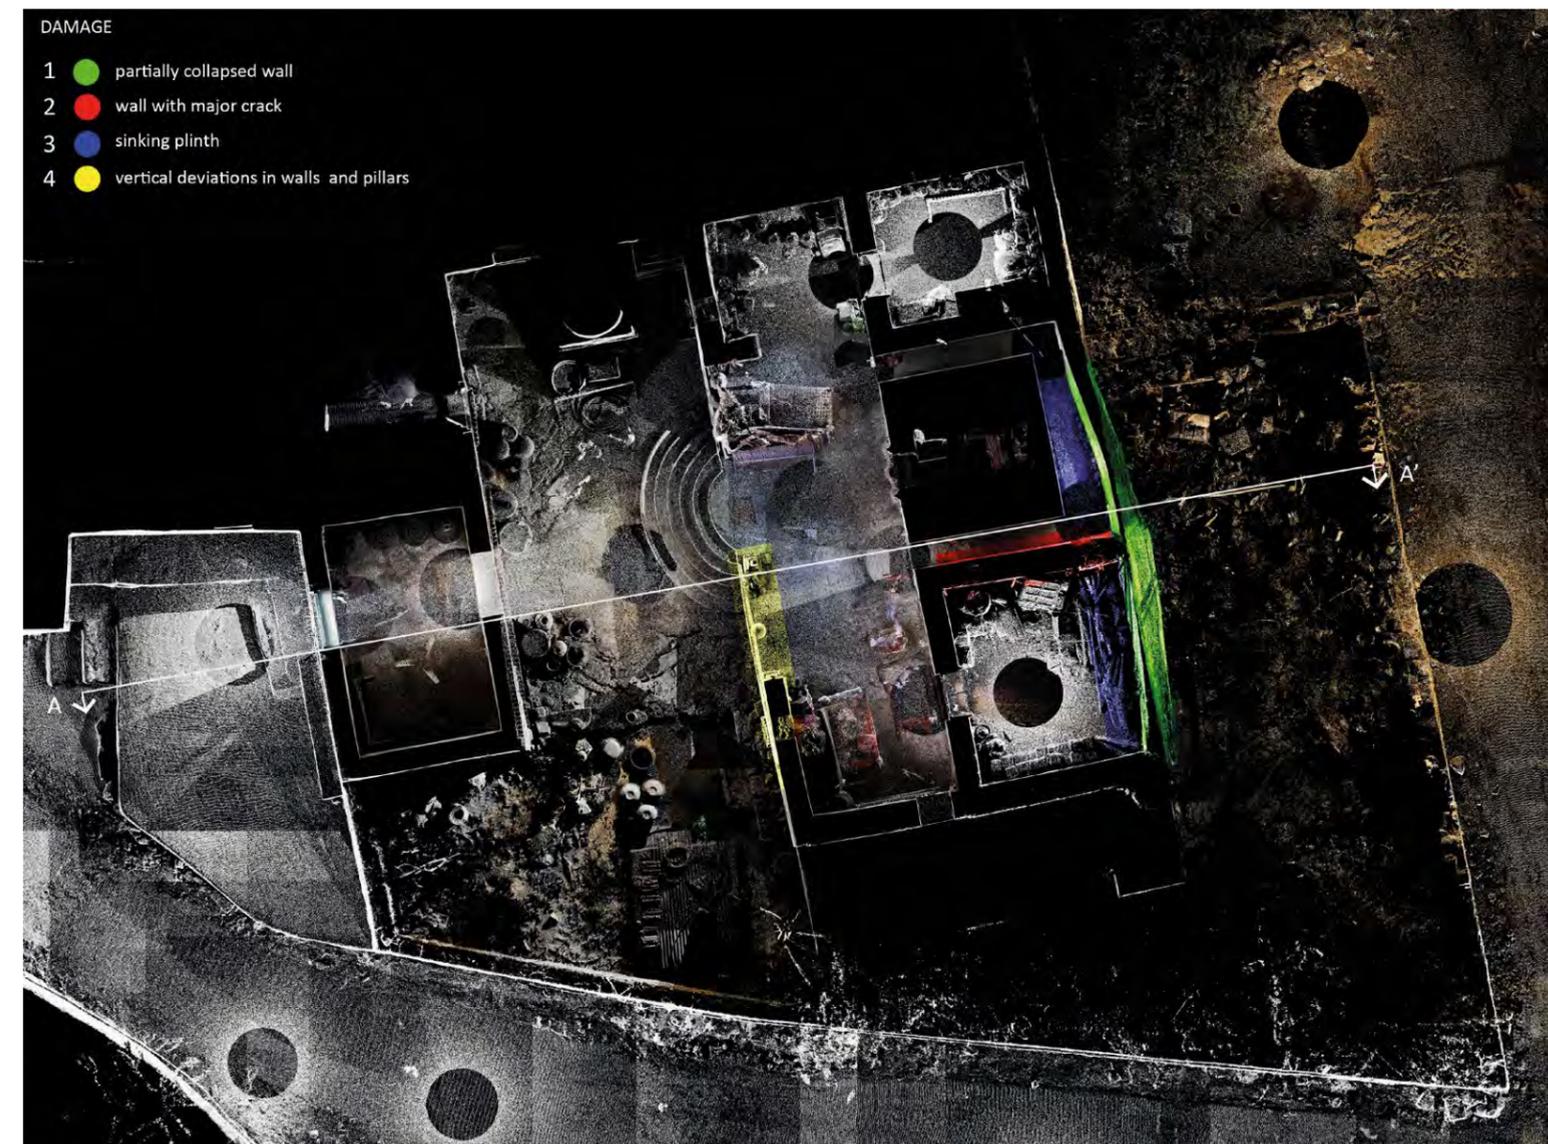
58. Plan of Building 5 rendered from the 3DLS data of June 2021 with damage identified in colour.

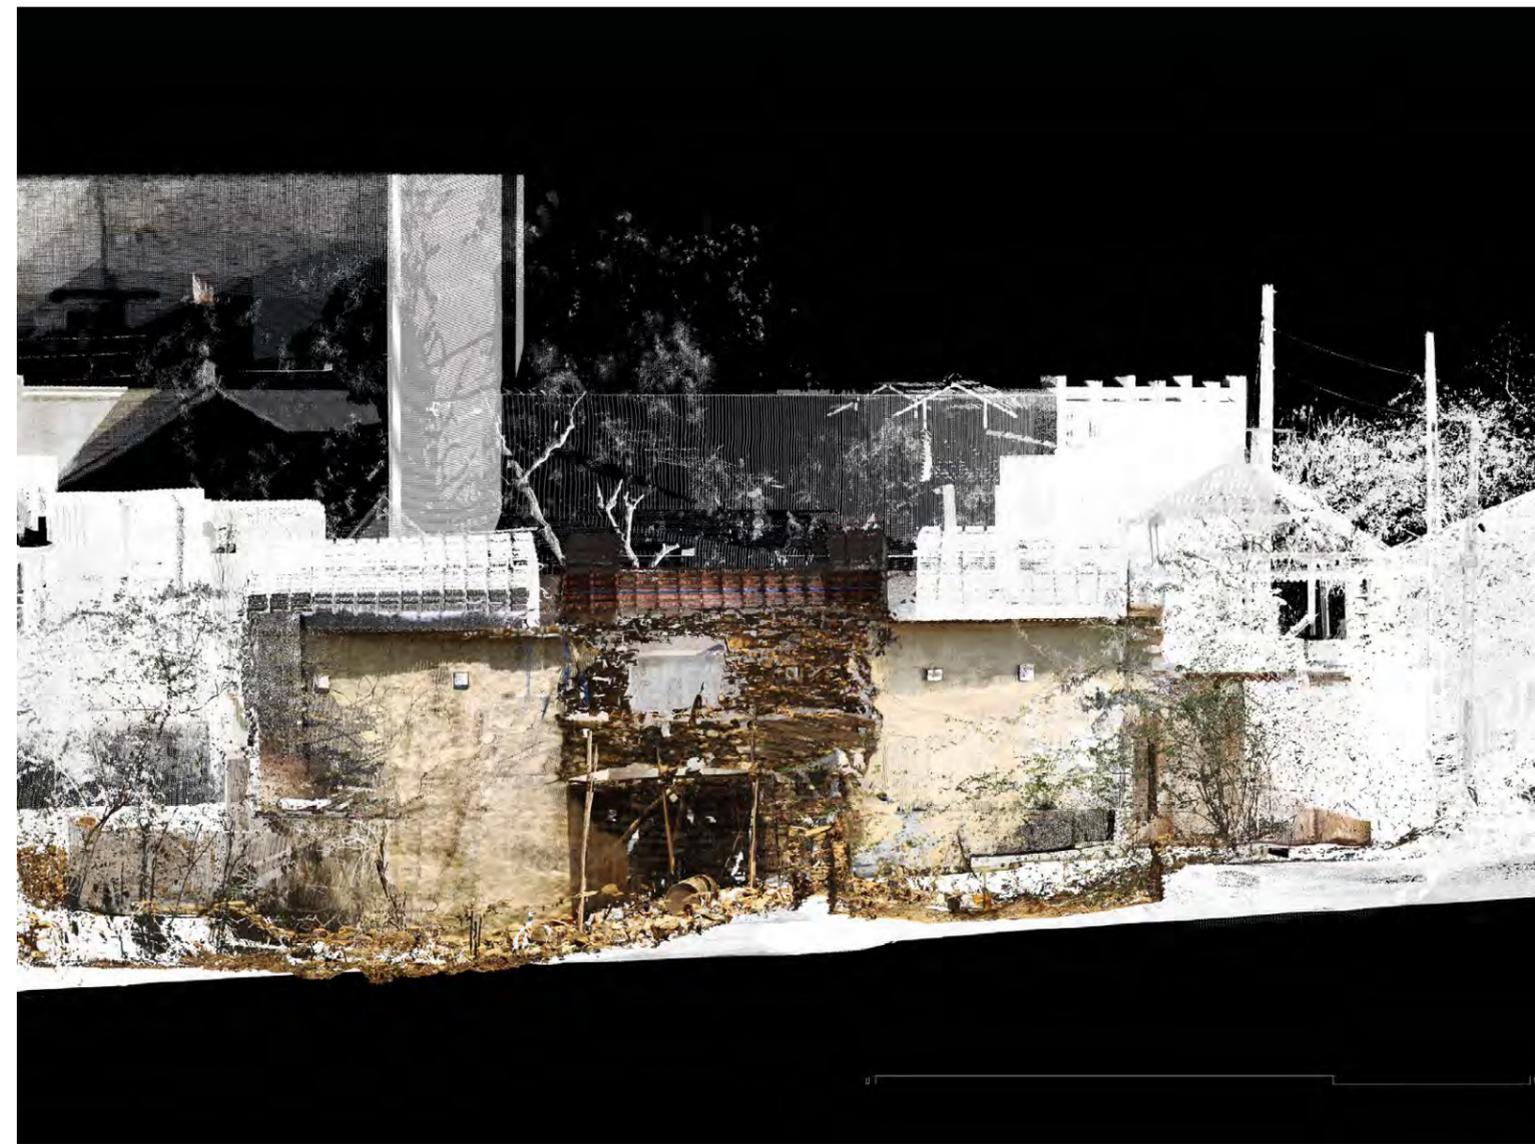
59. East elevation of temple 5 rendered from the 3DLS data in June 2021, showing the partially collapsed wall (damage 1).

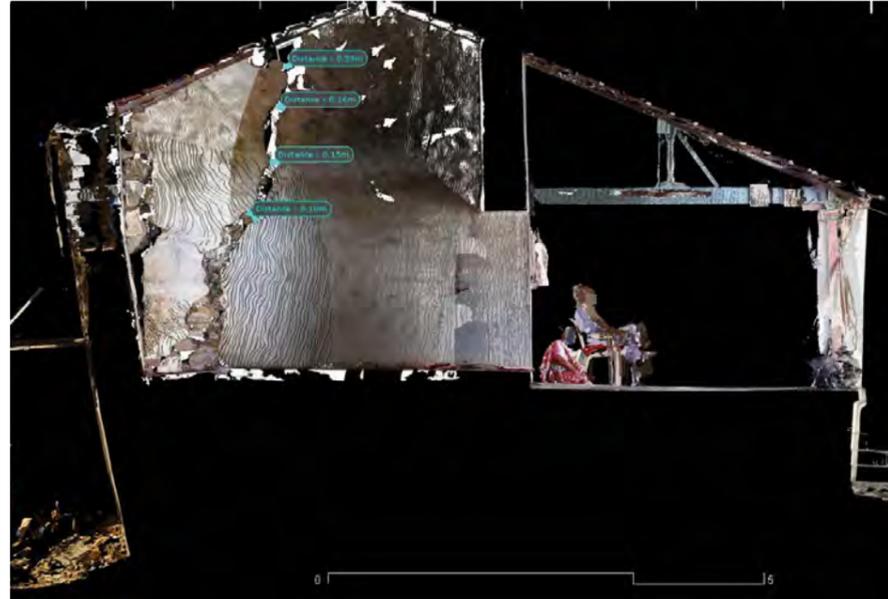
61. Section AA', showing the extent of damage 2 (wall cracks and deviation).

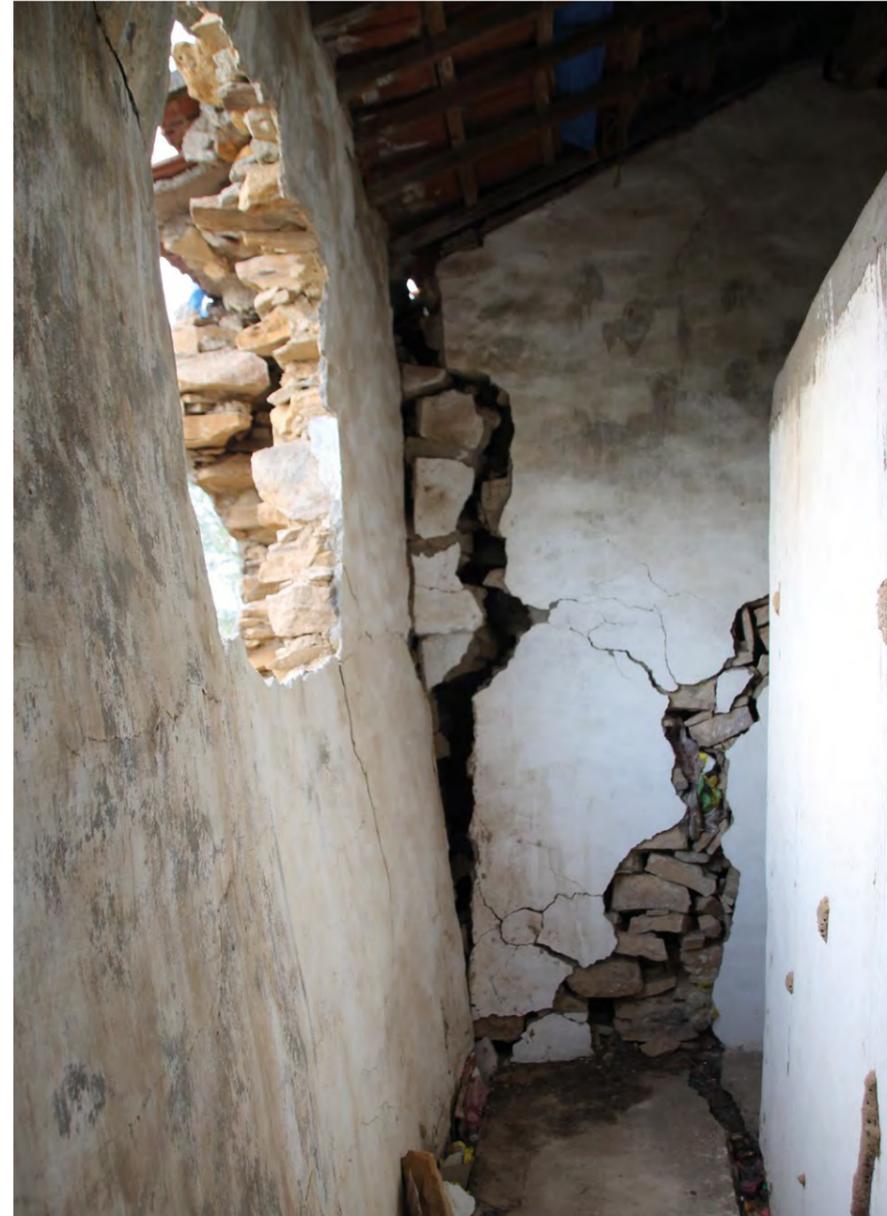
62. Internal view of Damage 2 (wall cracks) and portion of damage 1 (collapsed wall). Photographs can also serve as evidence of damage, but without accurate metric information as with 3DLS.

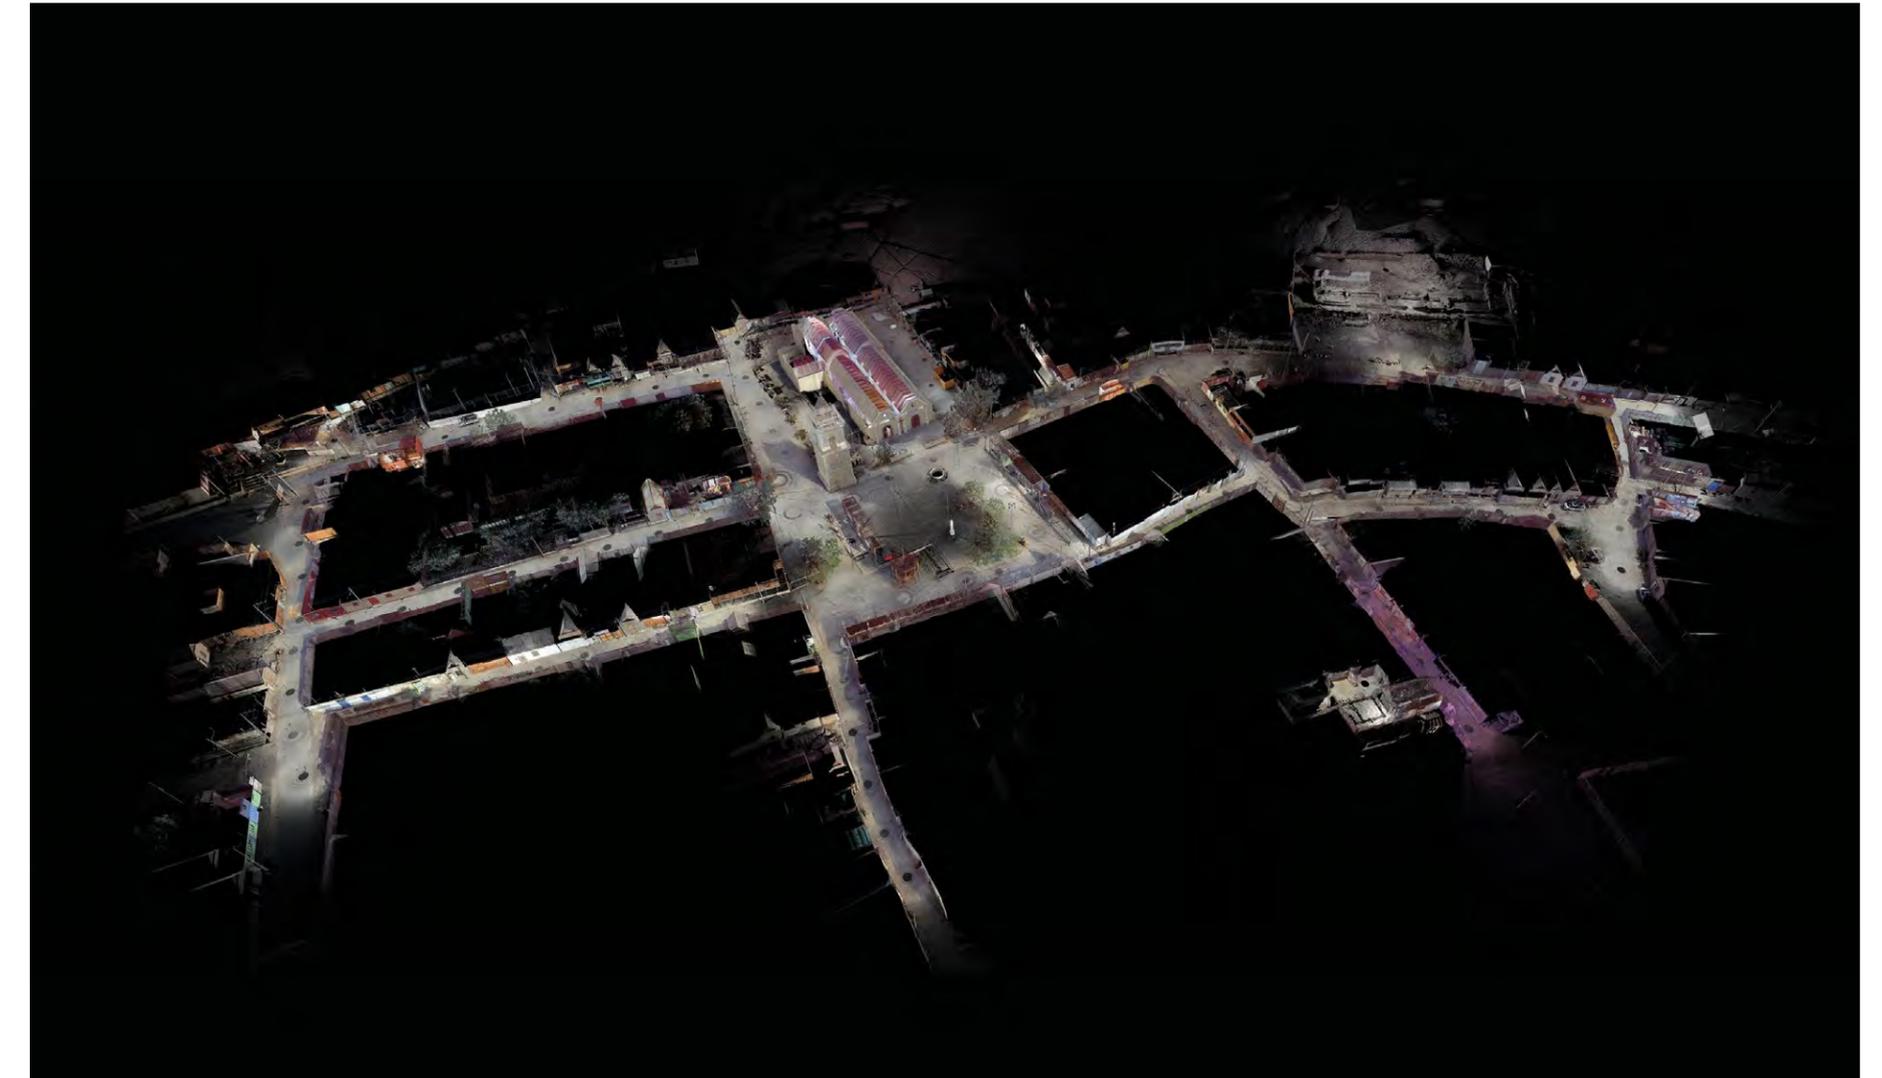
65. Aerial view of San Lorenzo de Tarapacá, Chile from the terrestrial 3D-laser-scanning obtained on-site in 2013, showing damage constructions and governmental reconstruction after the 2005 earthquake.

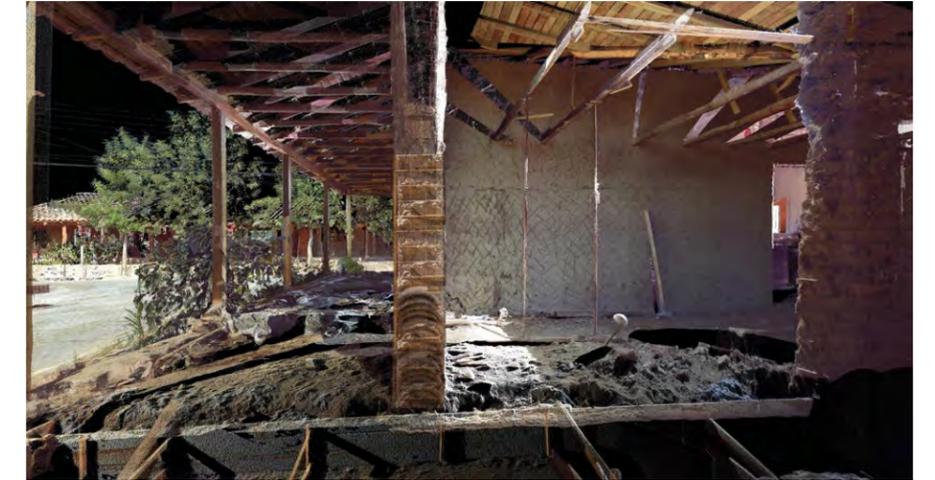
67. View of a dwelling affected by the 2010 earthquake in Lolol, Chile, with proposed storage-walls for materials and rubble to be re-used designed over the 3DLS data obtained on-site.
