A Low Cost Domestic Rainwater Harvesting Tank

Abstract

This paper describes a low cost roof rainwater harvesting tank, constructed and tested at three locations in the dry and wet zones of Sri Lanka to study the feasibility of such tanks in solving acute domestic water shortage. The cost is about RS 5400 (~£20 in 2007), but can be brought even lower (to about Rs 2600 or ~£12) by using the locally available materials and labour during construction. The tank uses bamboo as a reinforcing material and polypropylene as a water proofing membrane, both of which are available locally in any village. The low level technological input requirement was a design requirement, in addition to low maintenance. During a two year monitoring period, the tanks performed well and it is anticipated that, with correct use and maintenance, a design life of about 5 years could be achieved.

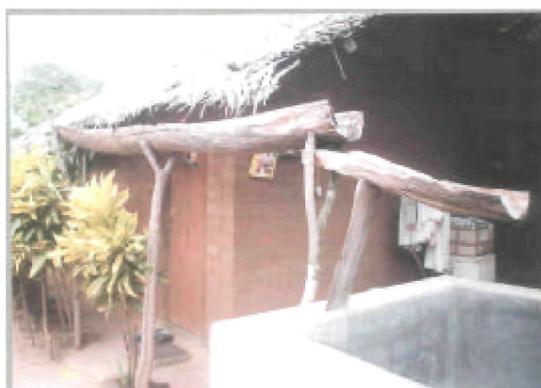
Fig. 3: A coconut frond thatched roof where rainwater is collected in a tank using indigenous wooden gutters [Source: Lanka Rainwater Harvesting Forum]
