An innovative approach towards enhancing energy conservation in buildings via public engagement using DIY infrared thermography surveys

Allan Hawas^a, Amin Al-Habaibeh^{b,*}

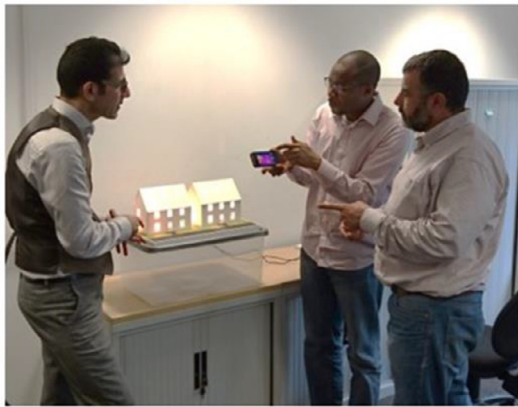
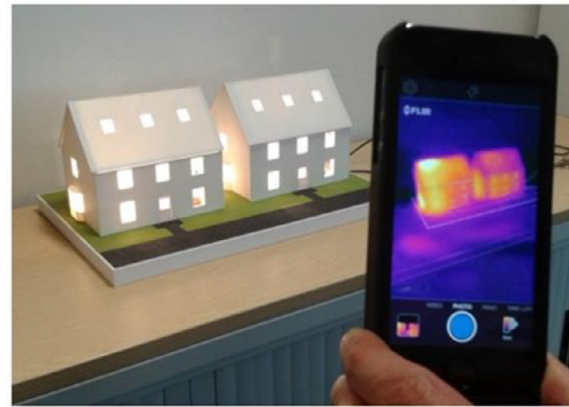
(a) Thermography training on the simulation model.

(b) Using the infrared camera on the simulation model.

Fig. 5. Training the householders on the developed simulation building model, the use of FLIR-ONE camera is shown in figures.

The thermal measurement system, see Fig. 5, consists of a low-cost smartphone-based thermal camera (FLIR-ONE) connected to a smartphone (iPhone 5). Two identical thermal systems were available to use in this study. Additionally, the auditing kit included a thermometer for monitoring of internal and external temperatures, a reflective vest, a health and safety instruction on how to carry out thermography survey and instruction on how to use the infrared camera. The training was done on the small model rather than an actual building, because the training in this case could be done in a safe and relaxed environment during the day time regardless of the outside temperature and weather conditions. Moreover, participants could attend at the same time and the insulated and poorly insulated building could be seen using the same image at the same time for comparison (Fig. 5-b).

Fig. 5 shows the simulation model of two buildings, one is insulated and the other is poorly insulated. The simulation model help in two ways: (1) to train people on using the infrared camera; and (2) train on detecting issues with building insulation. Each model a base of 20 cm x 15 cm with a maximum highest of 18.5 cm. Wall thickness is modular depending on the insulation used. For full details about the model, please refer to [31,32].
