GROUNDWATER DISTURBANCE AND SURFACE SETTLEMENTS
AROUND A DE-WATERED SAND AND GRAVEL QUARRY

IAN JOHN FROGGATT

A thesis submitted in partial fulfilment of the
requirements of The Nottingham Trent University
for the degree of Doctor of Philosophy

October 1997

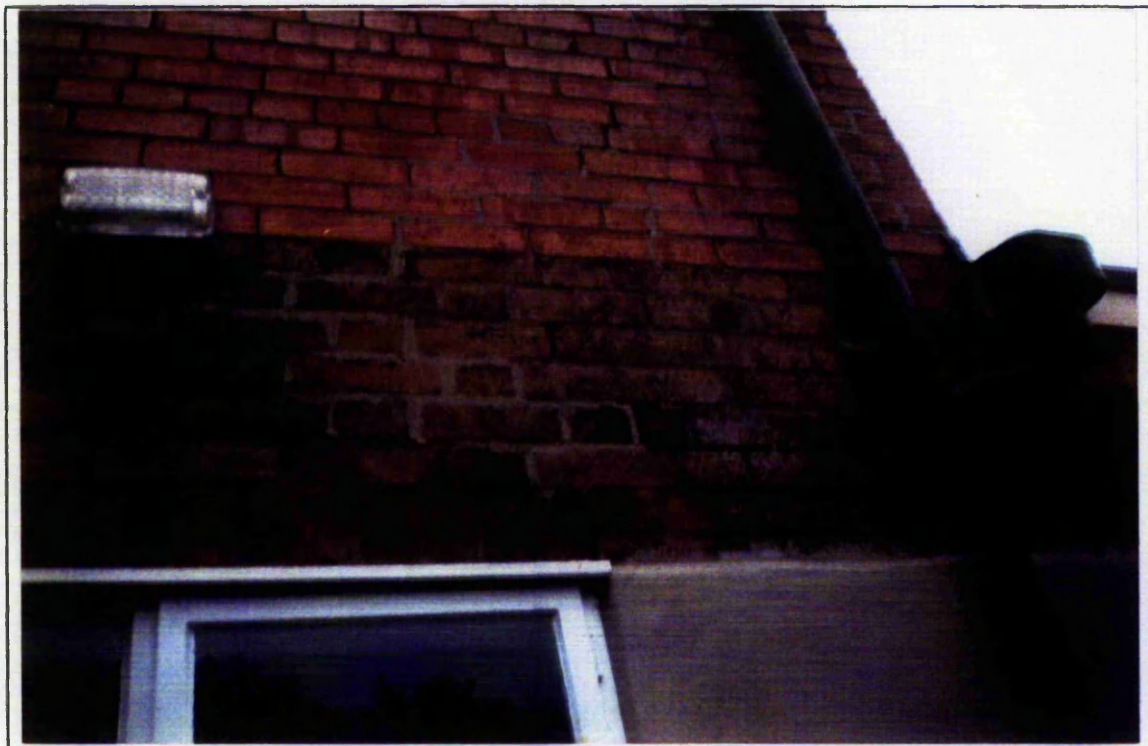
Figure 4.4

Trentham House - Apparent Settlement Crack Widening At The Top

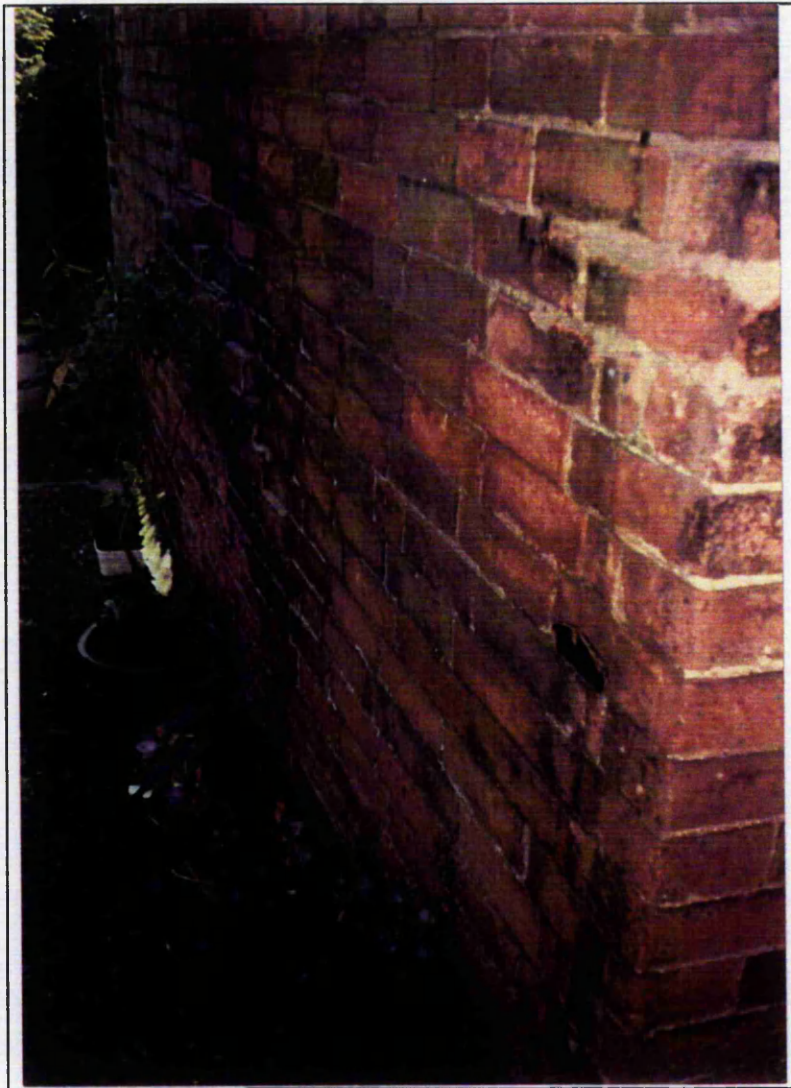
Figure 4.11
Church Farm House, Gonalston Lane
Cracking Due To Cattle Pushing Against A Wall

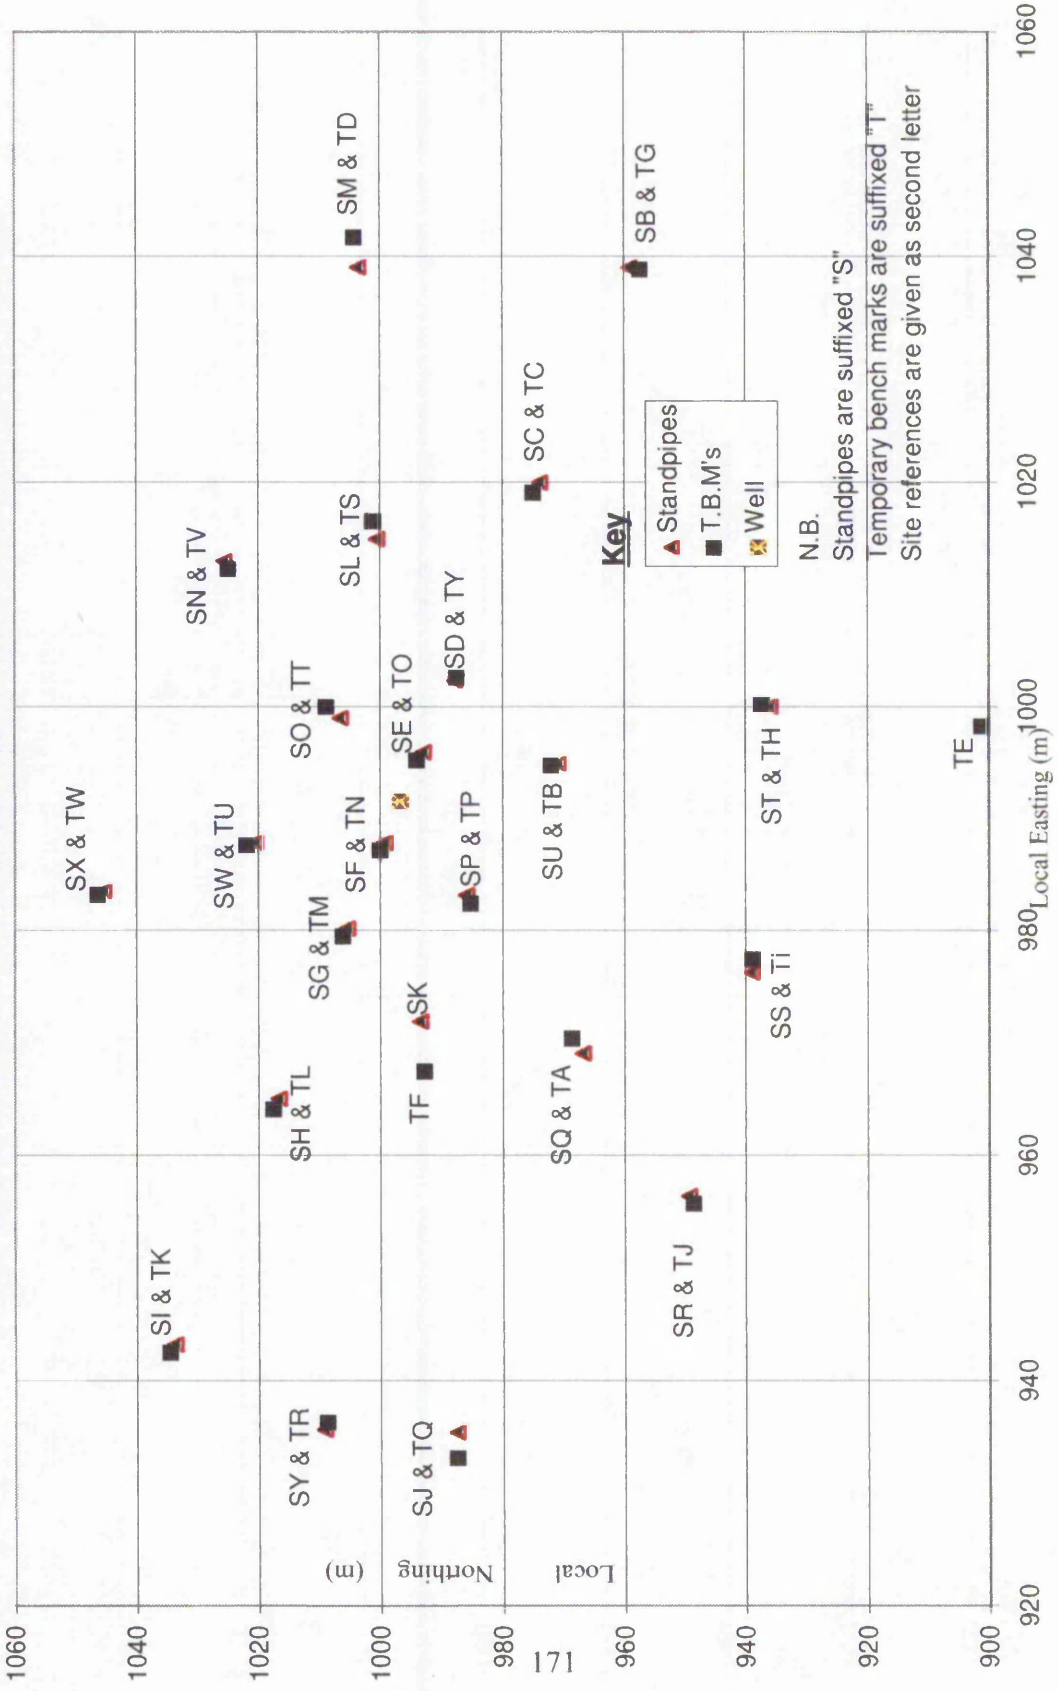
Figure 6.16

A Standpipe Being Read With A Temporary Bench Mark In The Foreground
