Pioneering advanced recording technologies for post-earthquake-damage assessment and re-construction in Chilean heritage areas

Dr Bernadette Devilat L.¹[0000-0002-2679-9629]

¹ Nottingham Trent University (NTU), Nottingham, NG1 4FQ, UK
bernadette.devilat@ntu.ac.uk

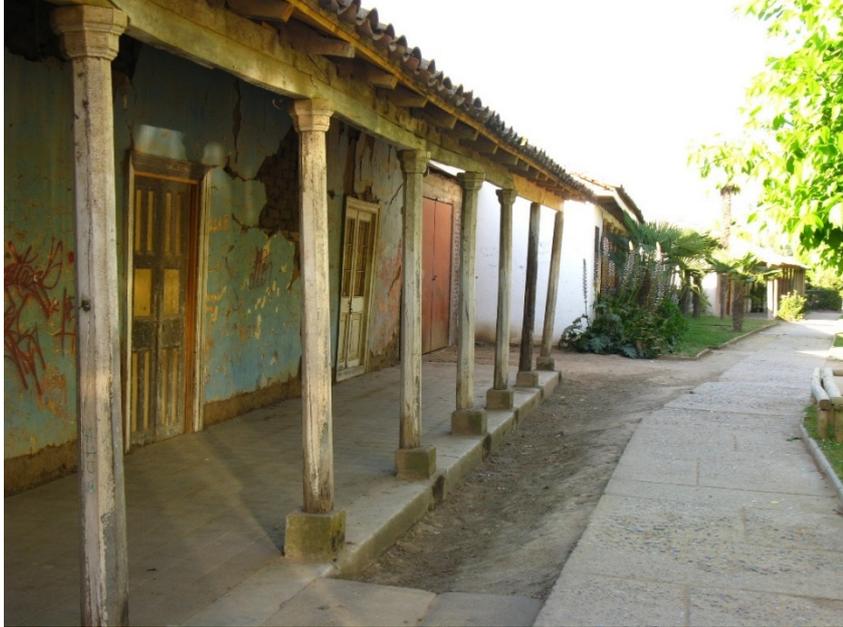
Fig. 2. A damaged house with porticos in Lolol after the 2010 earthquake. Source: Author.

Lolol is located in the Colchagua Province, VI region of Chile. Dwellings are built as continuous façades but are also characterised by having porticos, which generate a particular spatiality to the public space (Figure 2). It was declared a *Typical Zone* in 2003. After the 2010 earthquake, Lolol experienced damage and destruction of structures, but no fatalities occurred in the heritage area.¹

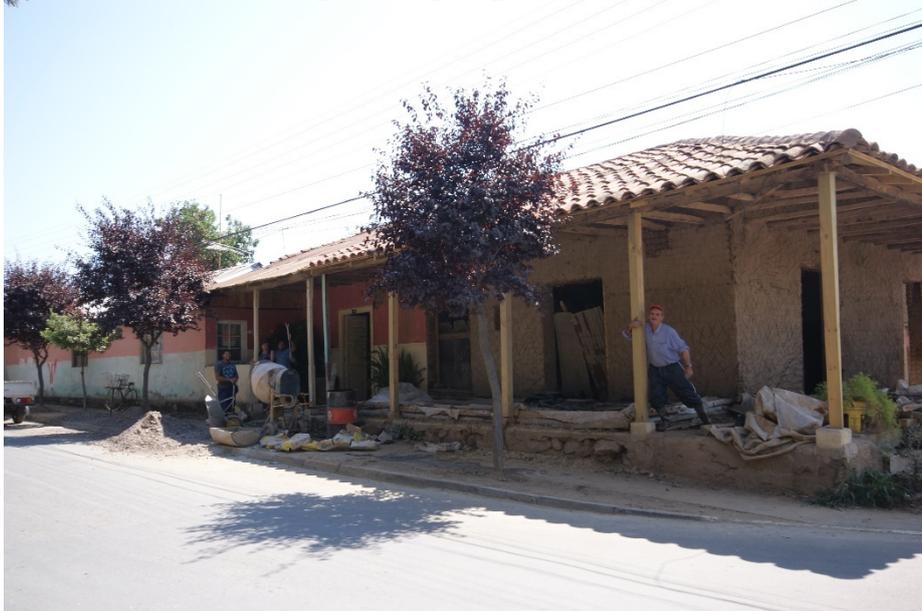
Fig. 4. A dwelling under repair in Lolol in 2013, showing the use of metallic meshes to stabilise damaged adobe walls. Source: Author.

After the 2010 earthquake, the Heritage Reconstruction Programme was created at the Regional Ministry Secretariat (SEREMI)⁵ of the MINVU VI Region of Chile, and then replicated in other affected regions [2]. One of the main advances of this programme was to organise the post-earthquake work to allow repairs and retrofits using the total funding available for a new house, resulting in larger dwellings and the conservation of more built heritage dwellings (Figure 4).

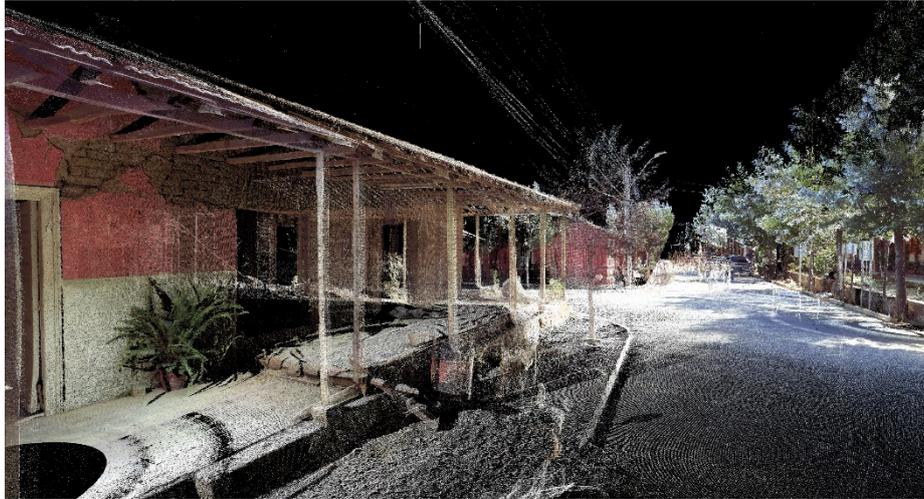
Fig. 5. Example of the 3D point-cloud of Lolol in 2013 using three scans. Source: Author.

The method of collecting data was to set the terrestrial 3D-laser-scanner⁷ in different locations separated by a range of 15 to 40 metres while spherical, and paper targets were placed as reference points that remained still. The exterior spaces were captured from the streets and pavements, and the interior spaces by accessing the buildings. Each scan took almost five minutes, including the photographs that provided the colour information (Figure 5).

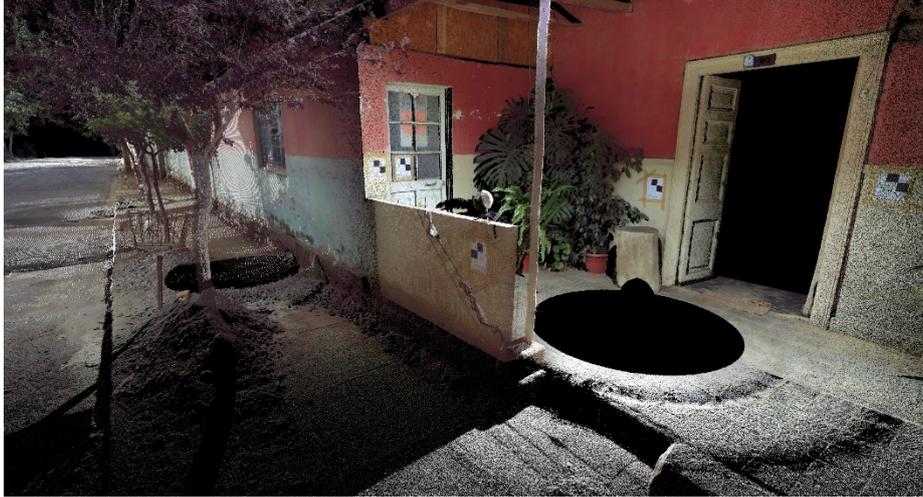
Fig. 6. Example of the targets used in the 3D data capture of Lolol in 2013. Source: Author.

Currently, 3D-laser-scans can be geo-referenced and located automatically using post-processing software, but reference targets—chequerboards and spheres—were needed for the on-site capture, carried out in January 2013. These targets remained still in between scans, allowing them to be used as reference points to align the 3D scans more precisely later (Figure 6).

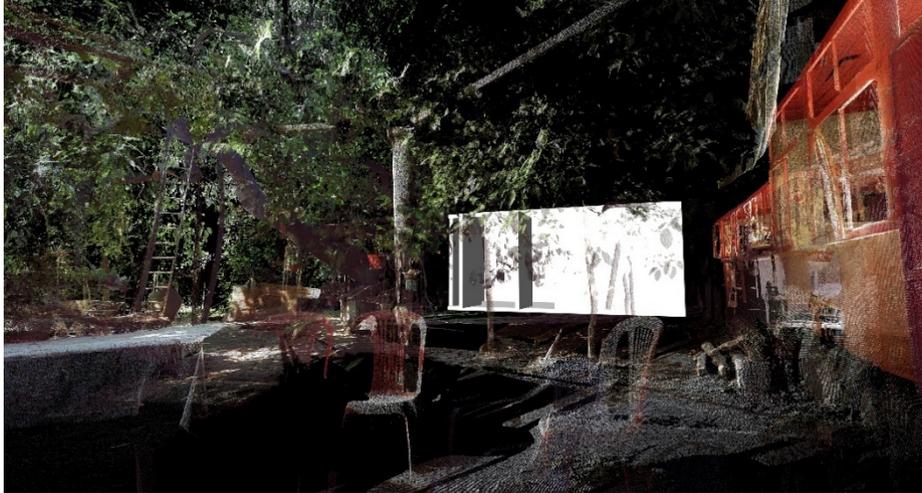
Fig. 16. Proposed view of the flexible emergency shelter installed in the back garden of the site conforming to an interior courtyard. Source: Author.

These features create a flexible space, which may be maintained and used by the inhabitants in the future, if located and installed after careful analysis of the site, e.g. to conform to an interior courtyard or patio (Figure 16).

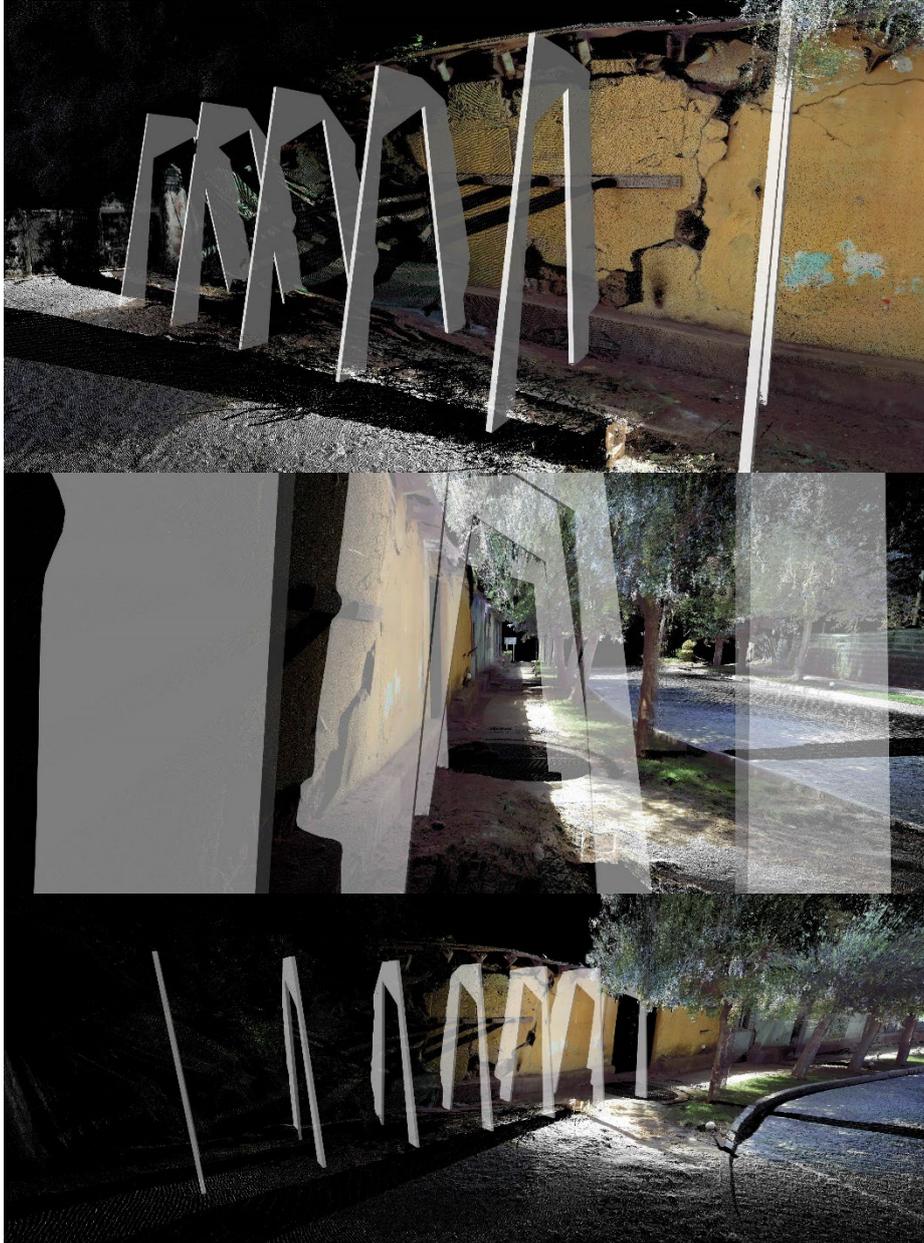
Fig. 18. Exterior emergency supports proposed as temporary corridors. Source: Author.

Their use—exteriorly or interiorly—can reduce the need for complete rebuilding if applied on time, a view shared with Jigyasu [15]. Exterior supports can take the shape of porticos to hold damaged façades together and avoid their collapse over the public space (Figure 18) while allowing a safer pedestrian passage.

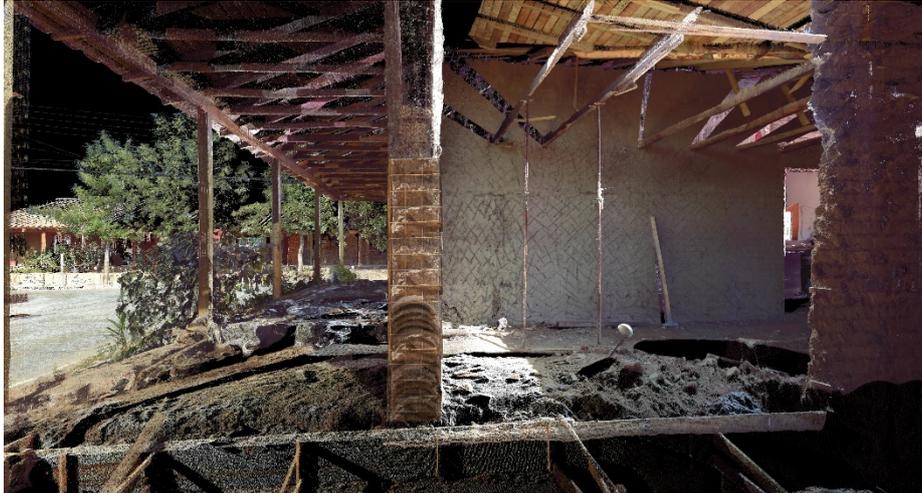
Fig. 20. View of the same affected dwelling in Lolol from the 3D-laser-scanning with proposed storage-walls for materials to be re-used. Source: Author.

To clear the areas that would be re-constructed, one proposal is to dismantle the affected part of the construction while building supports and storing the materials. It is proposed installing a metal structure at the back of the site, next to the shelter, that can serve for storing material temporarily or as walls for future extensions if located strategically from the beginning. This metal structure of thick and hollow walls would be filled with material from the dismantled part, clearing the area for re-construction, and taking advantage of that effort as an initial process of building. For example, if filled with old adobe bricks, the structure would ensure stability while the adobe would serve

only as insulation material. It could be taken out again or these could just become the first walls of a future extension of the house (Figure 20). All of this could be planned using the 3D data.
