# **Laser Scanning Intensity Fingerprint: 3D Visualisation and Analysis of Building Surface Deficiencies**

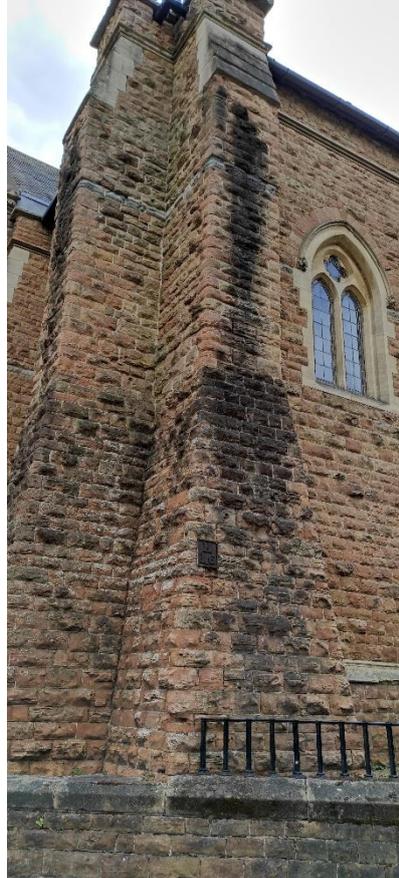
In relation to the conservation status of the case study, as seen in Fig. 1, both the church's straight buttresses and the boundary wall evidence a change in the colour of the masonry work in comparison with other areas without this pathology or presenting minor surface deficiencies. In this way, the vertical plane of the buttress and the wall sector on the right (except for the window area) were considered for this research as the affected area and the reference zone for comparison, respectively.

**Fig. 1.** Colour change in northwest faces of buttresses.

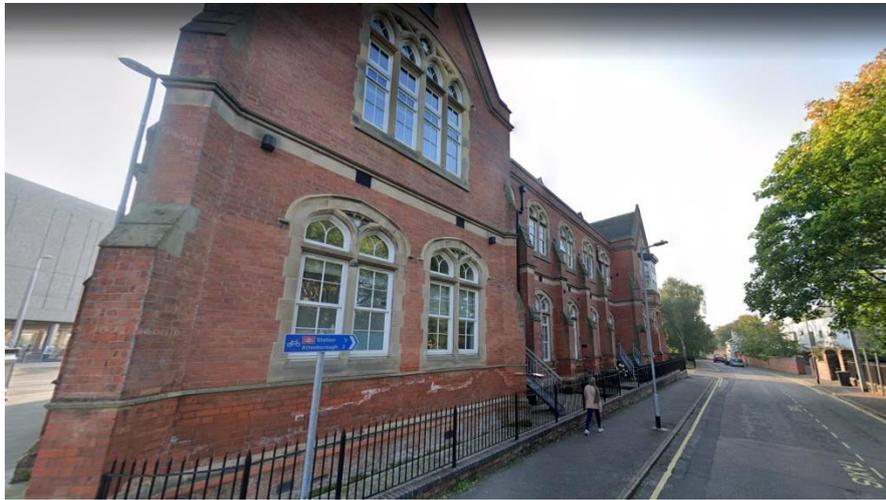
The part of Bromley House addressed in this research is the lower section of the ground floor western façade, which is made of traditional red brick. As a result of capillarity humidities, the façade shows efflorescence in diverse degrees, ranging from low-density areas to those with intense white stains, together with a slight loss of mass in some bricks.

**Fig. 2.** Bromley House. Efflorescence on the lower part of the western wall. Source: Google Street View (Google Inc. 2021).

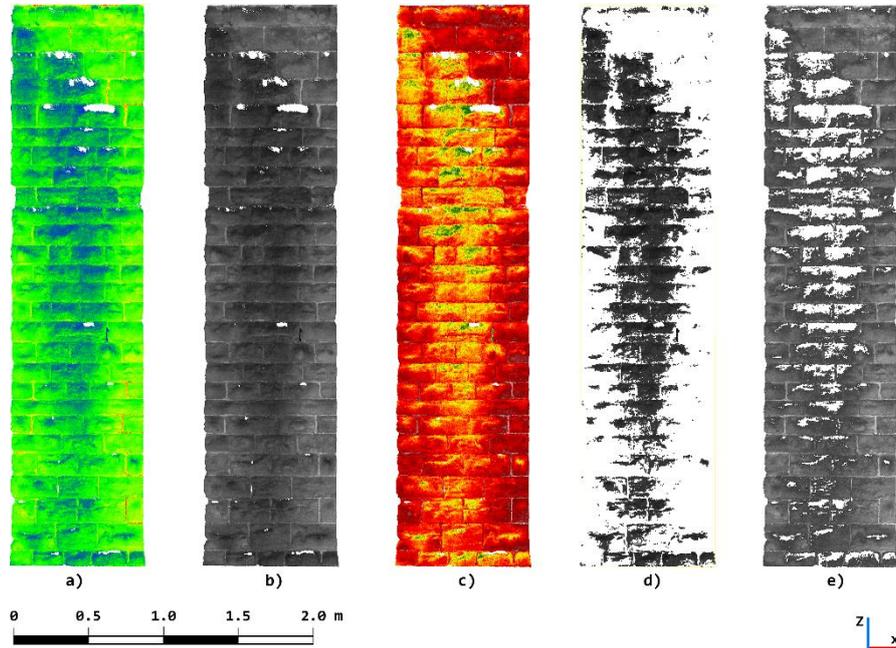
Fig. 3 displays the segmented area of the pathology (1) dataset enhanced with intensities—in different visualisation modes—, where the most affected parts are shown in blue, dark grey, and green colours.

**Fig. 3.** Segmented pathology buttress sector enhanced with intensities: a) blue-green-yellow-red; b) greyscale (monochrome); c) high contrast; d) most severely affected part, in monochrome; e) the rest of the sector, in monochrome.

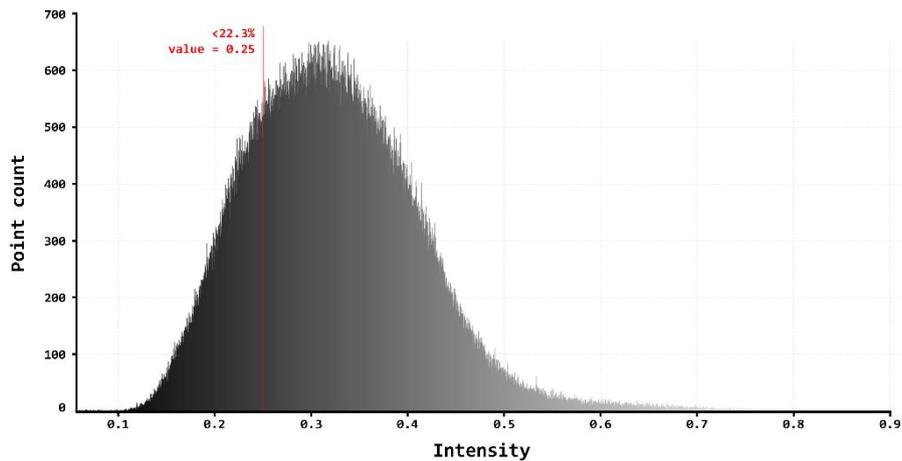
Fig. 4 shows the histogram of point cloud data intensities for the pathology sector (1):

**Fig. 4.** Greyscale histogram of points and intensities of the pathology sector (1).

- 556,171 values (points displaying intensity);
- Mean: 158.91 points (for each intensity value);
- Standard deviation: 213.56 points;
- Point of Interest (PoI): 0.25 intensity value.

Throughout the histogram in Figure 4, the point arrangement is not symmetrical; i.e., at lower intensities, the point count rate increases more significantly than it decreases at higher intensities. In view of Figure 3, that is a consequence of the dark areas on the buttress surface. In this way, by mirroring the highest intensities, the ending intensity value of the pathology was established at 0.25 (PoI) for being the symmetry breaking point. Filtering the TLS point cloud data by the intensity PoI, the dataset is split. The remaining 123,498 points with an intensity value lower than 0.25 correspond to the surface deficiency, which constitutes 22.2% of the total number of points in the pathology sector (1).

As seen in both histograms, the point distribution is more symmetrical in the reference wall zone against the pathology sector. However, in the region of low-intensity values, the curve symmetry starts at 0.315, thus comprising a small portion of the pathology from 0.1 to 0.315. In view of Figure 1, the reference wall sector also presents dark zones, but minor. By filtering the point cloud by 0.315 intensity value, the reference point set can be rectified (Figure 5) and be used as a reference for comparison with the pathology sector.

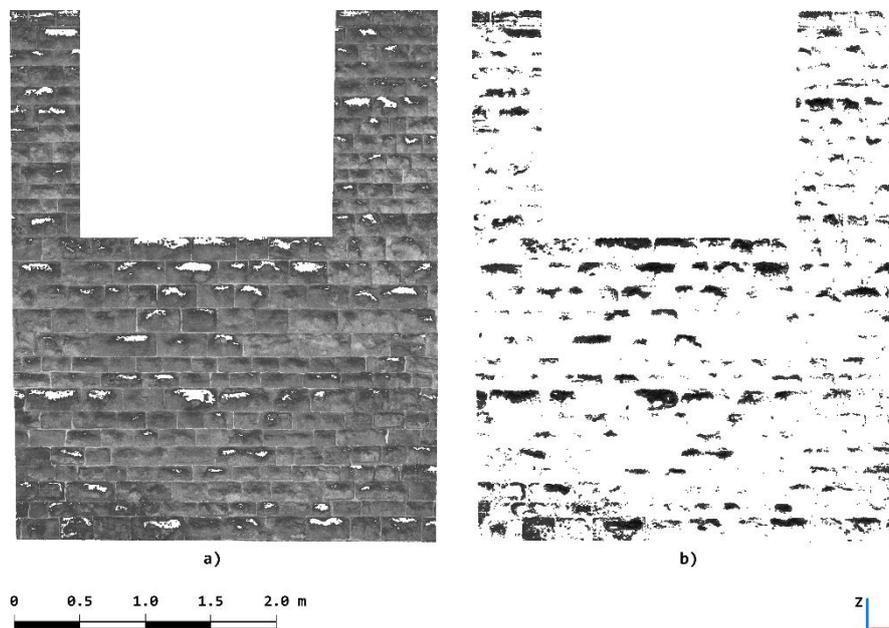
On the other hand, Fig. 5 displays the segmented area of the reference (2) dataset enhanced with intensities in the monochrome visualisation mode. The reference sector was rectified for comparison by excluding minor pathological zones on it.

**Fig. 5.** Segmented reference buttress sector enhanced with intensities, in monochrome: a) rectified reference sector; b) minor pathology in the reference sector.

Similarly to the pathology sector (1), when the point cloud is filtered by the intensity PoI, the remaining 91,475 points correspond to the minor surface deficiency in the reference sector (2) for rectification, which is 5.56% of the total number of points. Finally, considering the pathology (1) and reference (2) sectors, it is worth analysing the distribution of their data. The coefficient of variation (standard deviation divided by the mean) yields values of 1.344 and 1.328, respectively. This reveals a slightly lower dispersion of the data in (2), which indicates that the points not affected by the pathology prevail.

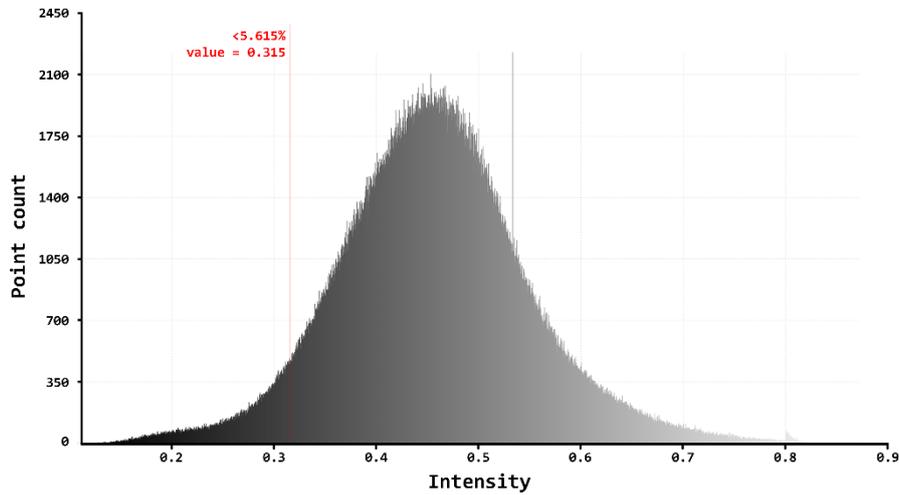
Fig. 6 shows the histogram of point cloud data intensities for the reference zone (2):

**Fig. 6.** Greyscale histogram of points and intensities of the reference zone (2).

- 1,645,779 values (points displaying intensity);
- Mean: 470.22 points (for each intensity value);
- Standard deviation: 624.32 points;
- PoI: 0.315 intensity value.

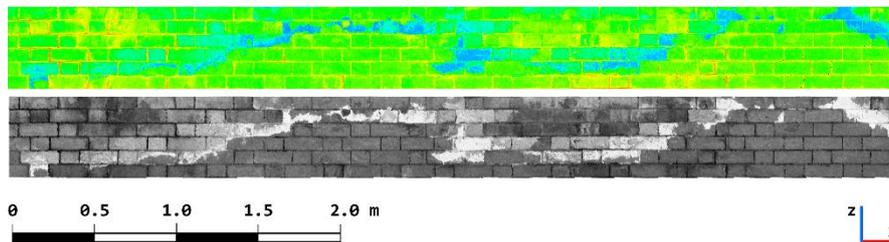
Efflorescences are the result of crystallisation of salts on the material surface (Lerma et al. 2014). This pathology can be easily identified in a photograph and detected using TLS because of the aforementioned changes in laser beam reflection intensity. Fig. 7 displays the segmented area of the point cloud enhanced with intensities, where the more severe efflorescences are shown in blue and light-grey to white colours, respectively.

Fig. 7. Segmented wall sector point cloud: top) blue-green-yellow-red; bottom) monochrome.

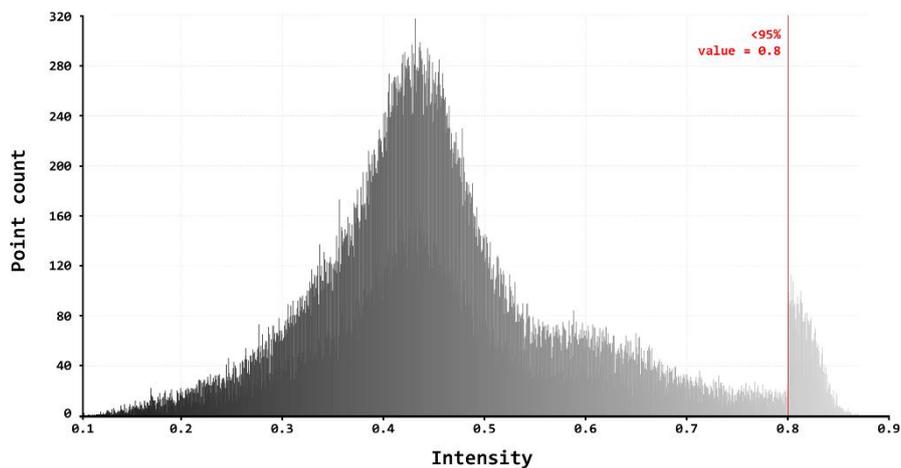
Given the reduced number of points in comparison with the St Andrew's Church case study, the analysis of the point cloud intensities was carried out considering 2,000 classes. Fig. 8 shows the histogram of point cloud data intensities:

Fig. 8. Greyscale histogram of points and intensities.

- 119,772 values (points displaying intensity);
- Mean: 59.89 points (for each intensity value);
- Standard deviation: 65.89 points;
- Image digital level (Digital Number, DN): from 39 to 223 (dark grey to light grey in the histogram);
- Digital level for 0.8 intensity value: 203.

Unlike the more gradual behaviour of the point count rate in the buttress case study, the histogram above (Figure 8) presents a breaking point in the distribution of points among the intensity intervals in the region of 0.55 intensity value. Considering Figures 7 and 8 together, 0.55 could represent the starting intensity value of the pathology (efflorescences), which is on the right side of the histogram, by the highest intensities. However, it is the sudden increase in the number of points for the 0.8 intensity value that causes it to become a PoI in the histogram, leaving 5% of points above.

Next, the relationship between the surface pathology, the point cloud intensities, and the DN of the images should be addressed. In the histogram's greyscale range (image DN from 39 to 223), the starting and ending colours are not black and white, respectively. Therefore, that range differs from the full range [0,255] (256 levels, 8-bit encoding) of the point cloud intensities in Figure 7 (from black to white), which makes it necessary to convert the former values into a comprehensive scale. Considering the current scale:

In view of those results, 5% of the points are within 9% of the intensities, which correspond to the highest values. Therefore, it can be stated that the most affected region of the pathology comprises those DN from 232 to 255 (white). Hence, filtering by intensity value, it is possible to extract that 5% of points (6004) from 0.8 to approximately 0.87 intensity. In this way, the most affected part of the building surface deficiency (0.13 m<sup>2</sup>) can be detached from the rest of the sector (the total area is 2.63 m<sup>2</sup>). It is also worth quantifying the intensities ranging from 0.55 (value where the efflorescences start) to 0.8 (lowest value of the most affected area). In this case, there are 20,369 points affected, 17% of the total number of points in the original segmented sector. Therefore, the complete pathology represents at least 22% of the entire surface area, approximately 0.58 m<sup>2</sup>. The intensity values mentioned above were verified by enquiring the DN of the colour of points in the images, such as the starting and ending value of the ranges, and the PoI. Fig. 9 shows the entire pathology subdivided into the affected zone and the most affected area, both filtered by the corresponding intensity values above.

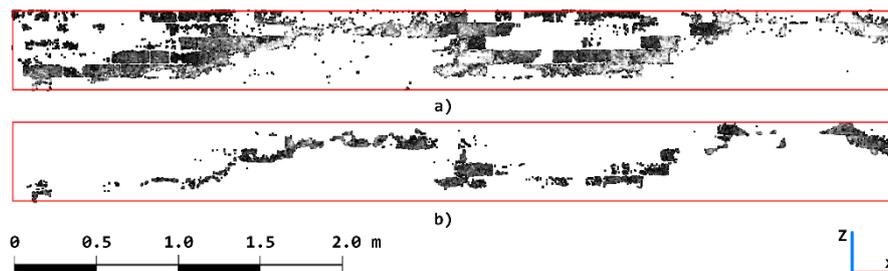
**Fig. 9.** Filtered efflorescences, in monochrome: a) intensity value range [0.55,0.8]; b) intensity value range [0.8,0.87].

Finally, both case studies should be discussed together. As seen in the results, the arrangement of points of the St Andrew's Church pathology is gradual, whereas the Bromley House's wall sector presents a clear symmetry breaking point around the 0.55 intensity value and a radical change in the distribution of intensities at 0.8. Besides, the coefficient of variation is 1.10 in the Bromley House wall sector, significantly lower than those in the first case study. By concept, this indicates a lower dispersion of the data, i.e. the distribution of points per intensity interval is more homogeneous. Nevertheless, this means a higher range of intensities corresponding to the pathology; in other words, the pathologies stand out from the reference range of intensities (the rest of the wall sector with no surface deficiency).
