Towards Detailed Digital Examination of Masonry Railway Bridges Using Terrestrial Laser Scanner

Arijit Sen¹, Saeed Talebi^{2*}, Song Wu¹ and Mark Shelbourn²

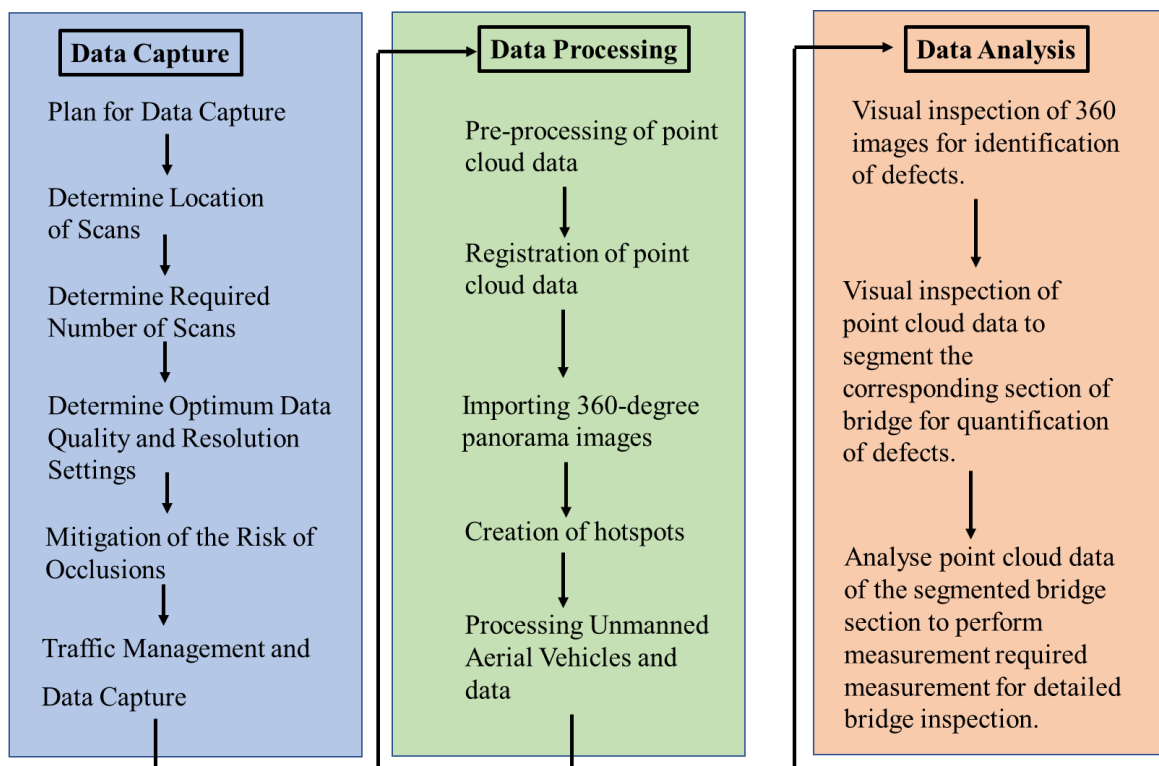
The proposed digital bridge examination process involves three steps namely data capture, data processing and data analysis as presented in Figure 1.

Figure 1. The proposed digital bridge examination process

The data capture activities start with proper planning for data capture which includes the determination of scan locations, determination of the number of scans required, optimum data quality and resolution setting, mitigation of risk of error, traffic management and data capture. The basic parameters of quality and resolution need to be correctly selected to obtain an accurate as-built data set. Having higher resolution and quality can increase the accuracy of data sets but they also significantly increase the time required to capture data. It is recommended to have more scans at lower scanner settings, rather than having a lower number of scans with higher settings. There are limitations which can have an impact on the workflow and the quality of the final data set. The most frequent instances are vegetation, vehicles and pedestrians obscuring capture, poor light, flooding, damp/rain, litter, animals, difficult terrain, limited safe working space, parking restrictions, narrow footpaths, existing structures and compass error. Vegetation and obstructions are common problems at many sites, obscuring data and preventing access in some cases. At structures where vegetation is an observation constraint occluding part

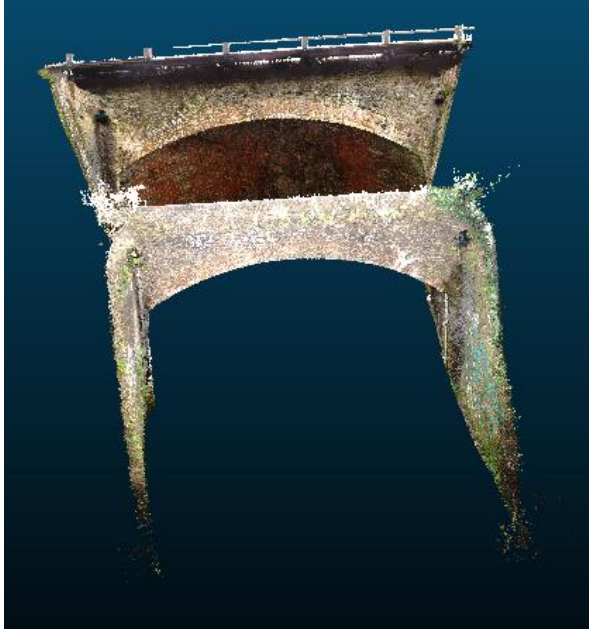
Figure 3. Cleaned and registered point cloud data of a masonry bridge.

captured point cloud data are collected for analysis to detect and quantify the defects mentioned in Table 1. Point cloud data is captured with a resolution of 10240×4267 pixels and point distance of 6.136 mm/10 m. 360 images are captured with resolution of 2748×3664 pixels. FARO Focus 3D (X330) TLS scanner was used for point cloud data capture and ISTAR 360 panoramic camera was used for 360 image capture. The registration process of TLS captured point cloud data is accomplished using FARO SCENE software. Figure 3 shows the cleaned and registered point cloud data of one of the bridges used in the project.

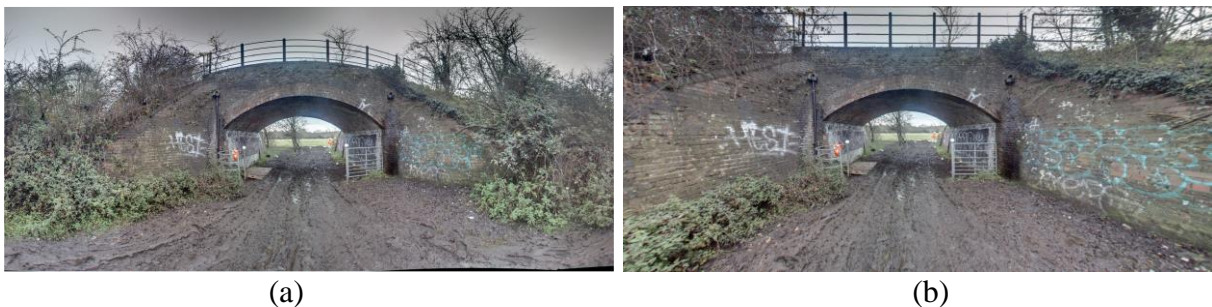
Figure 4-a shows the flat representation of 360 images of the same bridge shown in Figure 2. Figure 4-b shows the folded representation of the 360 images shown in Figure 3-a in a virtual tour environment.

Figure 4. (a) Example of a captured 360 image (flat image), (b) Example of a 360 virtual tour (folded image)

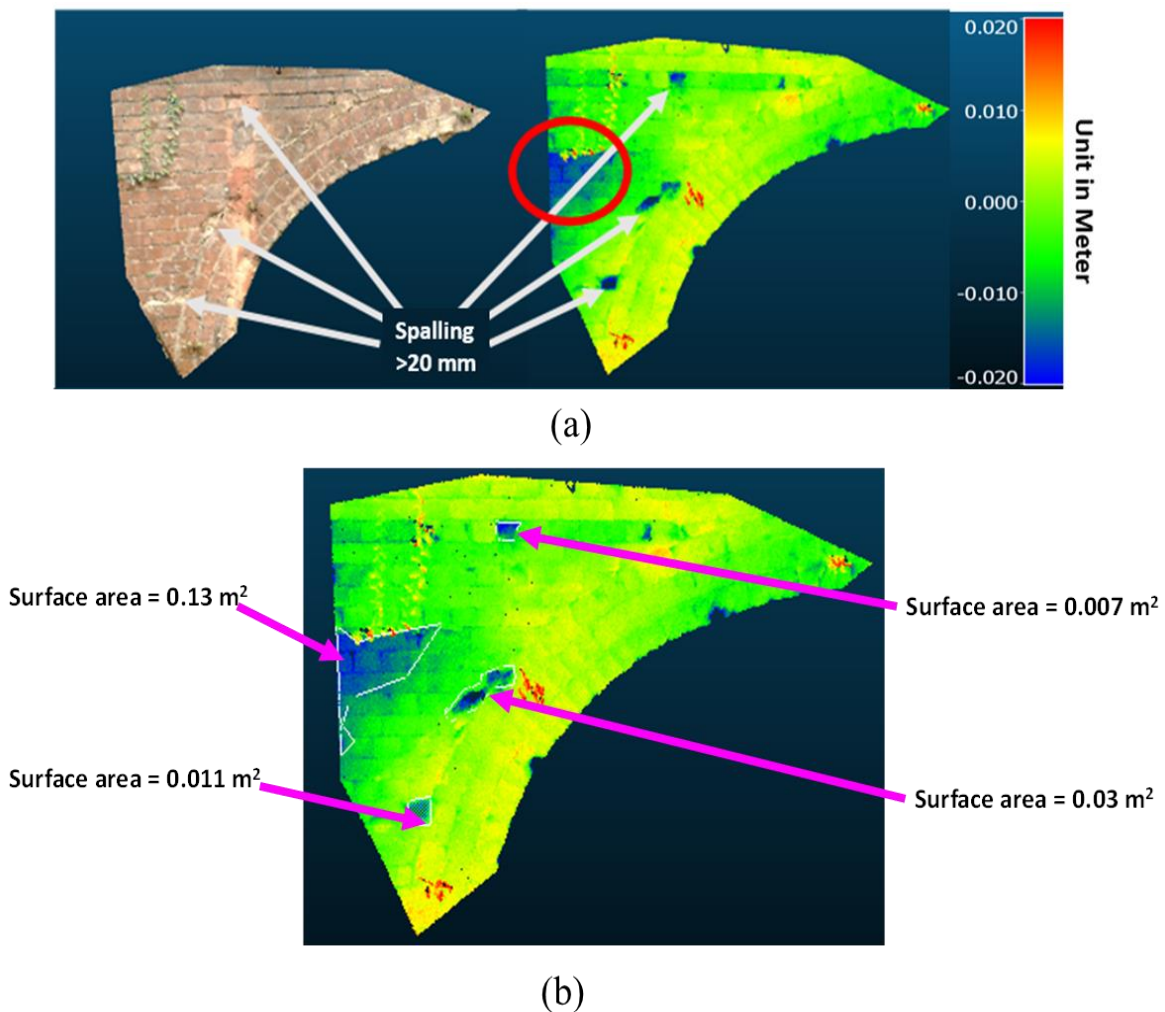
Figure 8-a shows an example of spalling detection using the proposed method at less than 20 mm depth and Figure 8-b shows the quantification of spalling in accordance with the measurement requirements presented in Table 1. The linear measurement related to the depth of spalling can be achieved from the colour bar associated with the scalar field representations in Figure 8-a. Measurement of any area can be performed in CloudCompare by bounding that area with a polyline and extracting the estimated area from its property pane. Figure 8-b shows an example of area measurement for spalling.

Figure 8. (a) detection of spalling from point cloud data, (b) quantification of spalling.
