An investigation of the moisture content in the walls of a straw-bale building

Steve Goodhew*¹ ^a, Richard Griffiths^b and Tom Woolley^c

Abstract

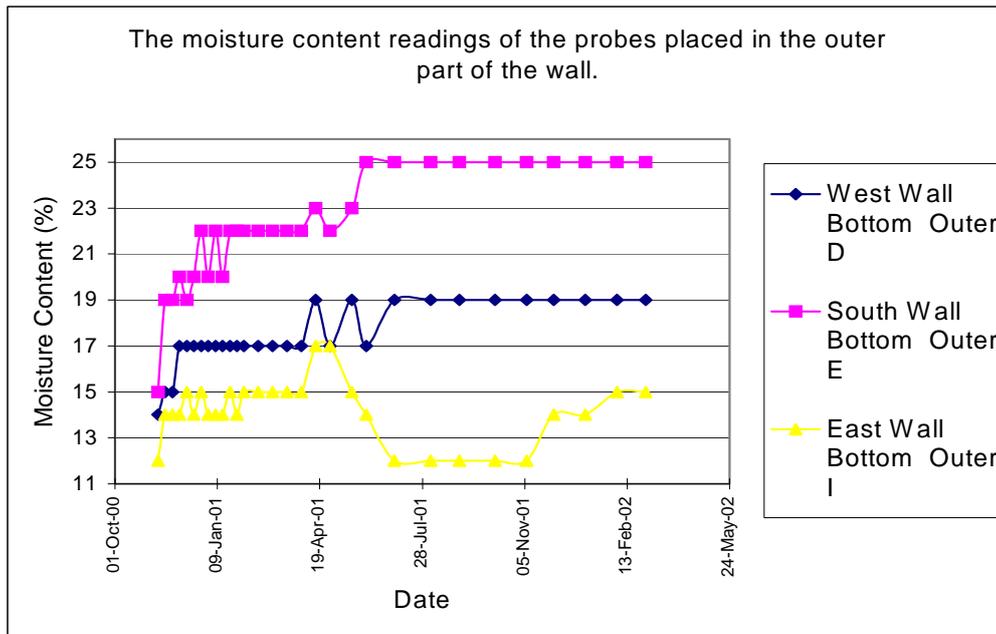
Figure 4, Moisture content of the outer section of the three main orientations of the straw-bale walls of the case study building.

As expected, the three outer probes, gave moisture readings that are influenced by the exposure at each wall. The south facing façade is most exposed and starts from a moisture content close to 15% and steadily rises to an equilibrium moisture content of 25%. The west and east facing walls have initial moisture contents of 14% and 12% respectively. Both east and west walls moisture content are steady until the 19th April 2002, but then sharply increase. The moisture content of the east wall falls to 12% and then gradually rises, in contrast to the more steady moisture content of the west wall, remaining at 19%.

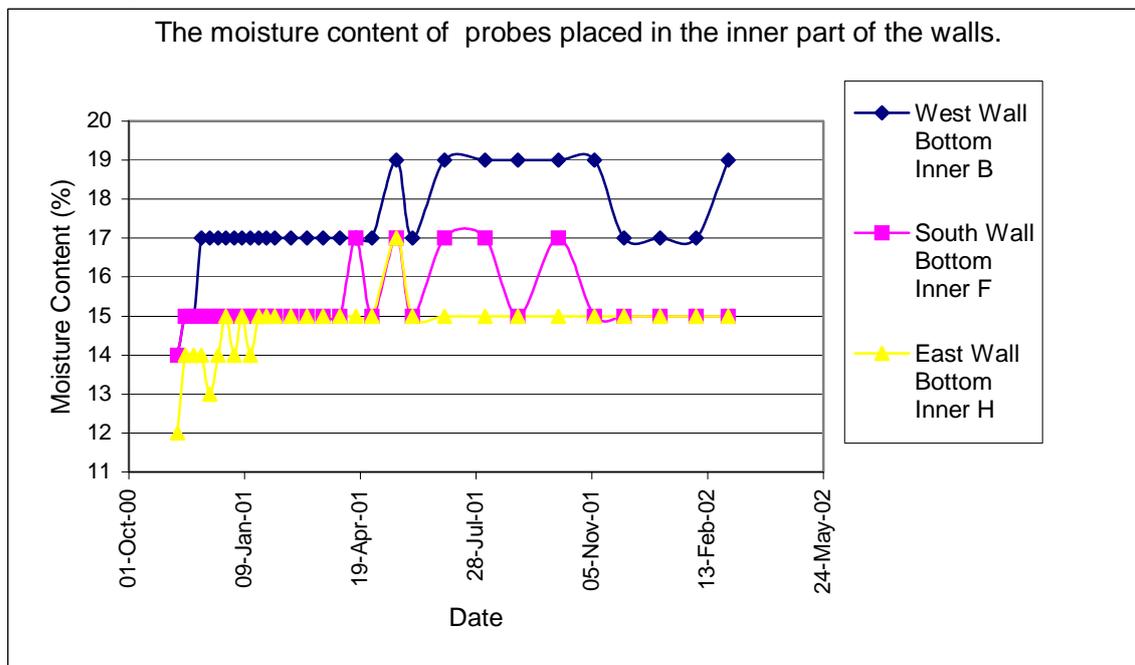
Figure 5, Moisture content of the inner section of the three main orientations of the straw-bale walls of the case study building.

Unsurprisingly, figure 5 shows the inner wall probes record initial moisture readings similar to those recorded for the outer parts of the same wall. However, the south facing wall is drier than the west facing wall, reversing the trend shown by the outer probe readings.

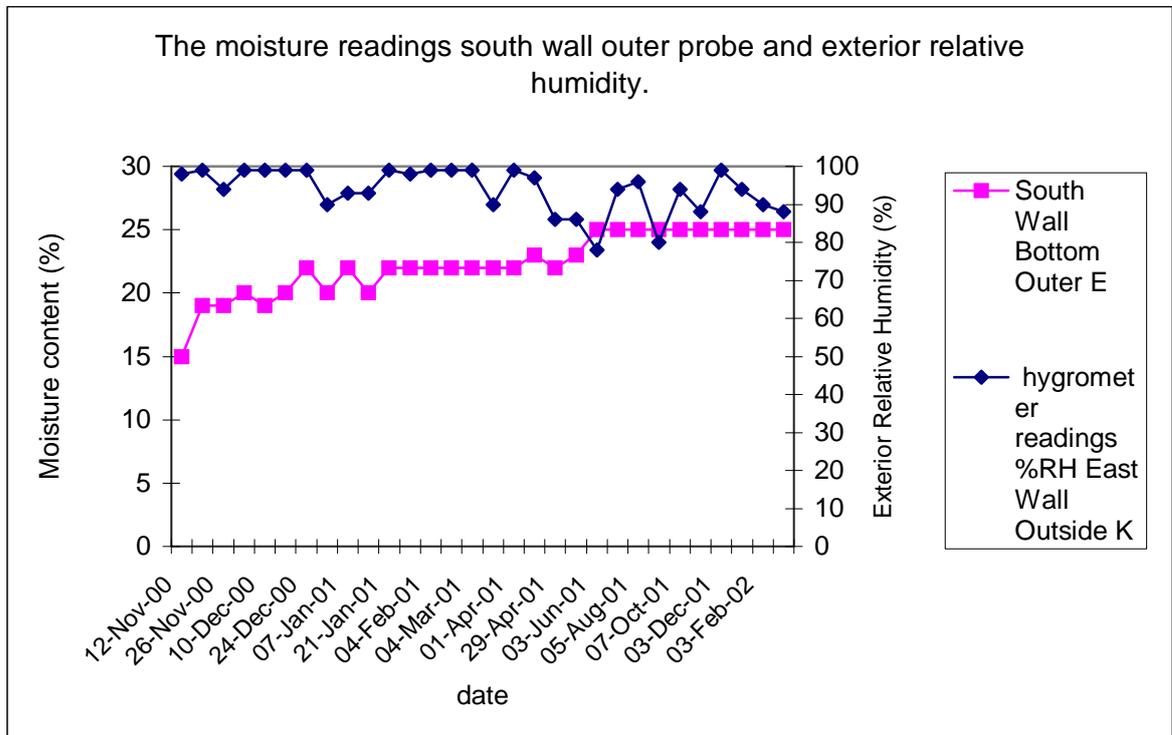
Figure 6, Moisture readings south wall, outer probe and exterior humidity.

The moisture content readings shown in figure 6 are taken from the outer lower probe in the most exposed, southerly wall. It can be seen that as the outside humidity rises, the moisture content of the wall drops. This may indicate that there is no connection between the relative humidity of the outside air and the moisture uptake of the lower, outer part of this wall. However, changes in temperature may have a further influence on these moisture values, but this information is not available.

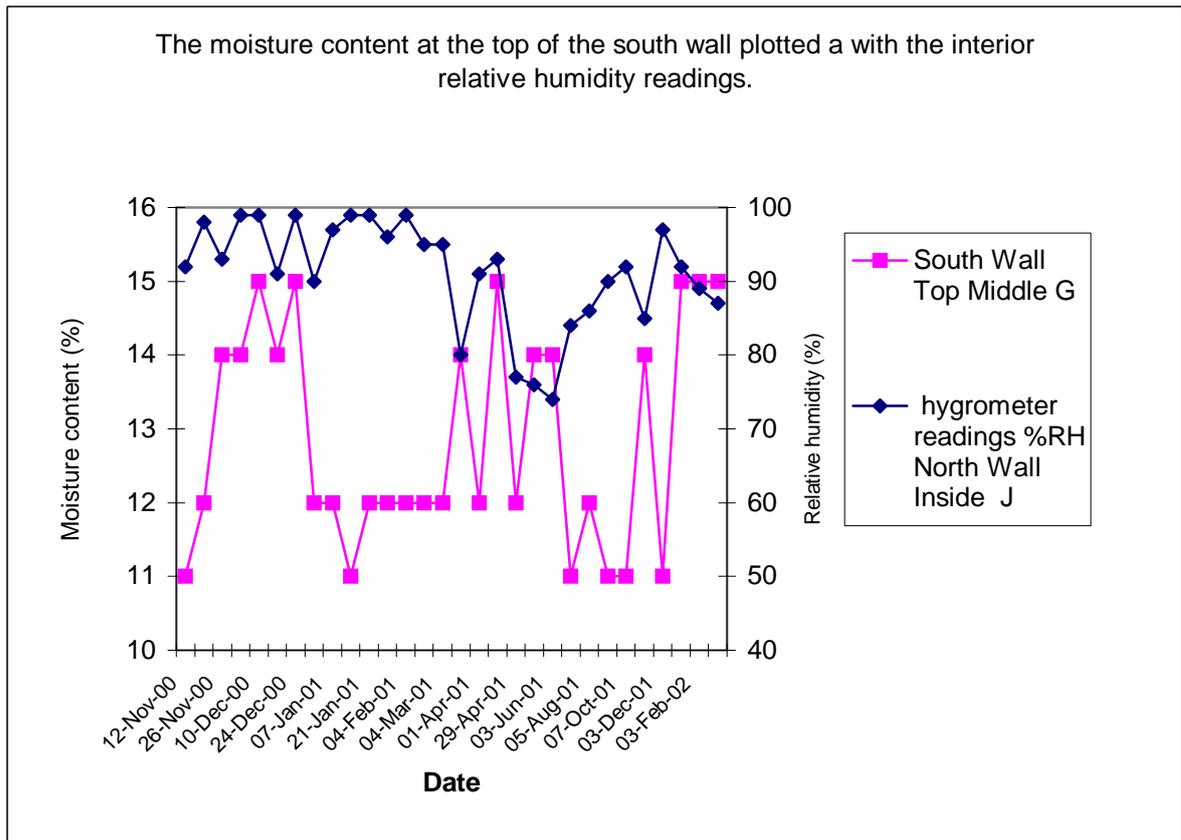
Figure 7, Moisture readings south wall, outer probe and interior humidity

The moisture content readings shown in figure 7 are taken from the middle upper probe in the most exposed, southerly wall. Similar to the readings shown in graph 3 the readings at first appear unconnected, but there maybe the hint of a delayed influence of the interior relative humidity upon the upper, middle part of the south wall. The rise and then dip in the exterior relative humidity readings, peaking at 98% on the 4th February 2001 and dipping to 75% at 3rd June 2001 appear to cause a similar peak in wall moisture readings of 15% at about the 1st April 2001 and a dip down to 11% at around the 7th Oct.

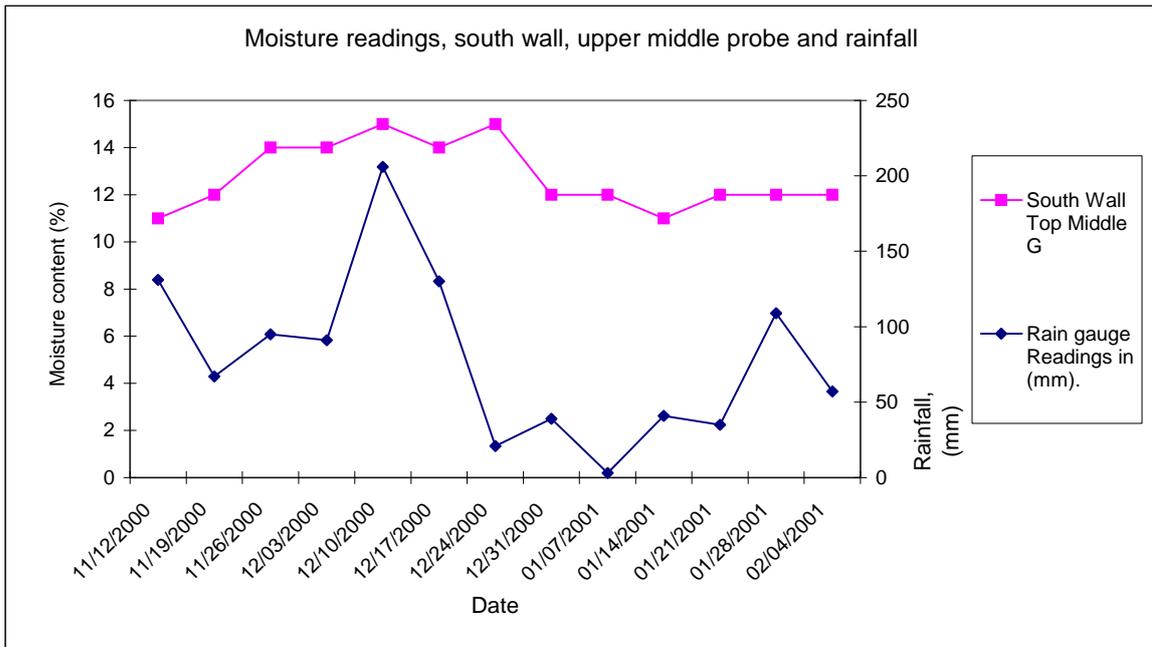
Figure 8, Moisture readings south wall, upper middle probe and rainfall.

Figure 8 shows the measured readings from the top of the southern wall and plots the rainfall measured close by. In December 2000 and to a lesser extent in late January 2001, a peak in the rainfall is reflected in a peak in the wall's moisture content.

A better correlation between the average rainfall close to the building and the moisture content of the upper part of the 'wettest' wall was observed. There was no evidence of water ingress due to faulty render or roofing coverage to suggest that wind-driven penetrating dampness was responsible for this association. The average moisture figures from the probe in the top of the south wall were quite low compared to the readings from the probes at different orientations and lower down and considerably lower than the lower outer probe readings from the same wall. It therefore suggests that the drier the straw-bale wall the more readily it will be to take up moisture associated with rainfall, but not necessarily from water vapour in the surrounding atmosphere.

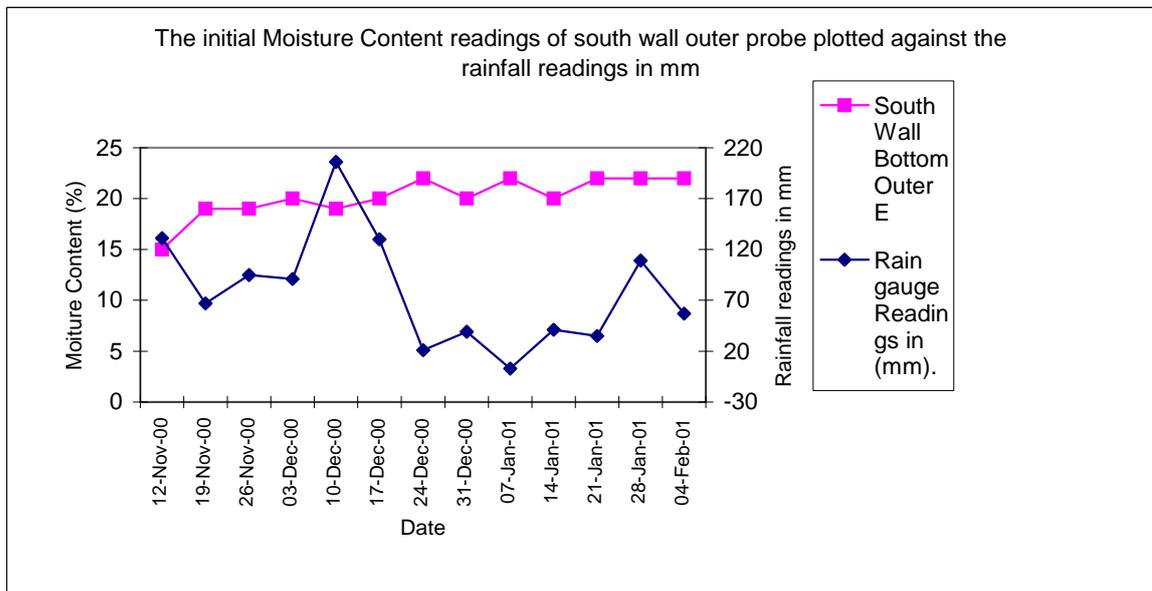
Figure 9, Moisture readings south wall, upper middle probe and rainfall.

Figure 9 shows the measured moisture readings from the lower outer region of the southern wall with the rainfall that was measured close by. The same rainfall peaks shown in figure 7 do not appear to have affected the wall's moisture content.

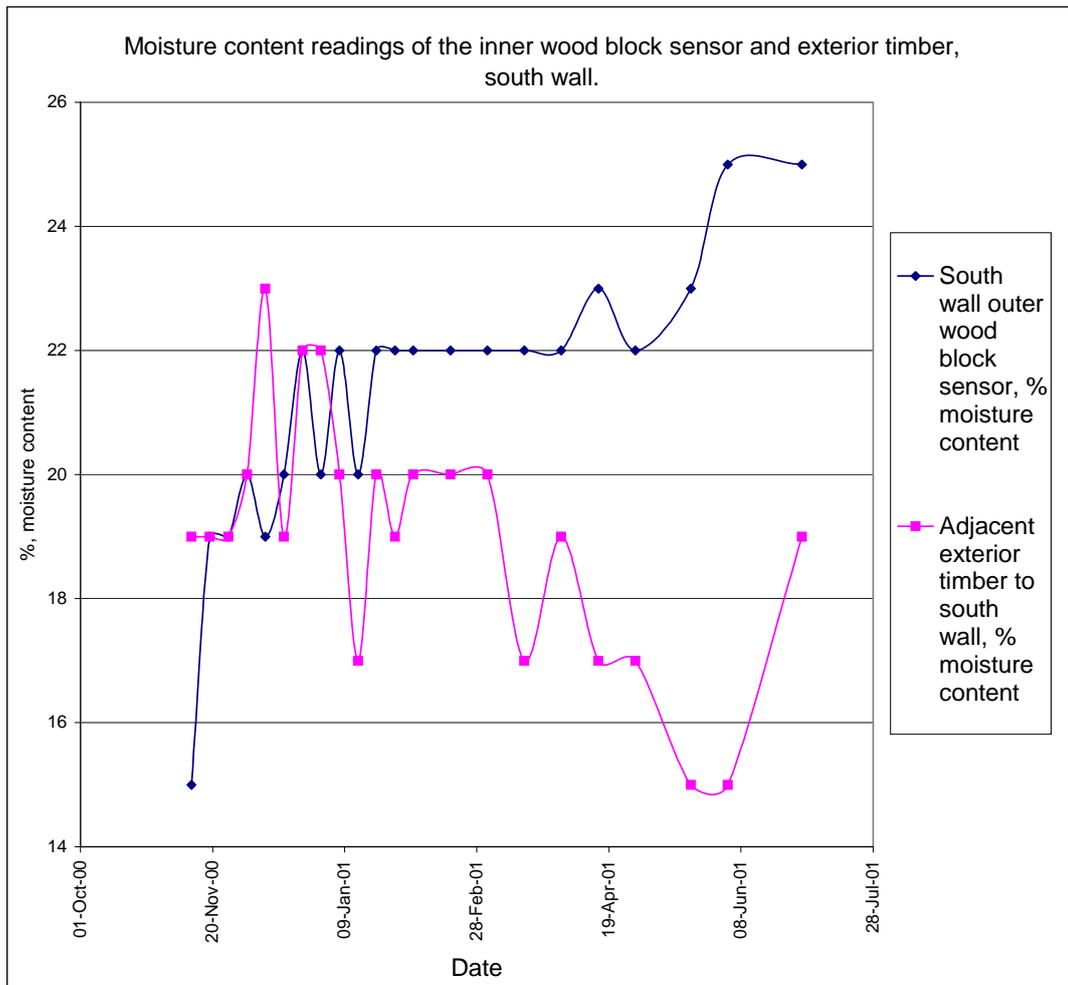
Figure 11, Results of moisture content measurements using the inner wood-disc sensor and exterior adjacent timber in the south wall of the case study building between November 2000 and July 2001.

Figure 11 shows a similarity in the moisture content readings of the straw-bale probe and the exterior timber until the spring of 2001. At this point the exterior timber dries whereas the moisture content of the straw within the wall continues to rise. The divergence is at its greatest in the summer of 2001 when the exterior timber is approximately 8% drier than the readings from the straw-bale wall. This level of divergence is obviously not a good indicator of the moisture conditions within the straw-bale wall. For this reason it is probably only best to use exterior timber reading as an indicator of straw-bale walls moisture content during the winter months and only as a guide.
