EXTERIOR BRICK WALLS: LEARNING NON-QUALITY THROUGH FAILURES AND CLIMATE-PATHOLOGICAL DISTRIBUTION

*Manuel J. Carretero-Ayuso¹; M^a Teresa Pinheiro-Alves².
Daniel Antón³ and María Fernández-Alconchel⁴*

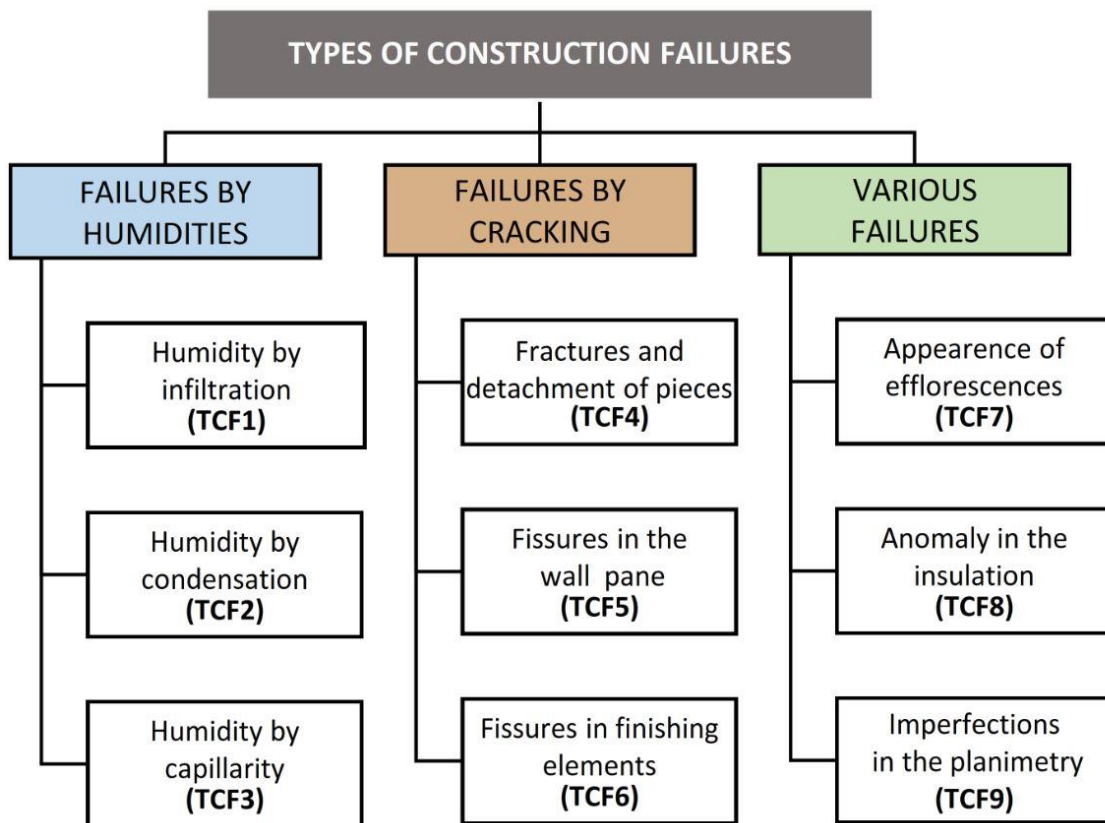
Figure 1 – Types of construction failures found

In this research, a total of 1043 cases of construction failures were found to have a connection with the external brick walls of dwellings (398 in 2016, 349 in 2017, and 296 in 2018). There are two finishing variants in these external walls: cladded walls – with rendering – (W1) and facing walls –brick-faced walls – (W2). The data collection was systematised accordingly, yielding a characterisation of 9 types of construction failures (TCF) that are indicated in Figure 1 and are defined at the end of the paper.

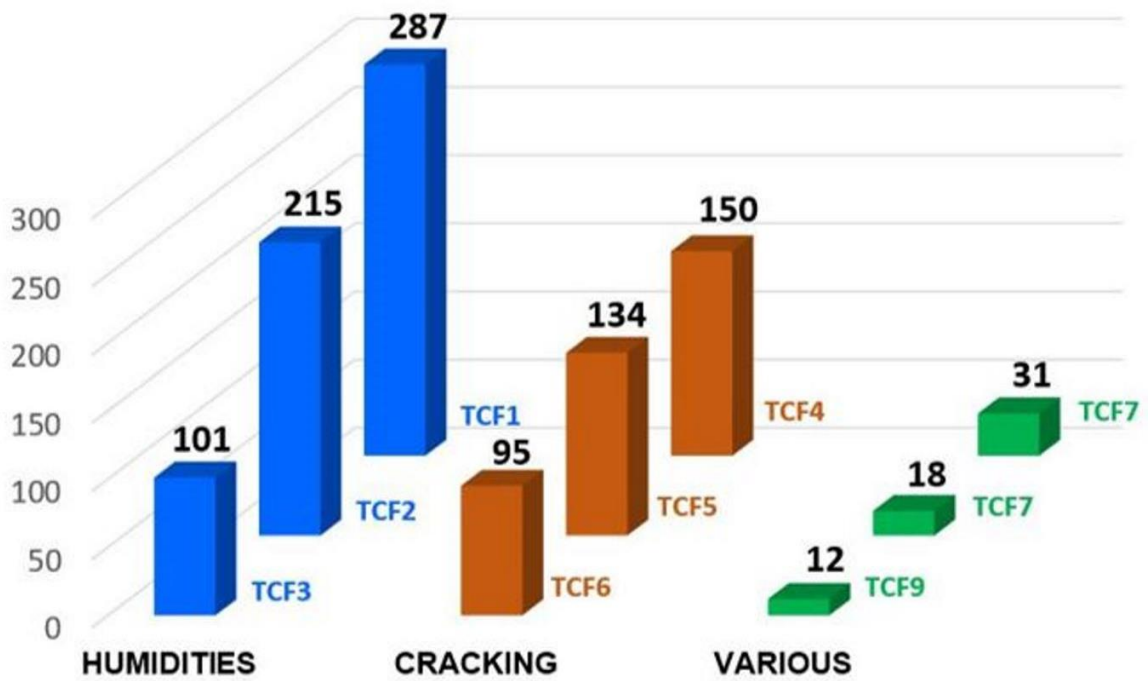
Figure 3 – Number of cases by type of construction failure

Figure 3 shows the number of cases found for each of the 9 types of construction failures. The type of failure with the most cases was ‘humidity by infiltration’ (TCF1=287), which represents 27% of the total. It is followed by ‘humidity by condensation’ (TCF2=215) and ‘fractures and detachment of pieces’ (TCF4=150).

The variables ‘situation’, ‘latitude’, ‘climate’ and ‘annual rainfall’, indicated in Table 2, the dwelling typology, and the finishing variants W1 and W2 are interrelated to the construction failures shown in Figure 3 in different ways and intensities. The percentage of recurrence is expressed in the following sections, sorted by type of construction failure.

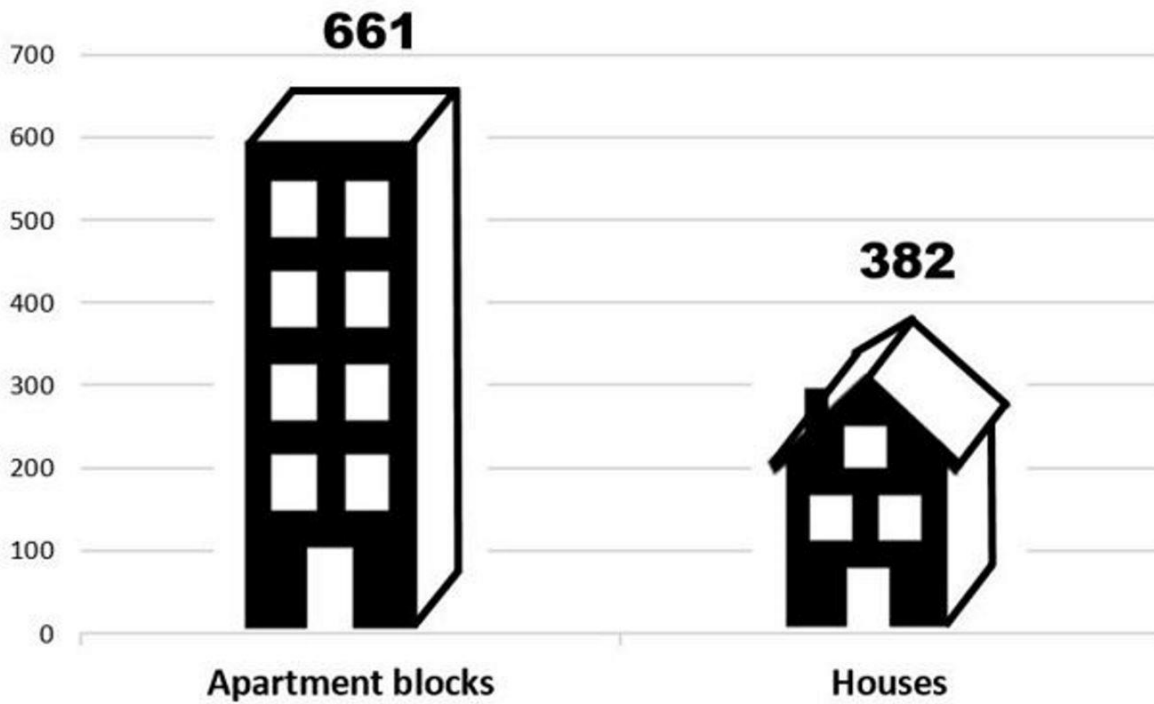
Figure 4 – Number of cases according to dwelling typology

The cases were broken down according to the dwelling typology in which they occurred (see Figure 4). Most of the time (nearly two thirds of the time), failures were concentrated in apartment blocks (689 cases). Just over a third occurred in houses, be they detached or attached to other houses. It should be noted that these general values are in accordance with the dwelling typology built in Spain, where there is a clear preponderance of apartment blocks.

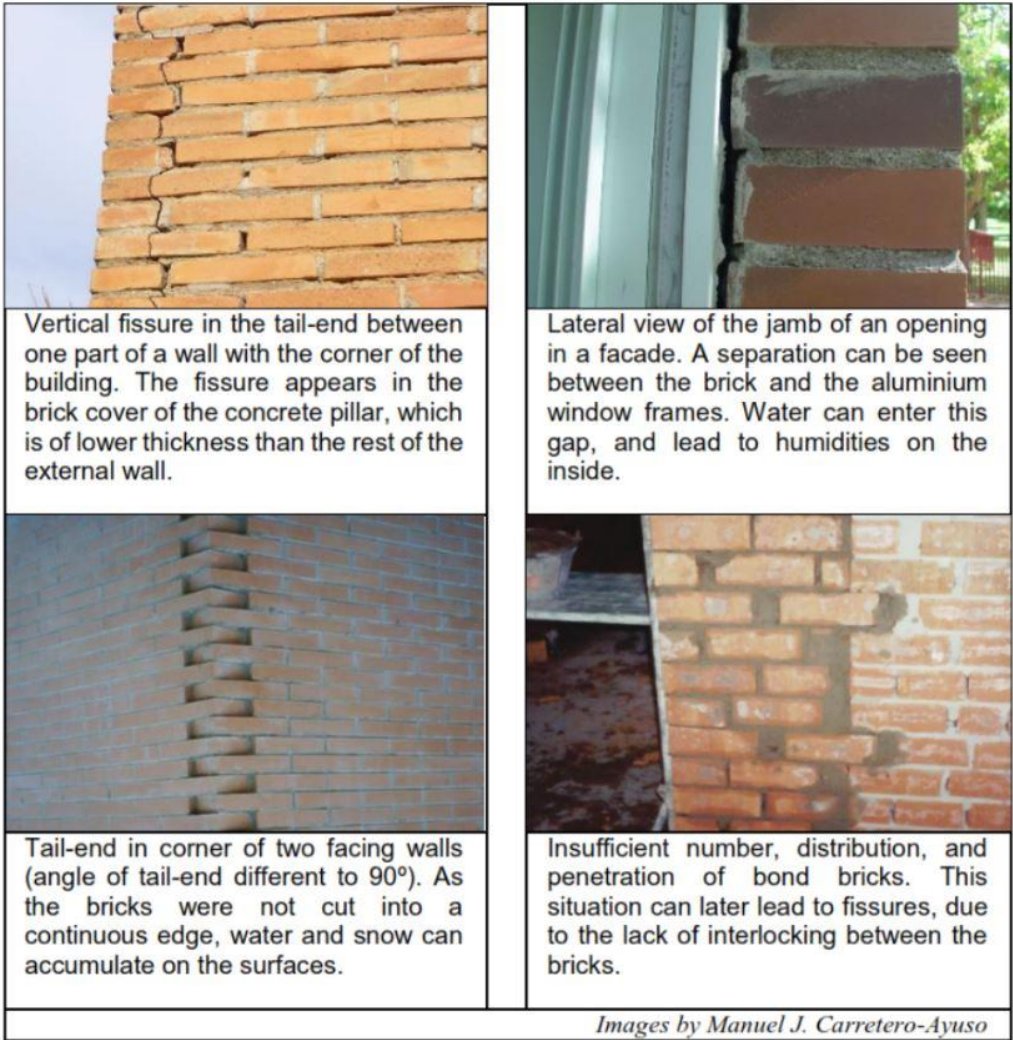
Figure 5 – Photographic examples of several execution problems

It was found that the different failures studied can occur as a result of irregularities or deficiencies during the construction works. Quality control during the execution of the works is fundamental so as to prevent cases that lead to problems during the service life of the external walls. Indeed, it was found that these situations can very frequently lead to cracks or humidities issues. Figure 5 shows some photographs that visually depict some of these deficiencies.
